Letter of Notification for the Fostoria – East Lima 138 kV Transmission Line Rebuild Project

(East Lima – North
Woodcock and New
Liberty – West End
Fostoria)

PUCO Case No. 24-0076-EL-BLN

Submitted by:
AEP Ohio Transmission Company, Inc.

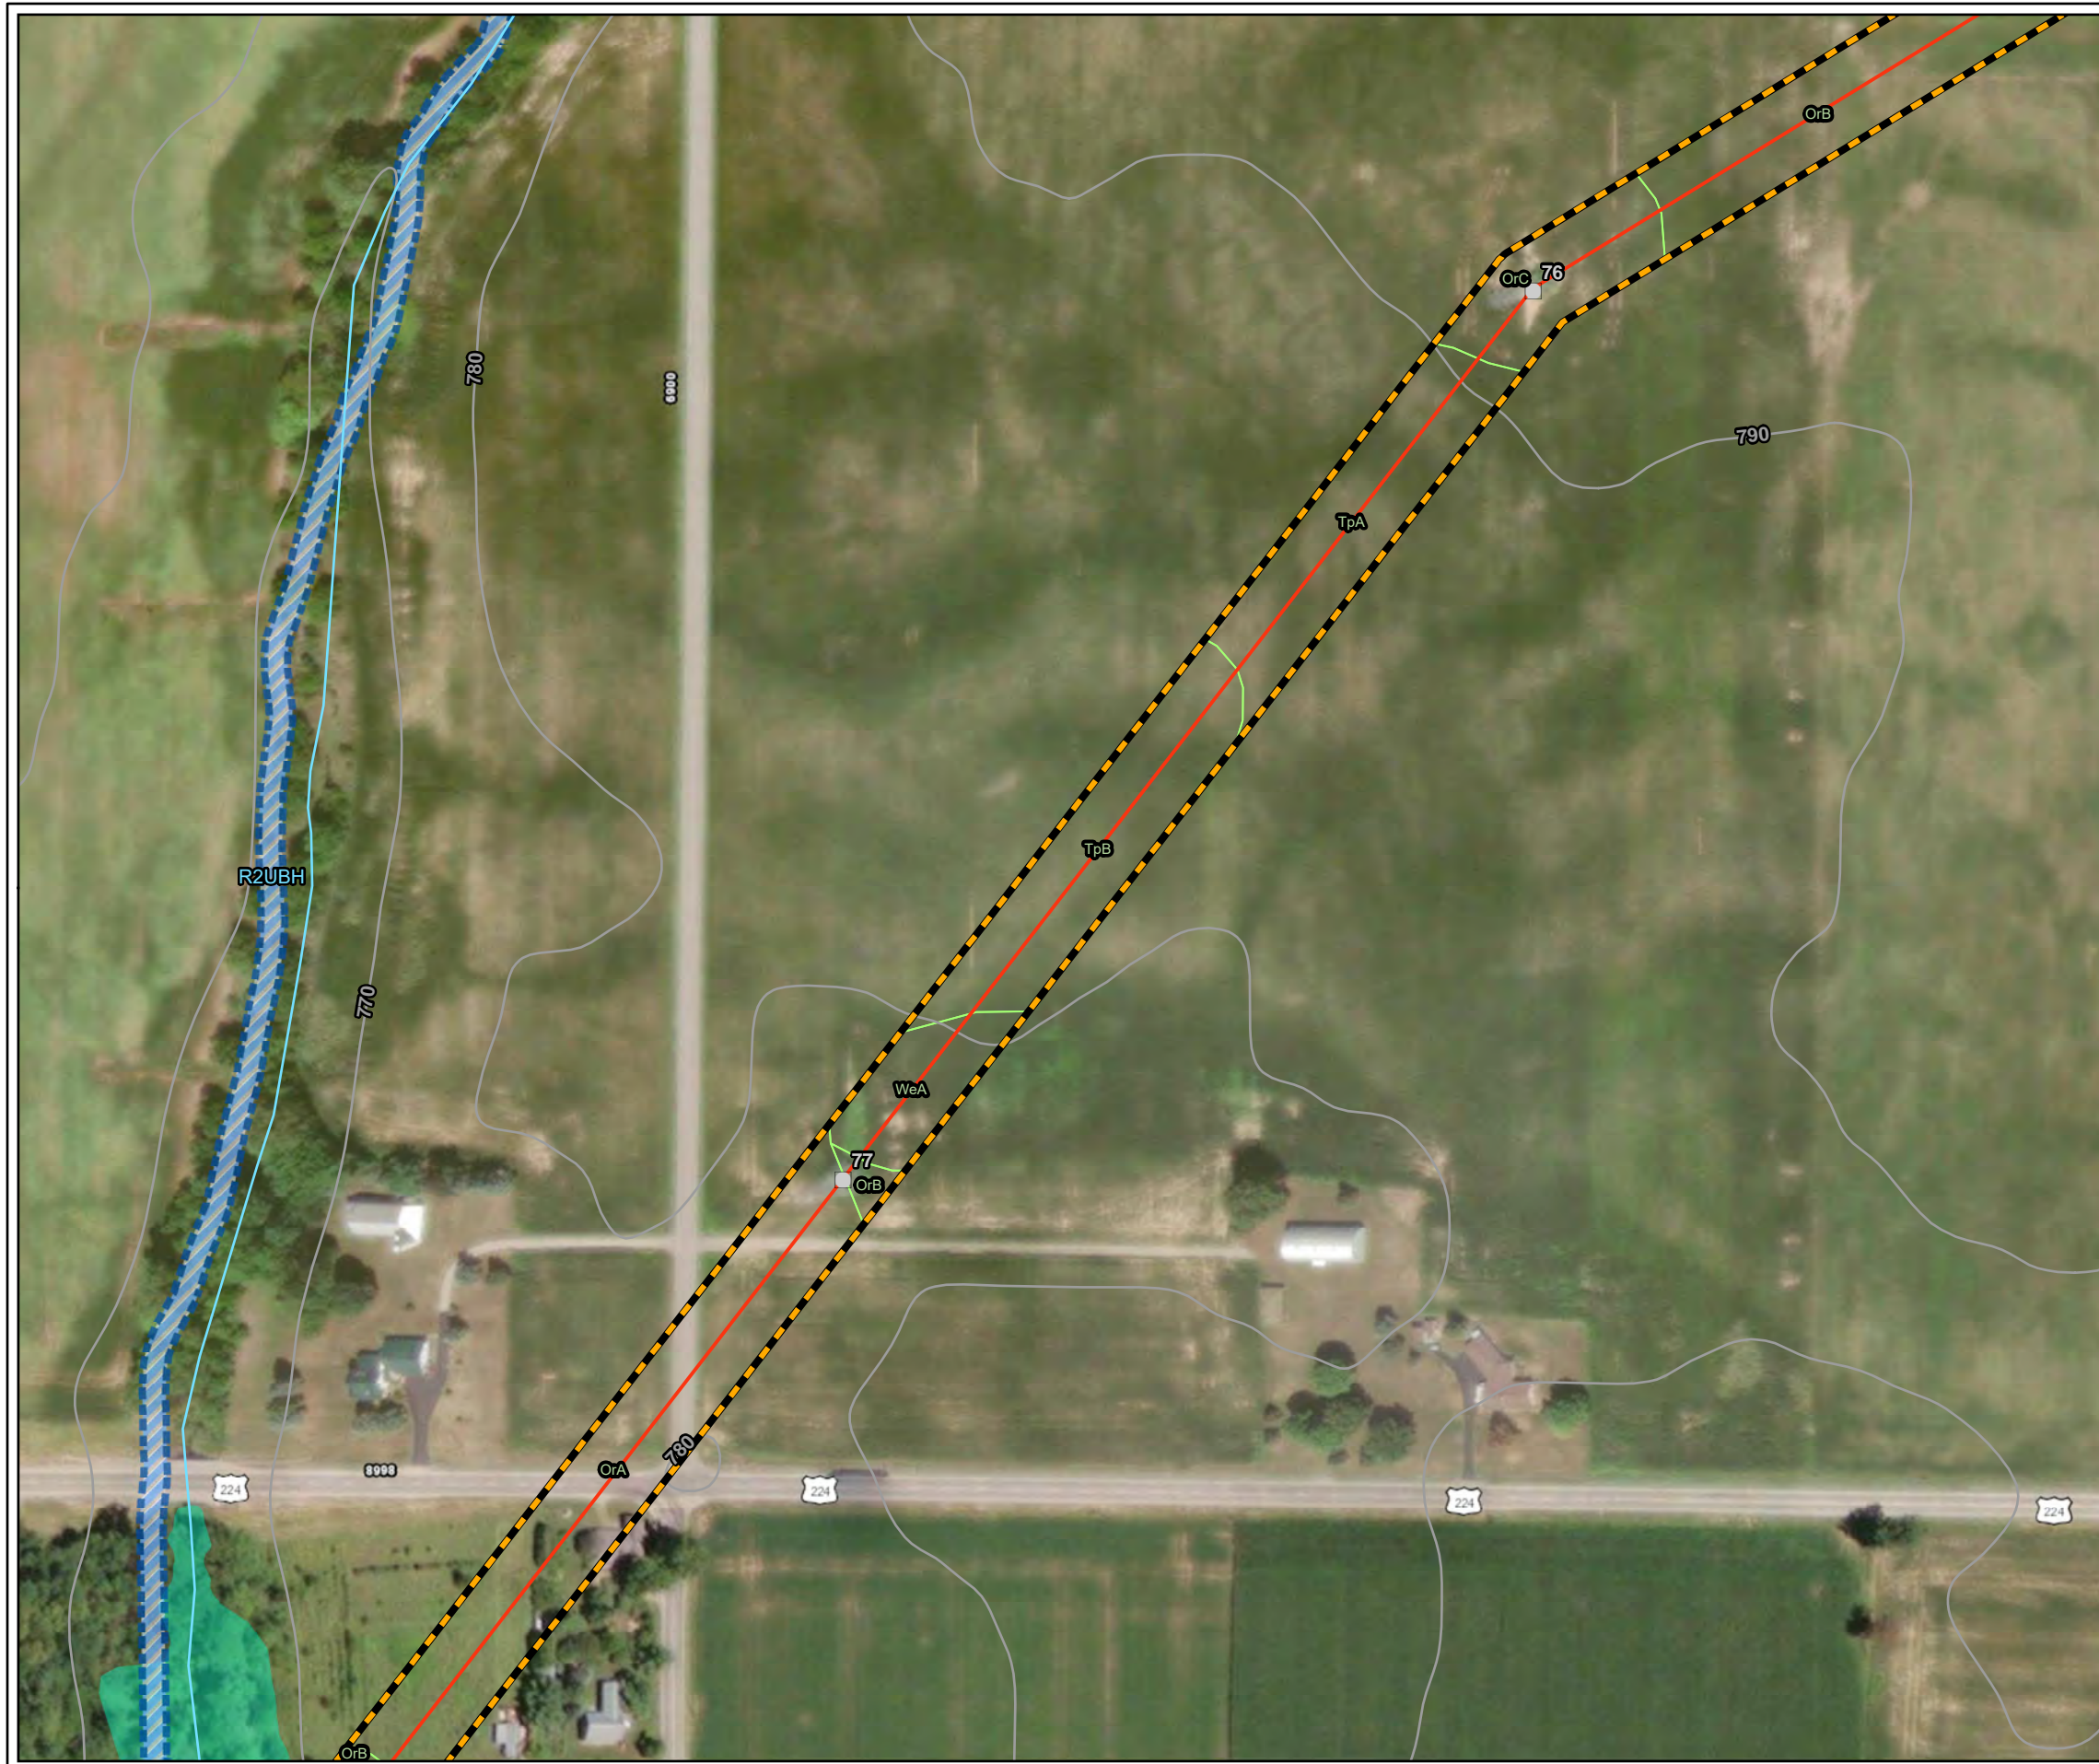
Figure 2. Aquatic resource delineation on the AEP Fostoria—East Lima 138 kV Transmission Rebuild Project in Allen and Hancock Counties, Ohio.

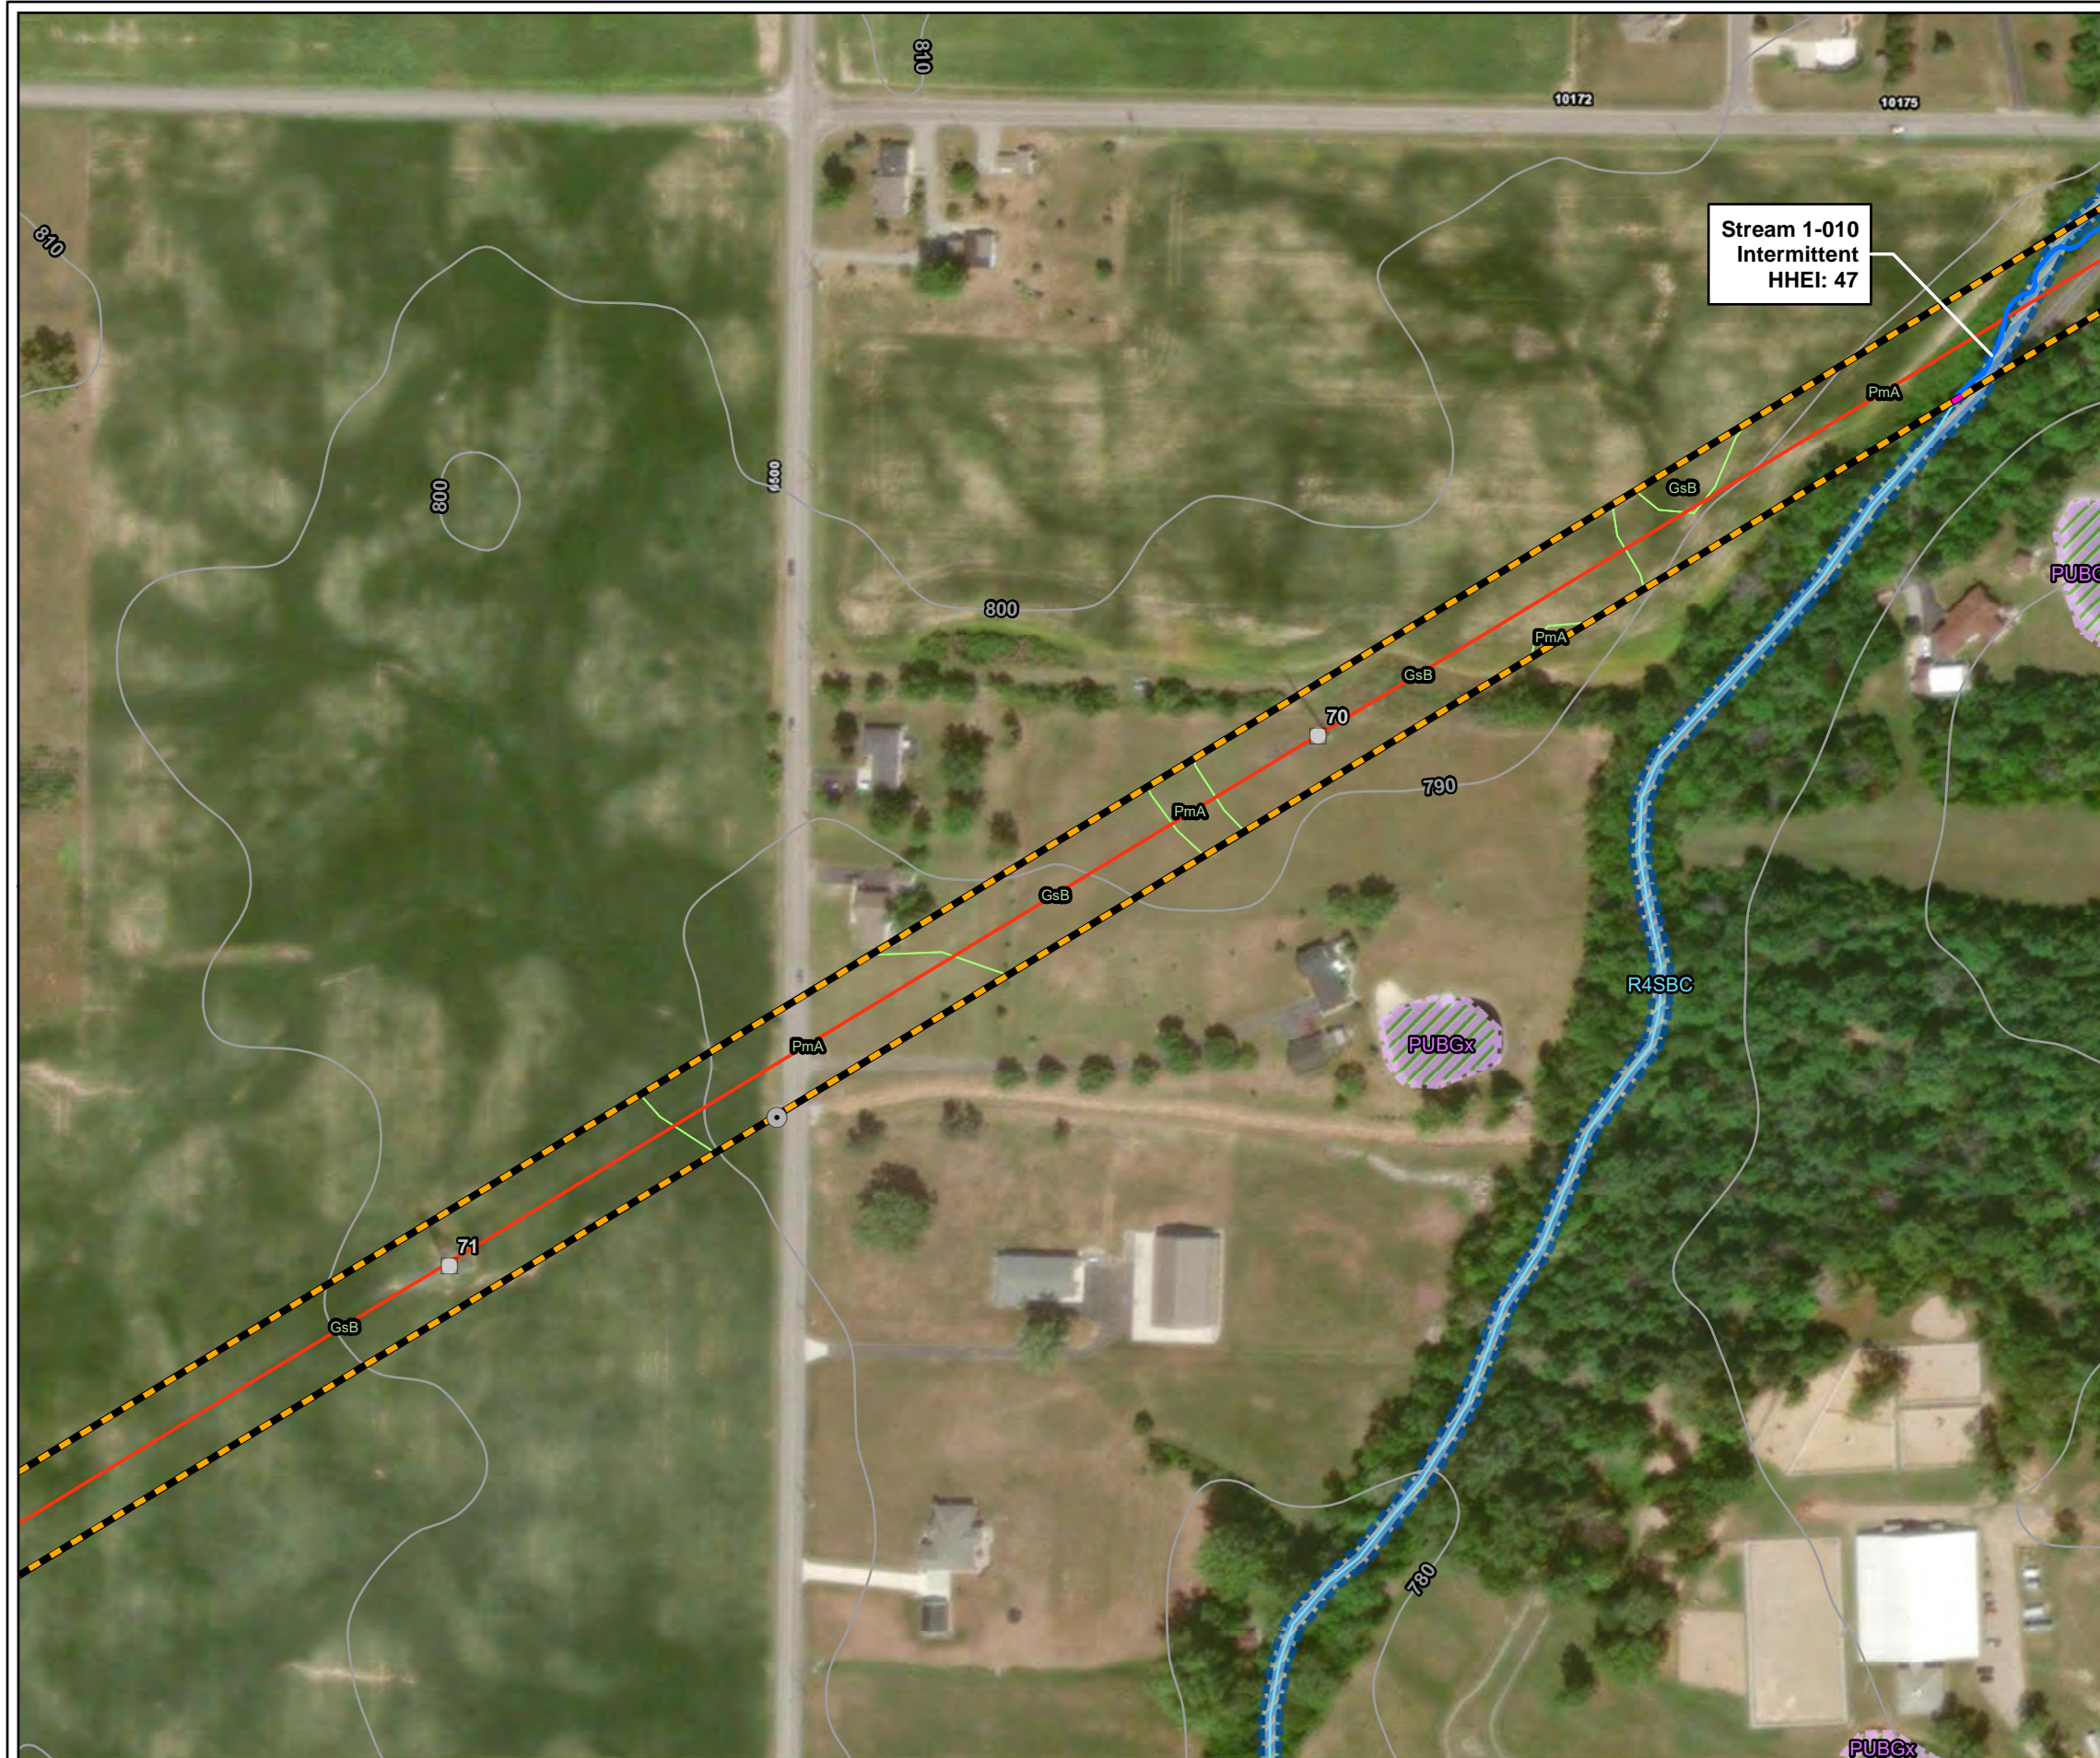
Figure 2. Aquatic resource delineation on the AEP Fostoria—East Lima 138 kV Transmission Rebuild Project in Allen and Hancock Counties, Ohio.

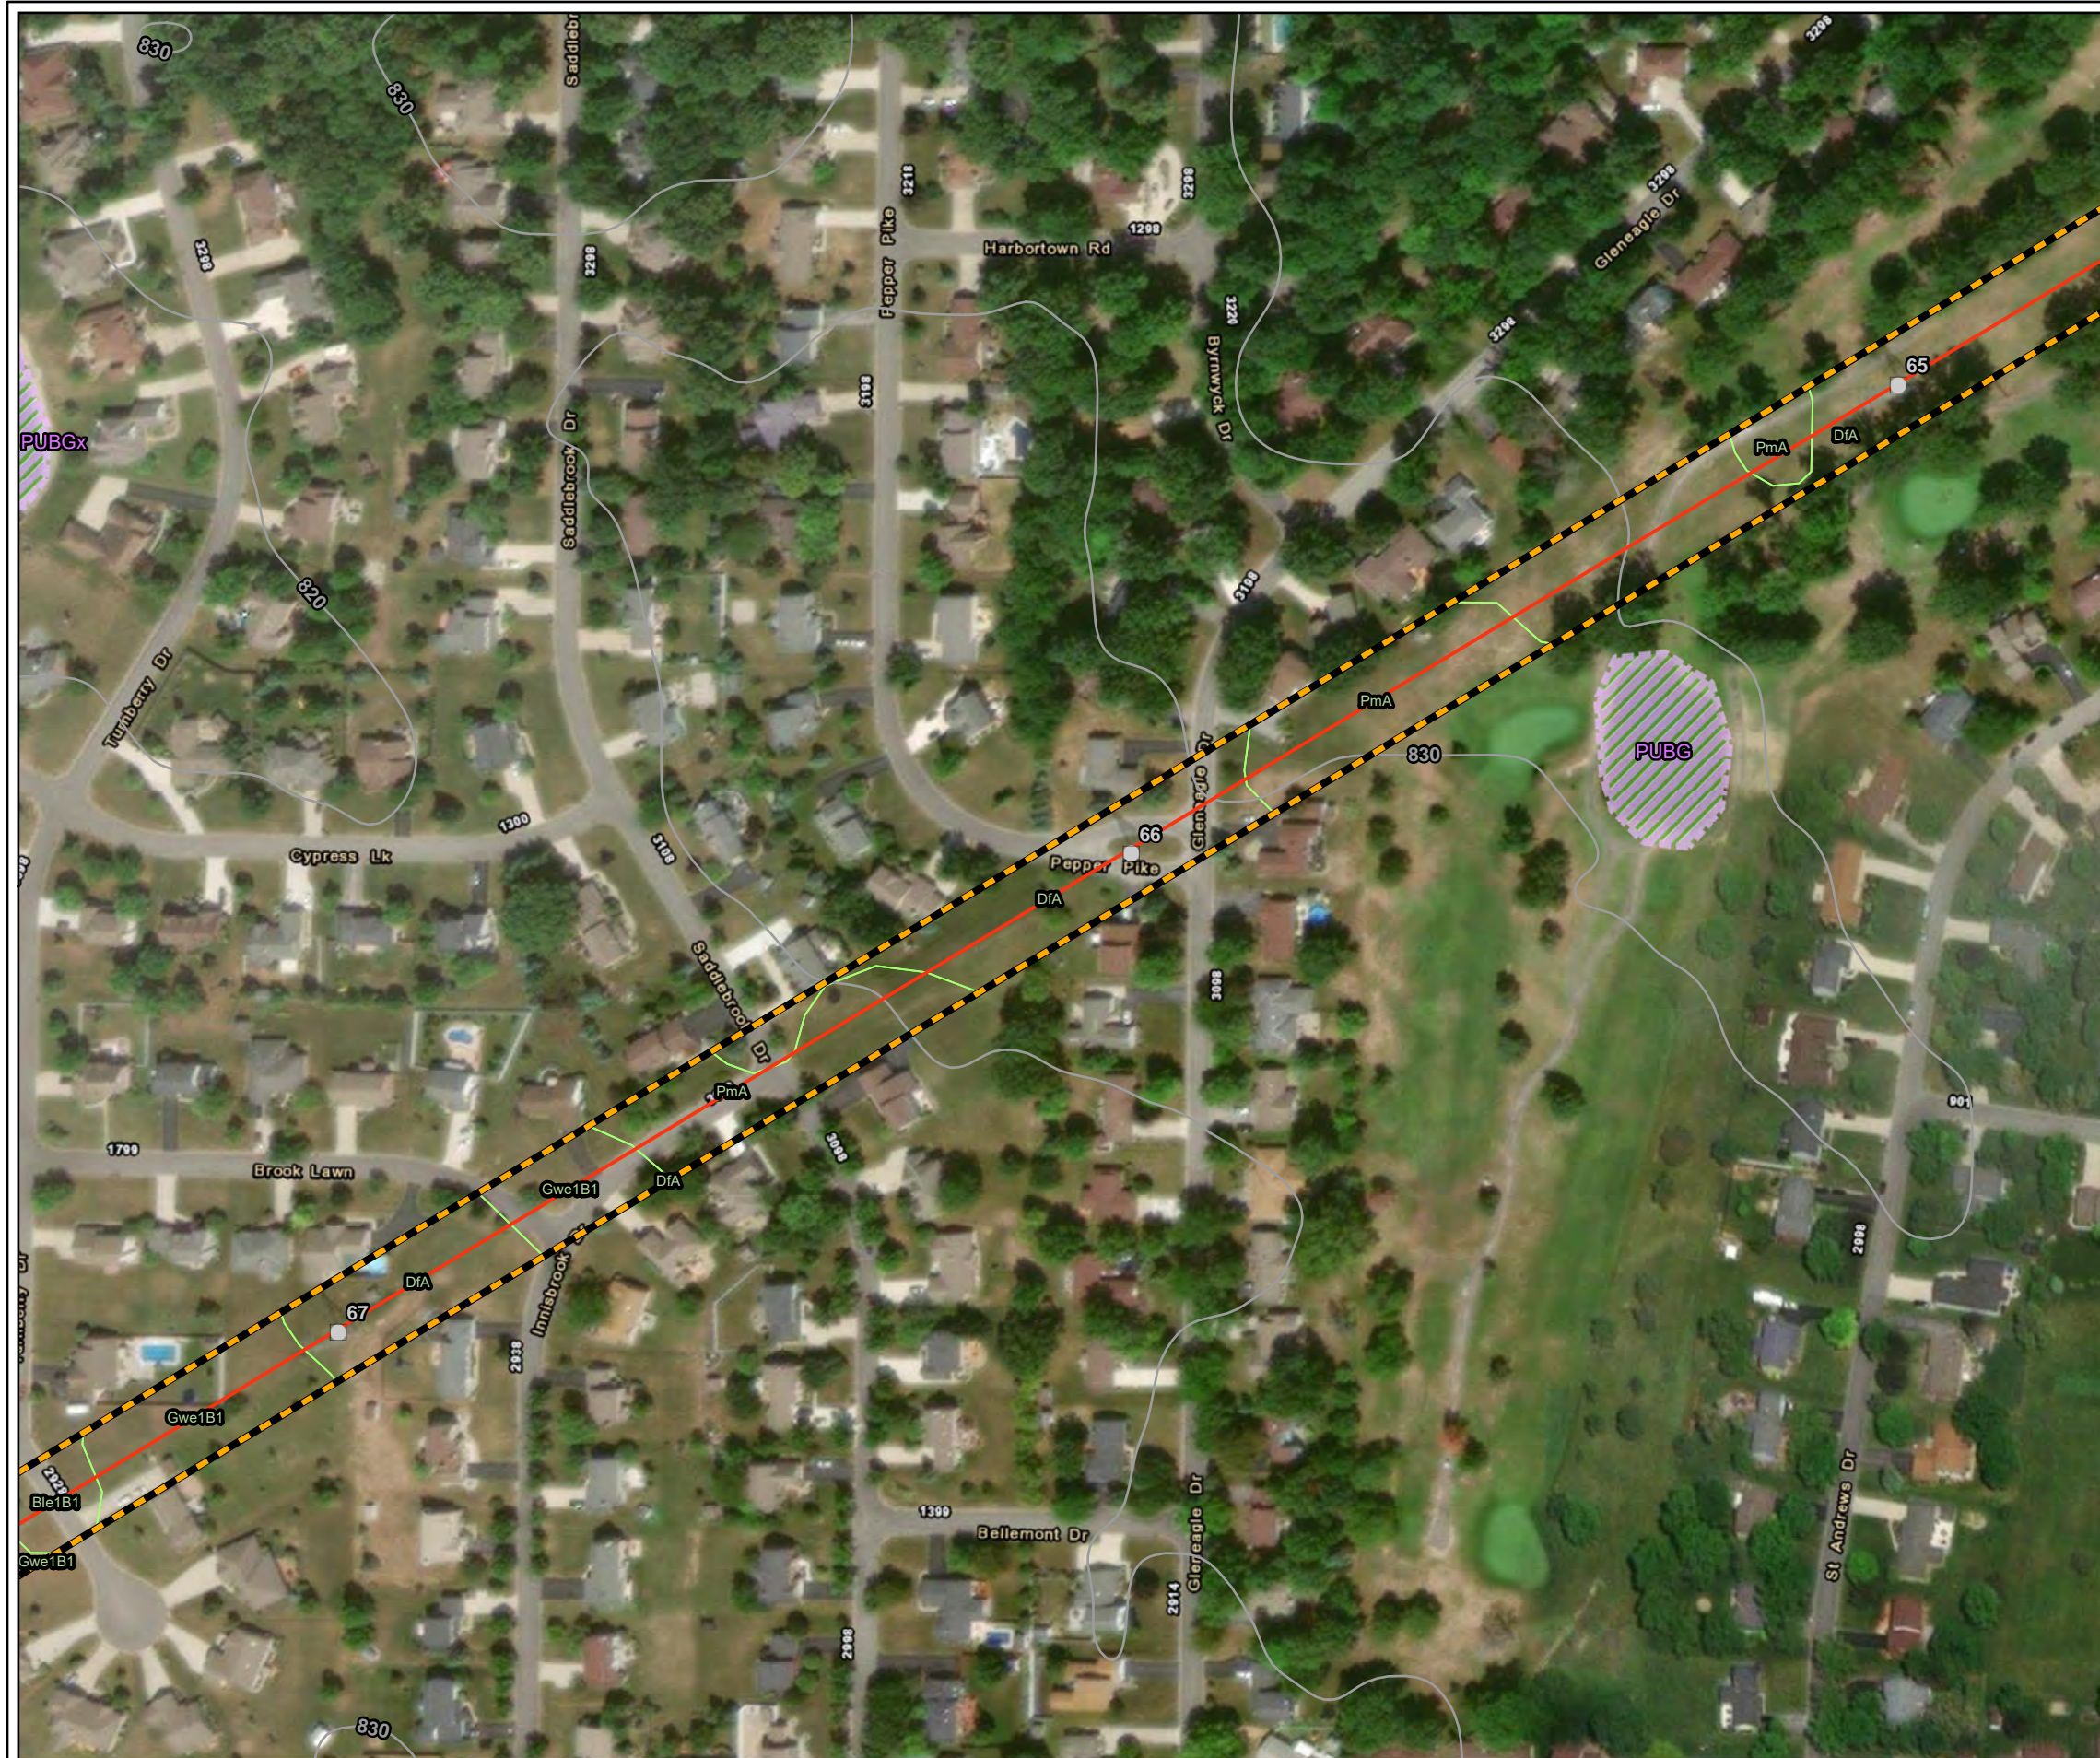
Figure 2. Aquatic resource delineation on the AEP Fostoria—East Lima 138 kV Transmission Rebuild Project in Allen and Hancock Counties, Ohio.

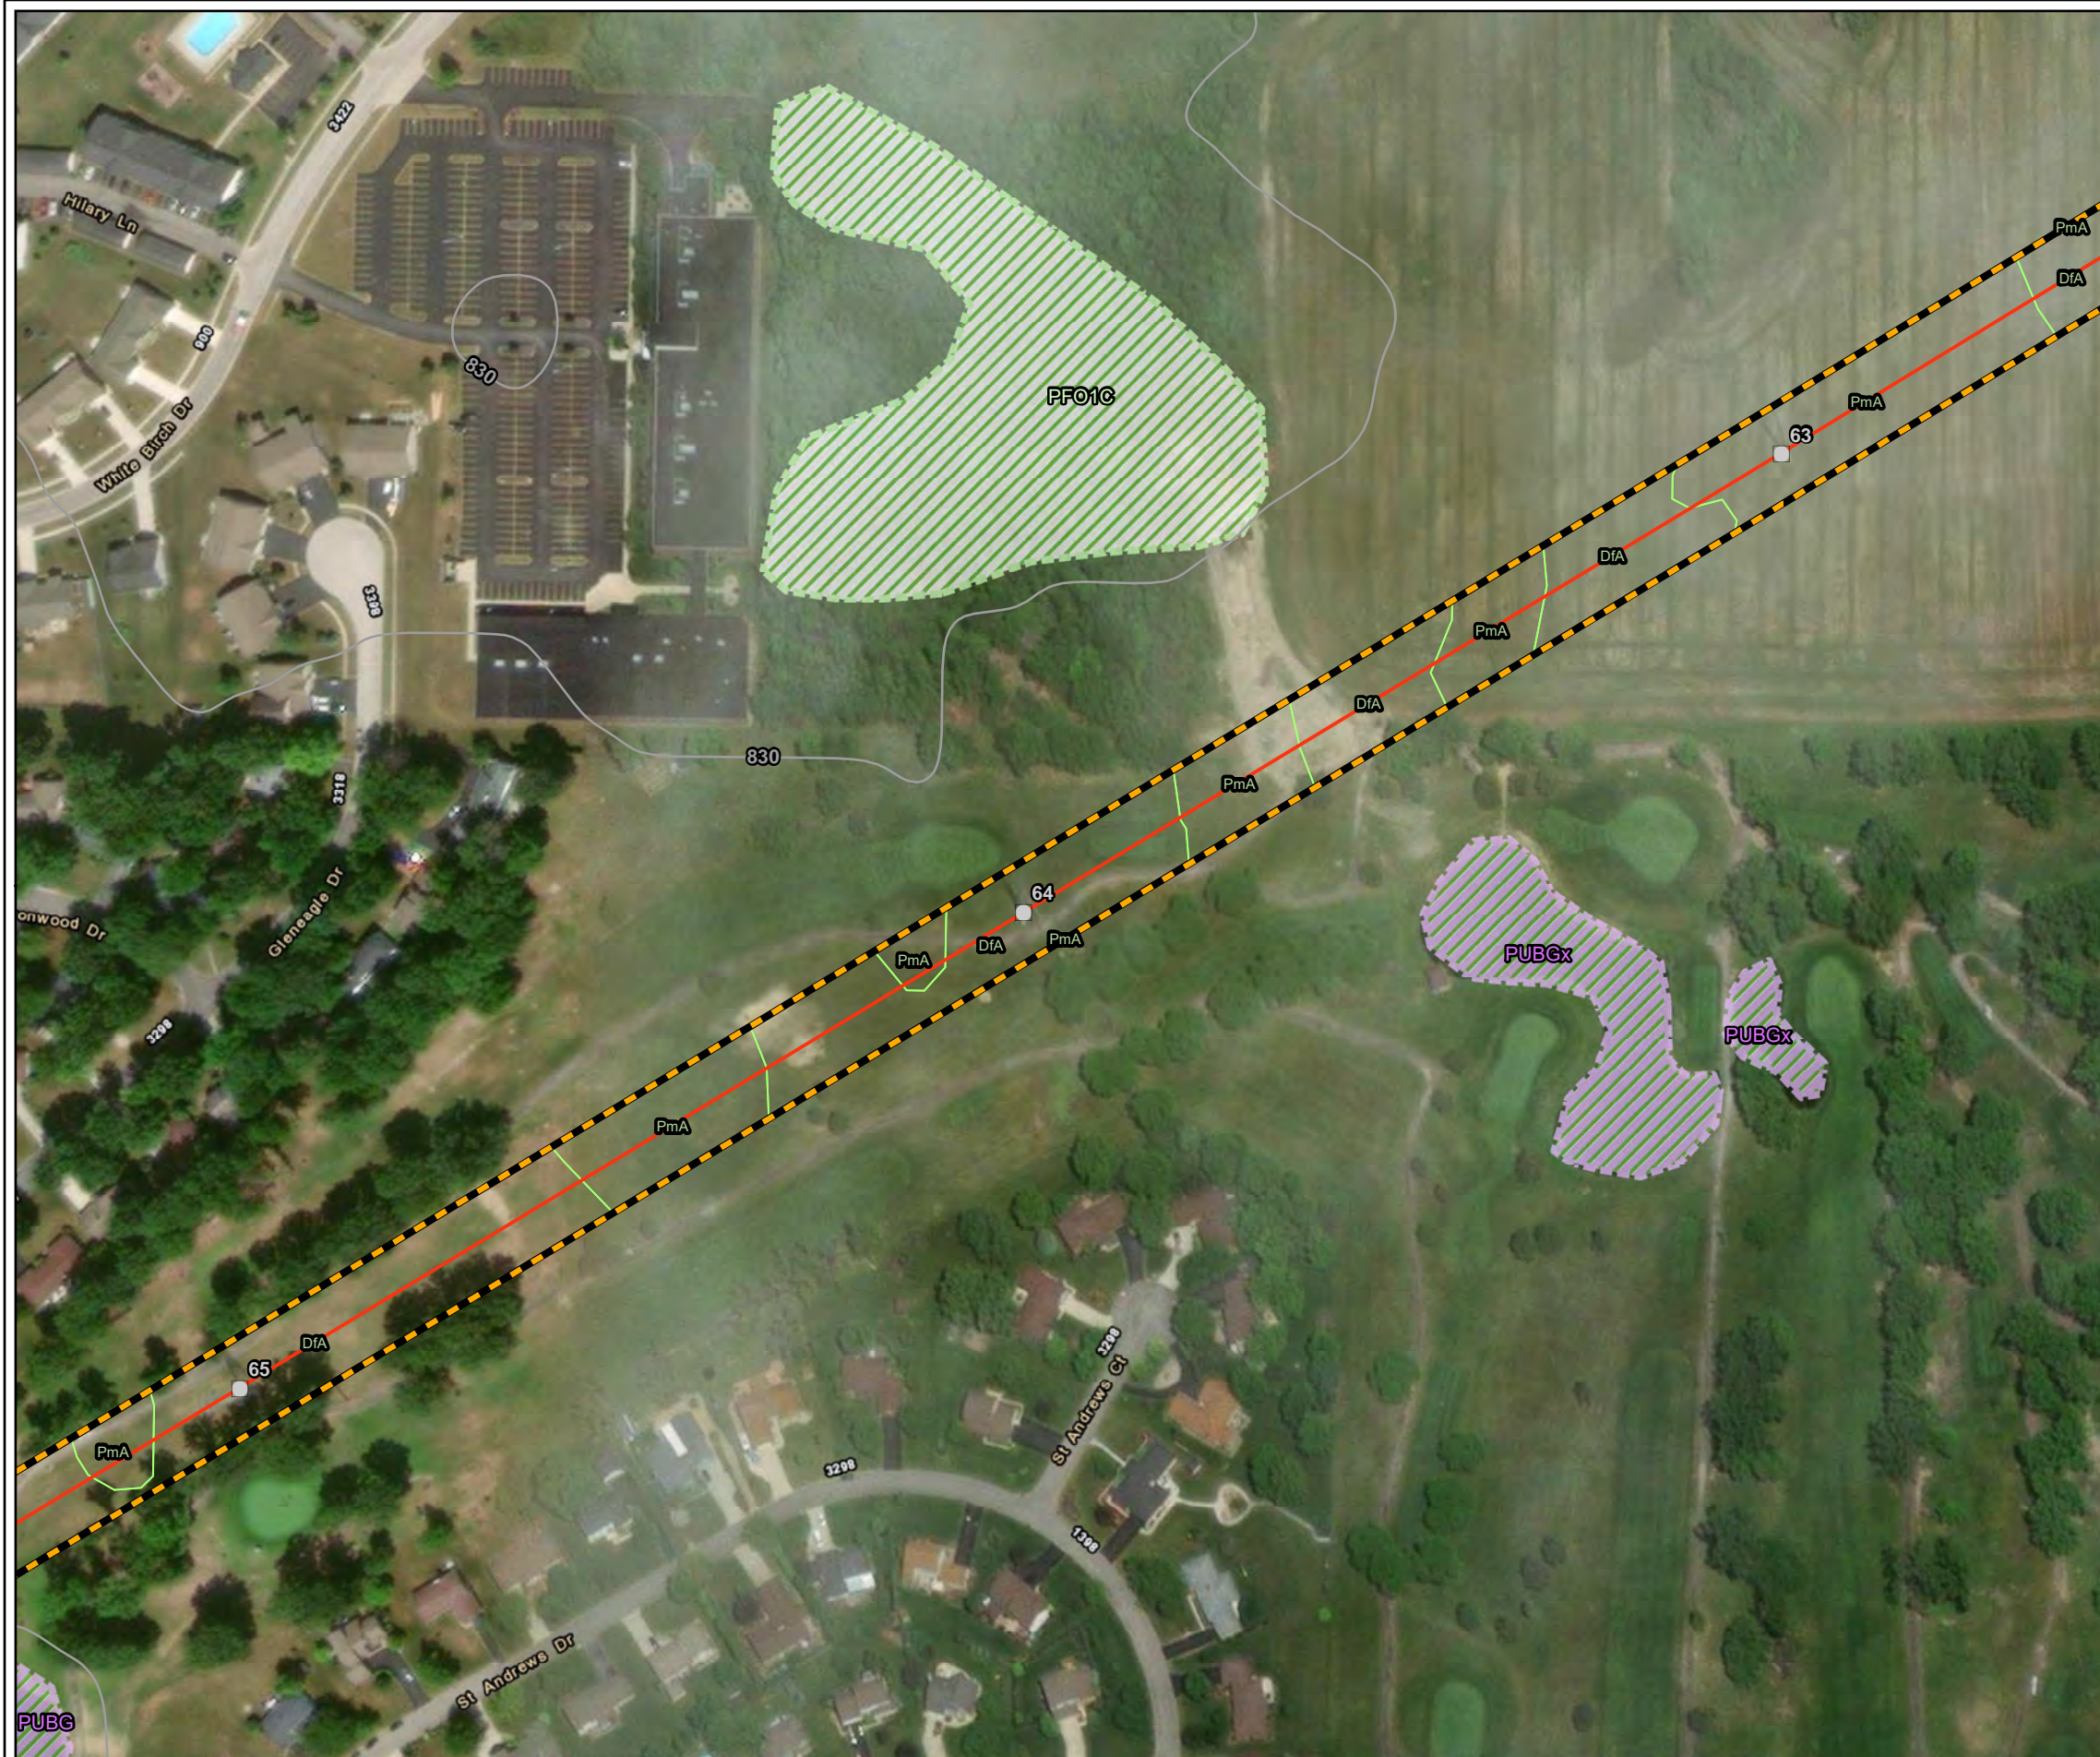
Figure 2. Aquatic resource delineation on the AEP Fostoria—East Lima 138 kV Transmission Rebuild Project in Allen and Hancock Counties, Ohio.

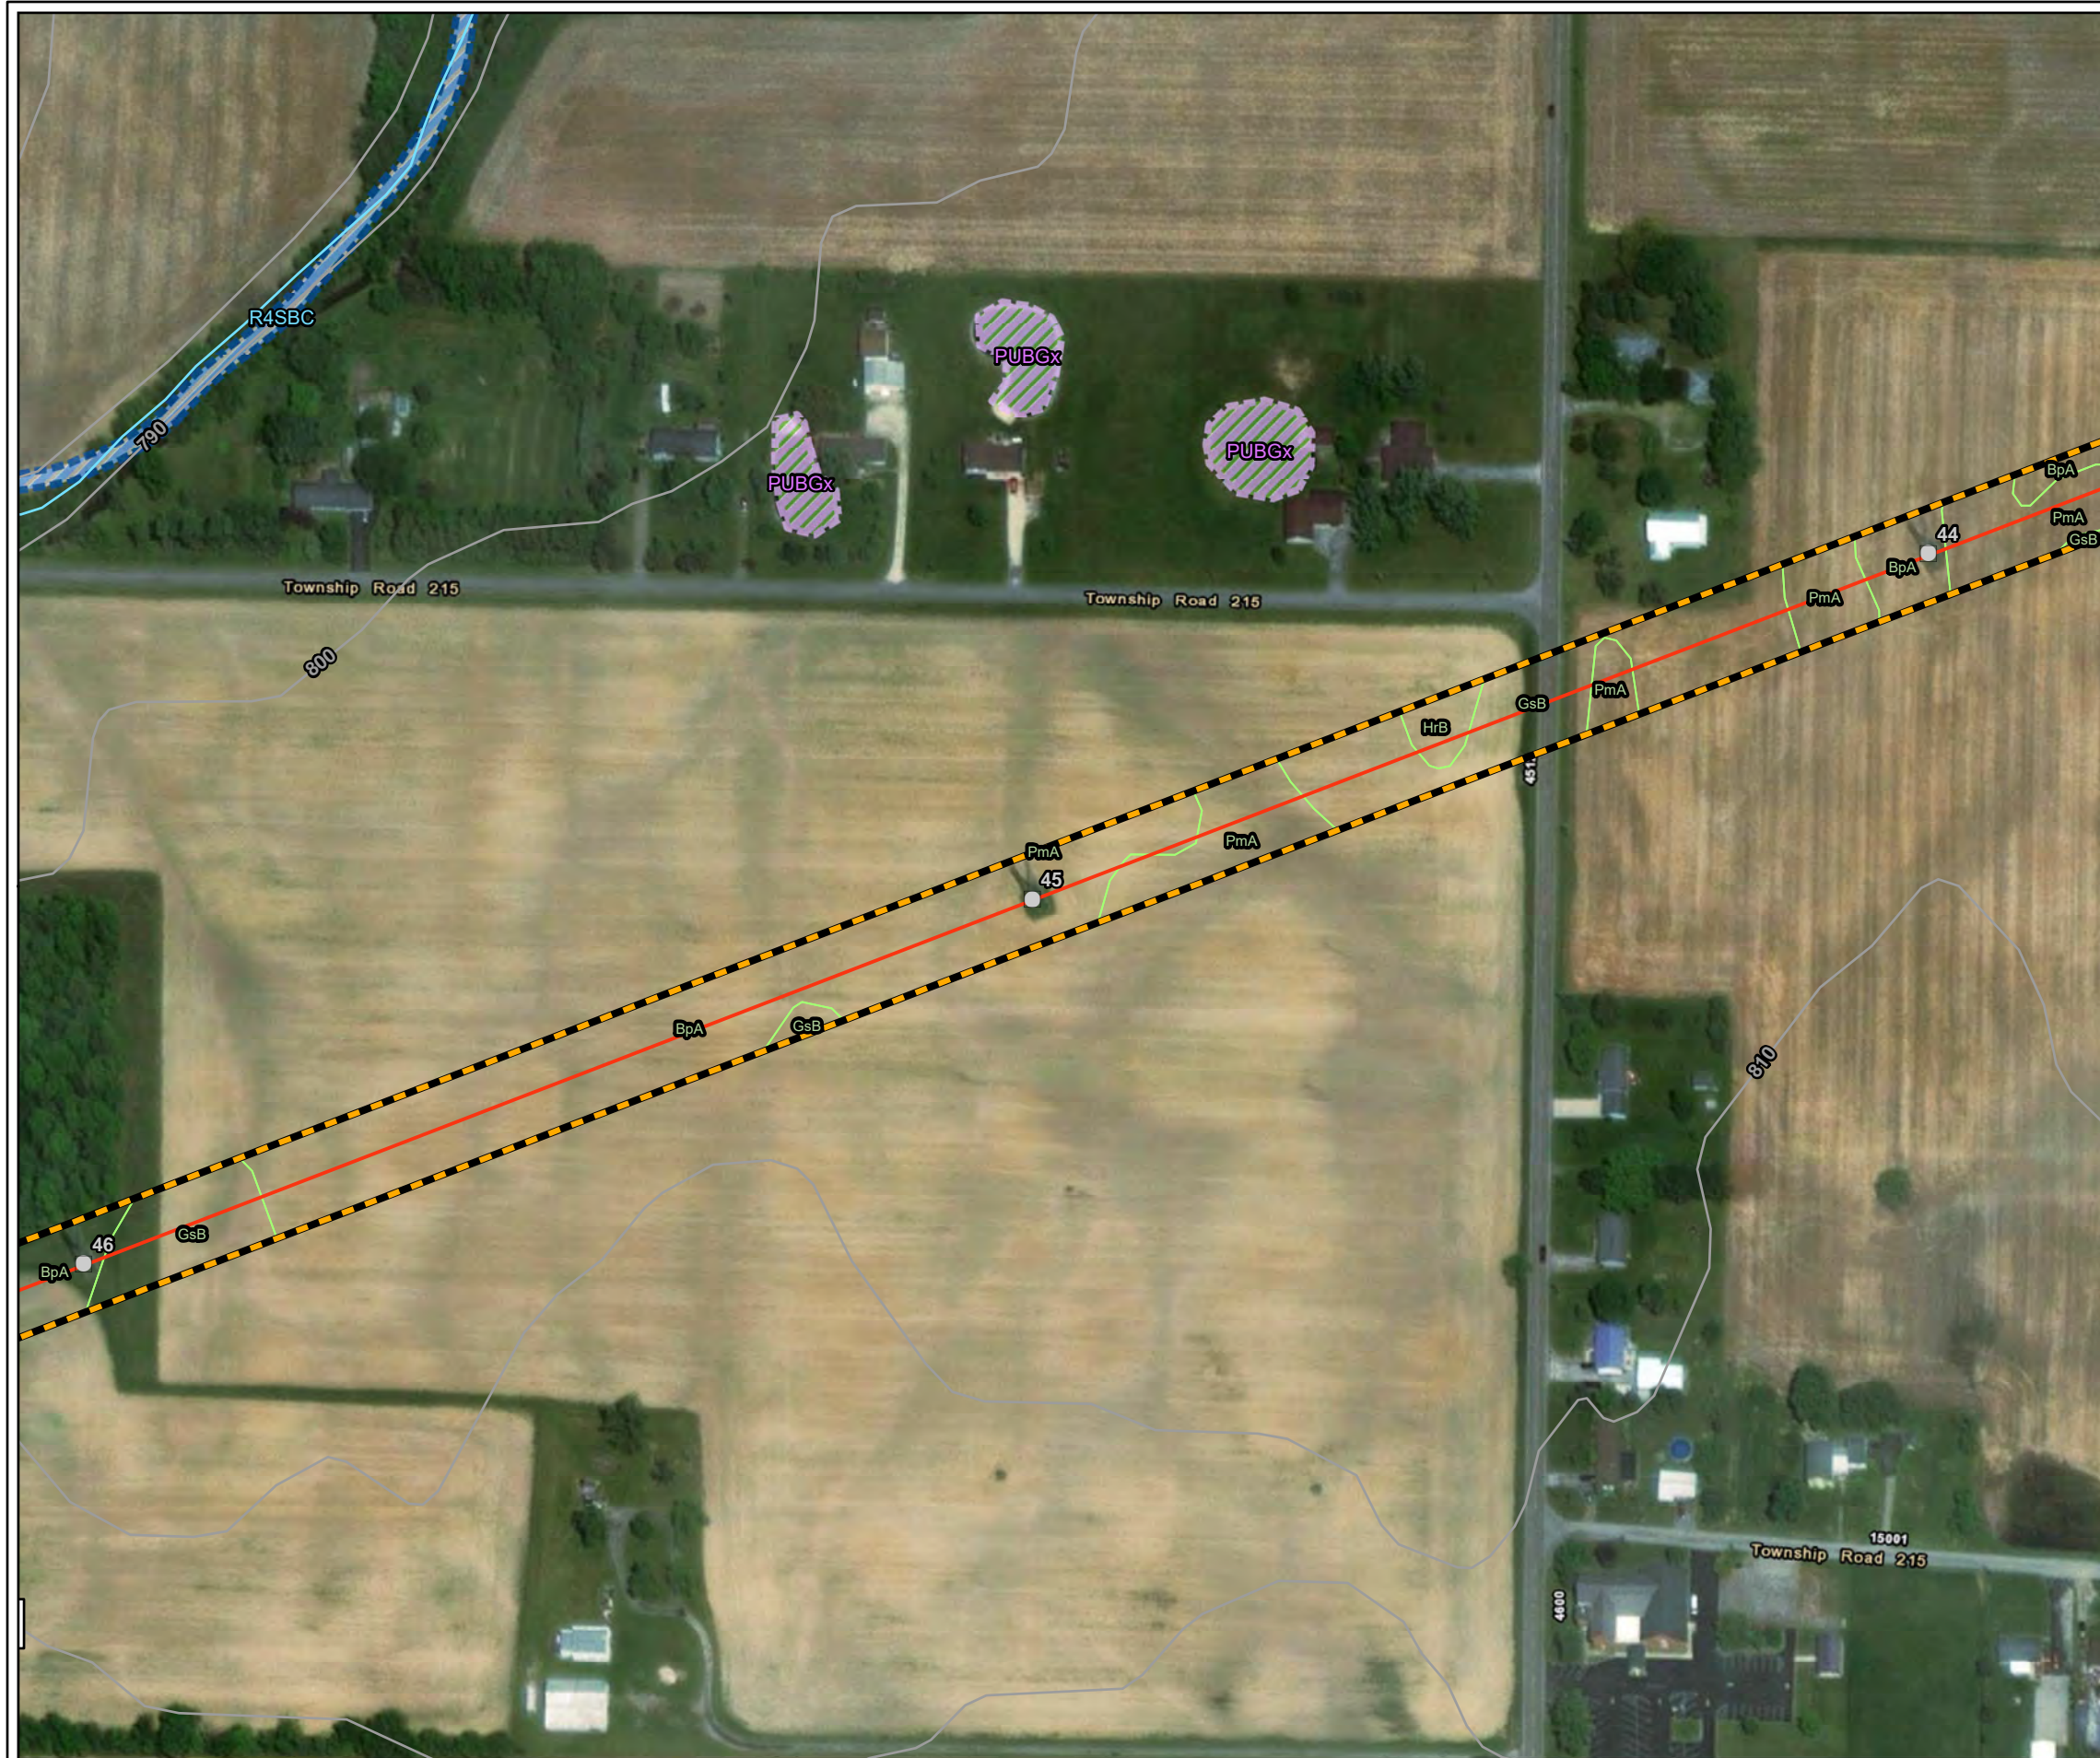
Figure 2. Aquatic resource delineation on the AEP Fostoria—East Lima 138 kV Transmission Rebuild Project in Allen and Hancock Counties, Ohio.

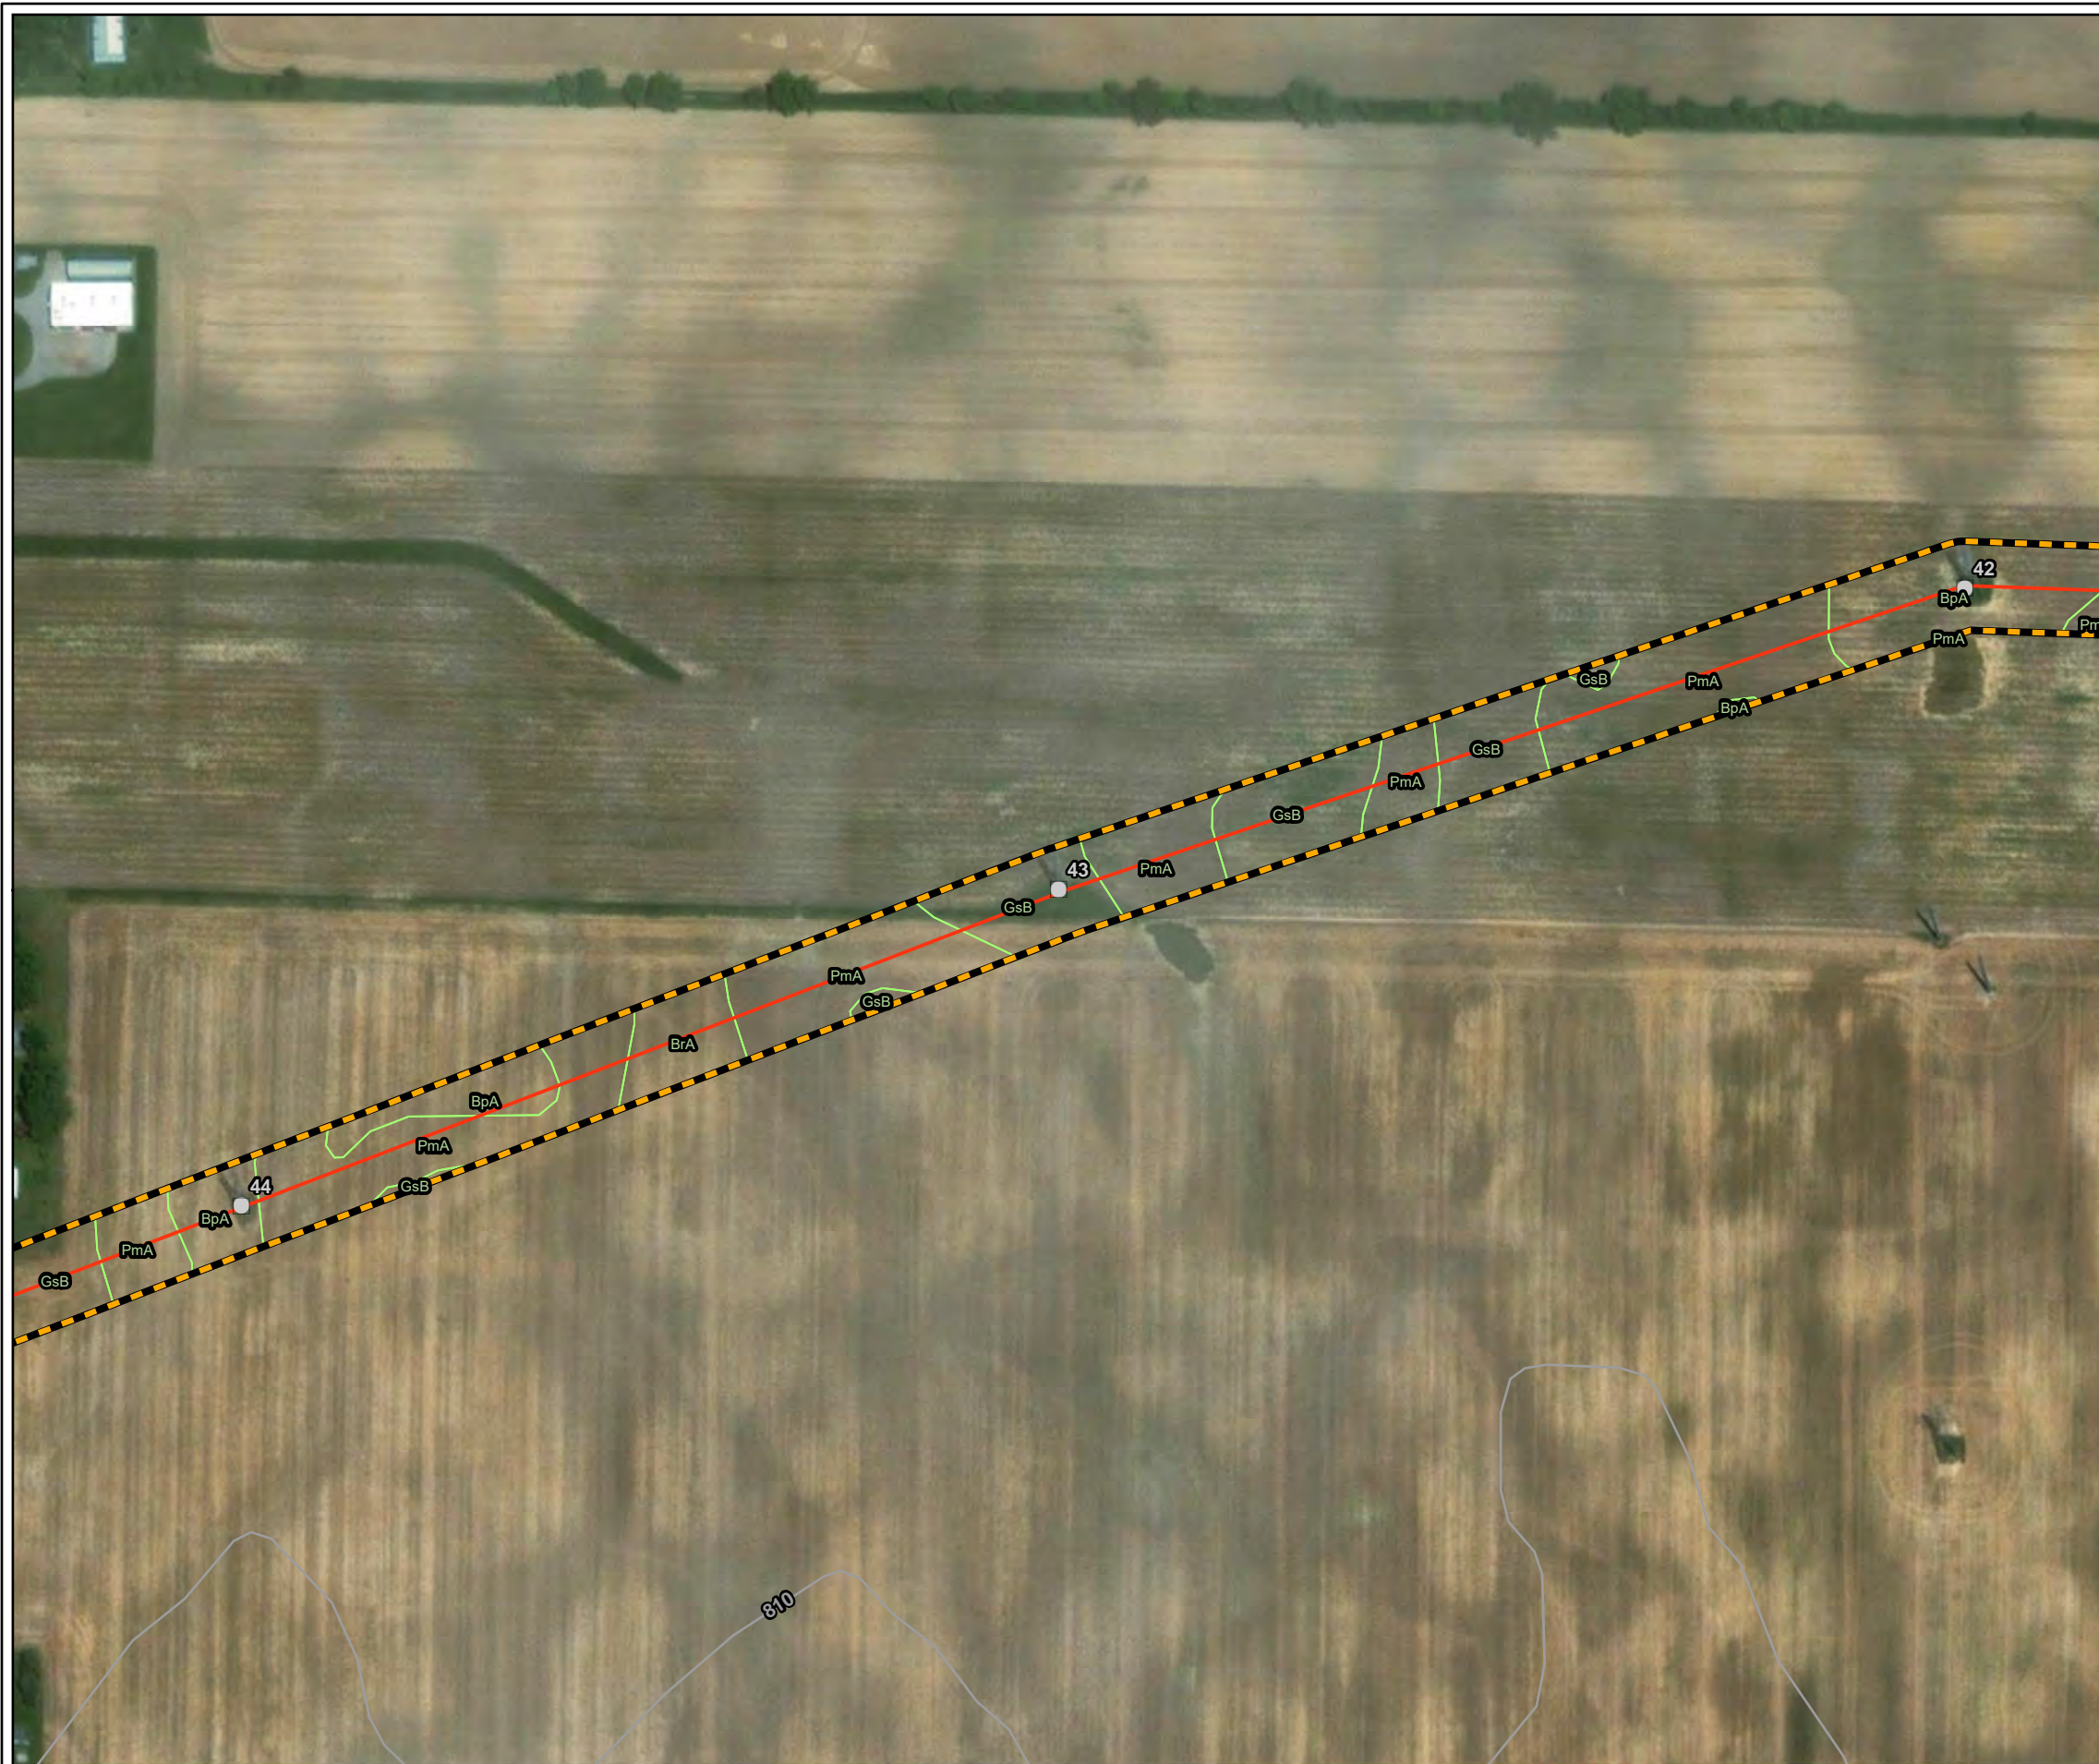
Figure 2. Aquatic resource delineation on the AEP Fostoria—East Lima 138 kV Transmission Rebuild Project in Allen and Hancock Counties, Ohio.
