Construction Notice for the Sifford-Ruble 2 138 kV Tie-Lines Project

PUCO Case No. 24-2384-EL-BNR

Construction Notice for the Sifford-Ruble 2 138 kV Transmission Tie-Lines Project

Ohio Power Company Sifford-Ruble 2 138 kV Transmission Tie-Lines Project

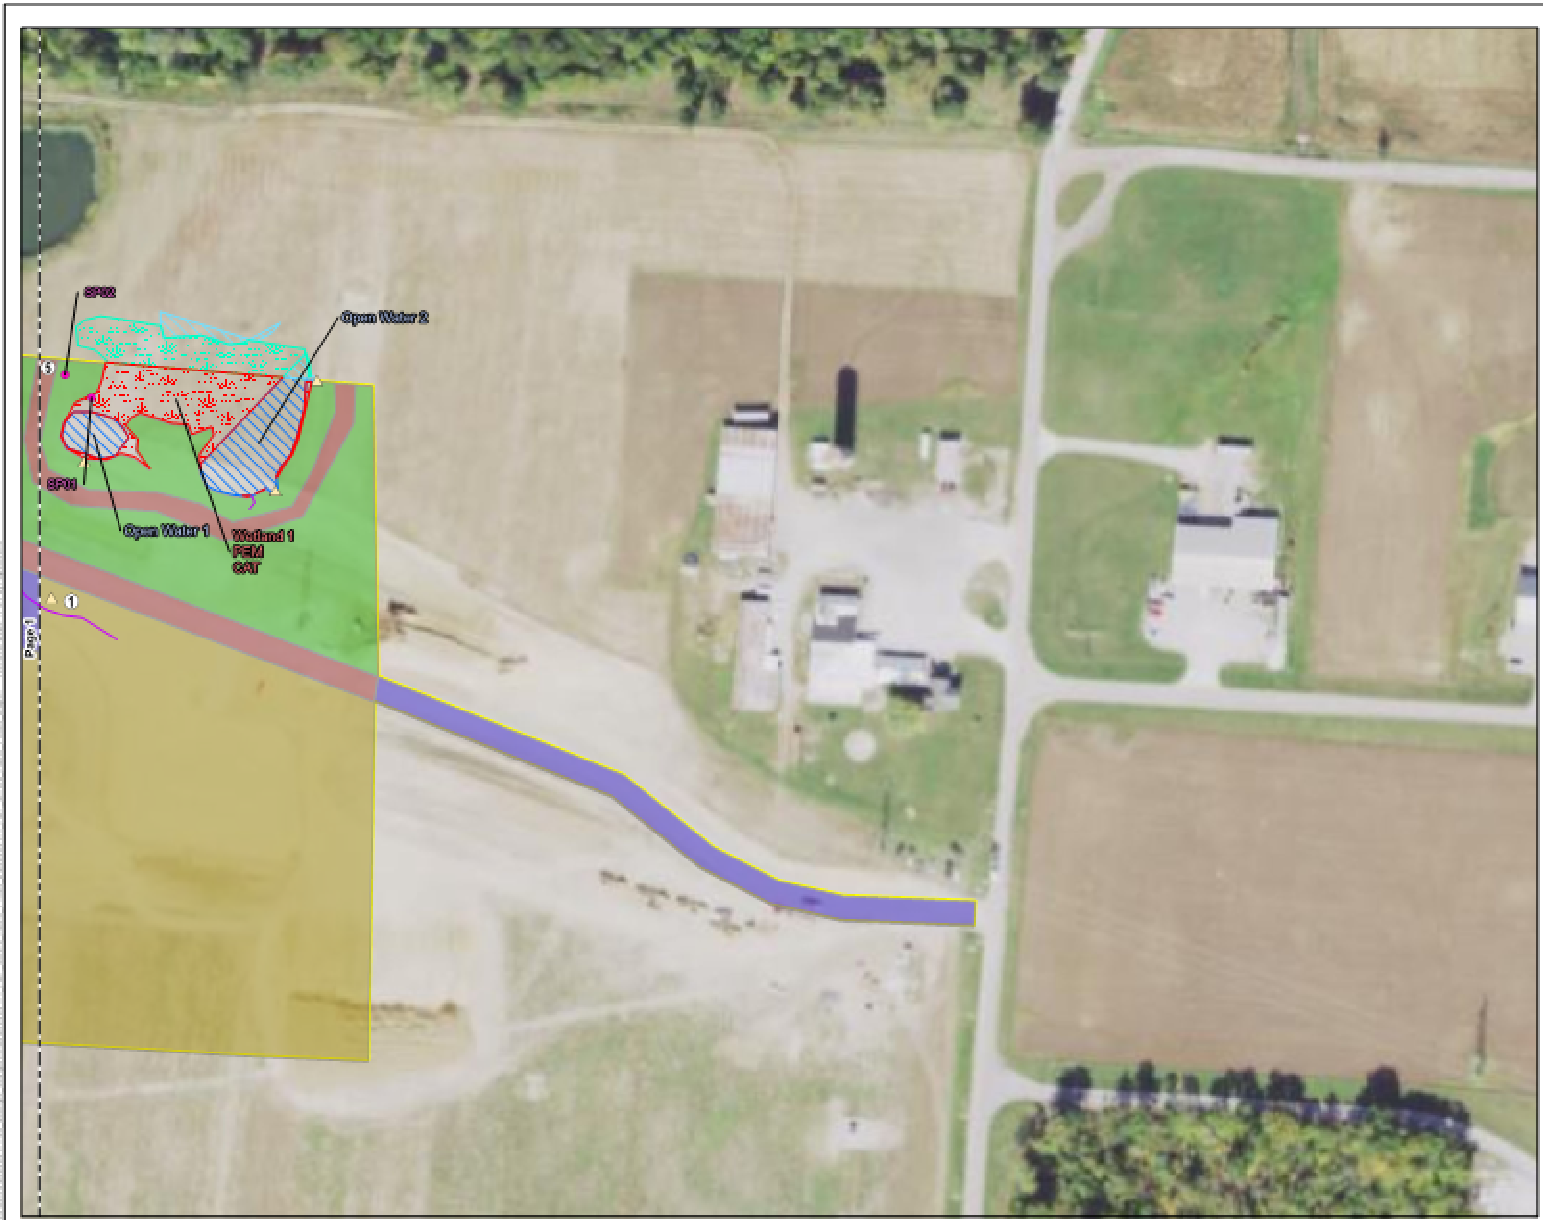
Figure No.
3

Habitat Assessment Map

Stantec completed field surveys for threatened and endangered species or their habitats on October 3, 2023. Figure 3 (Appendix A) shows the vegetation communities/habitats and land cover types identified within the Project area and the locations of any identified rare, threatened, or endangered species habitat observed within the Project area during the time of the habitat assessment surveys. Representative photographs of the vegetation communities/habitats and land cover types identified within the Project area are included in Appendix C of this report (photo locations are shown on Figure 3, Appendix A). Information regarding the vegetation communities/habitats/land cover types identified within the Project area is provided in Table 1.

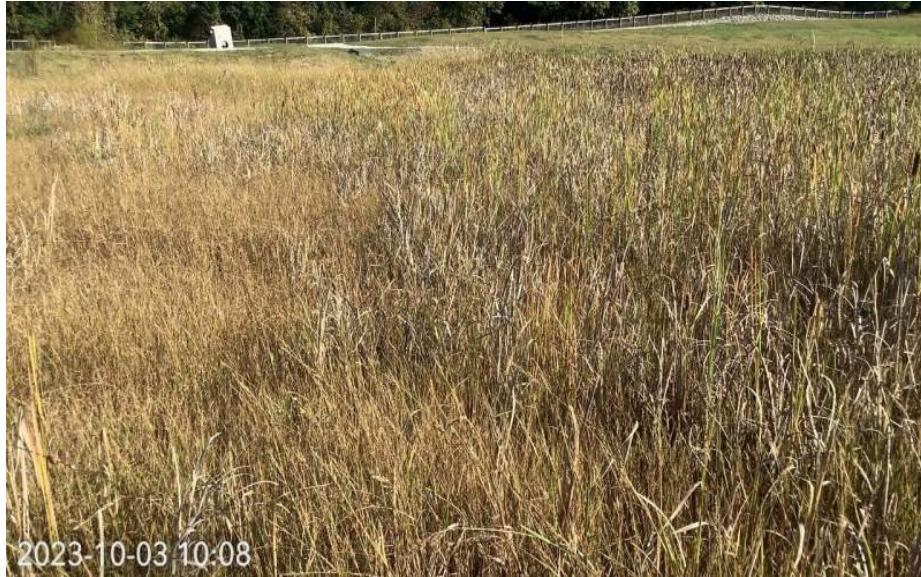
Photo Location 1. View of Wetland 1 at wetland determination sample point location SP01. Photograph taken facing north.

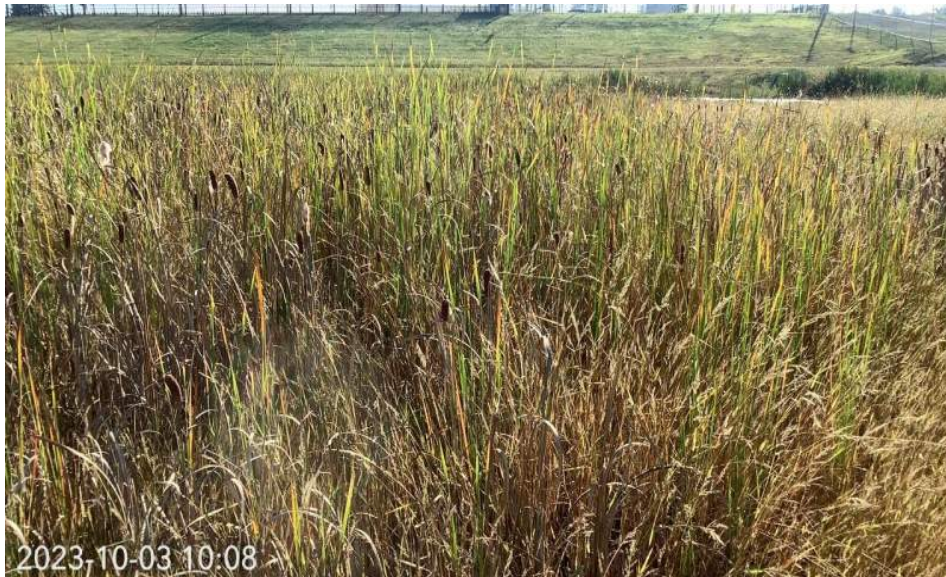
Photo Location 1. View of Wetland 1 at wetland determination sample point location SP01. Photograph taken facing east.

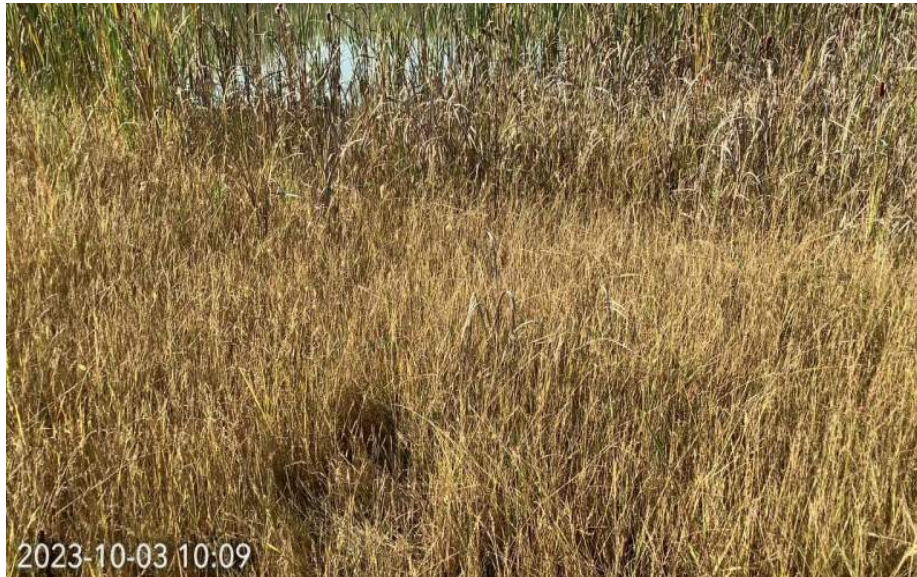
Photo Location 1. View of Wetland 1 at wetland determination sample point location SP01. Photograph taken facing south.

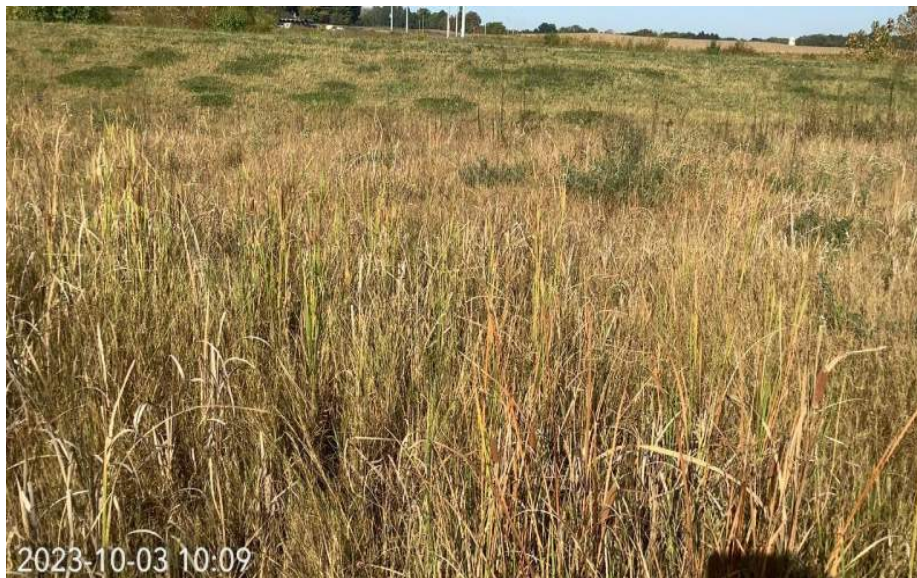
Photo Location 1. View of Wetland 1 at wetland determination sample point location SP01. Photograph taken facing west.

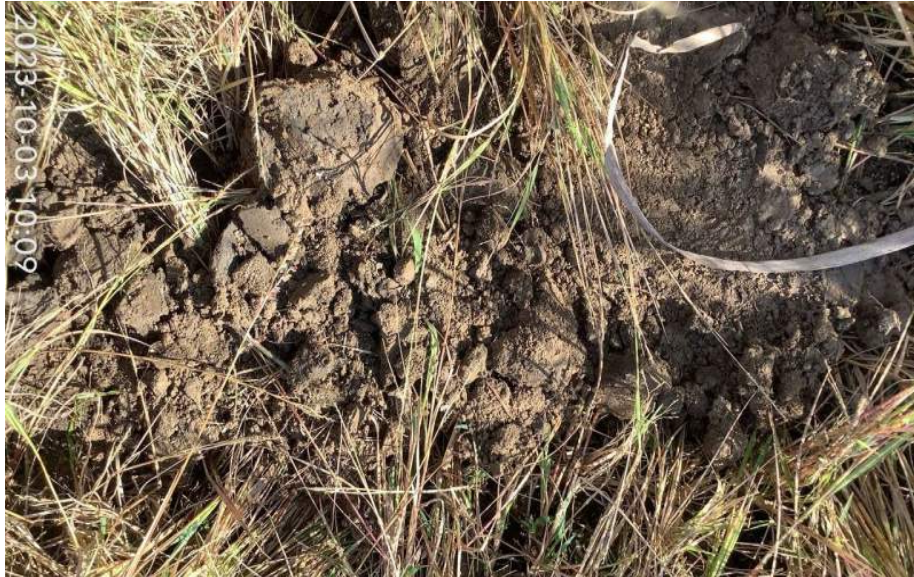
Photo Location 1. View of soil profile at wetland determination sample point location SP01.

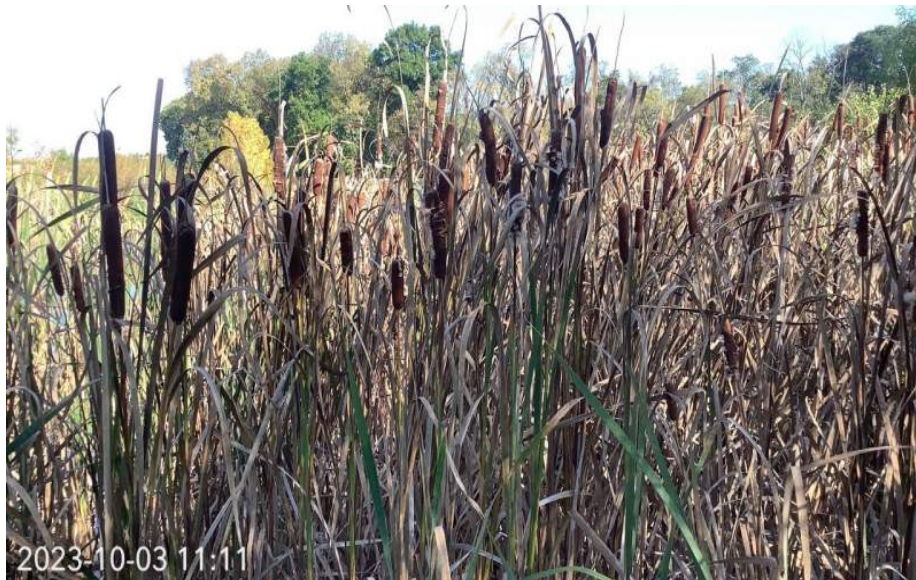
Photo Location 3. View of Wetland 2 at wetland determination sample point location SP03. Photograph taken facing north.

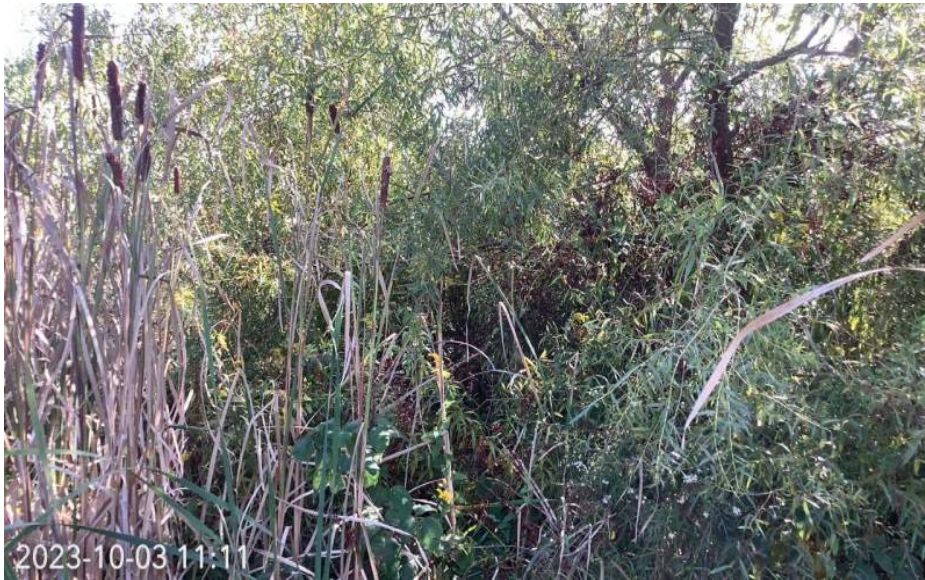
Photo Location 3. View of Wetland 2 at wetland determination sample point location SP03. Photograph taken facing east.

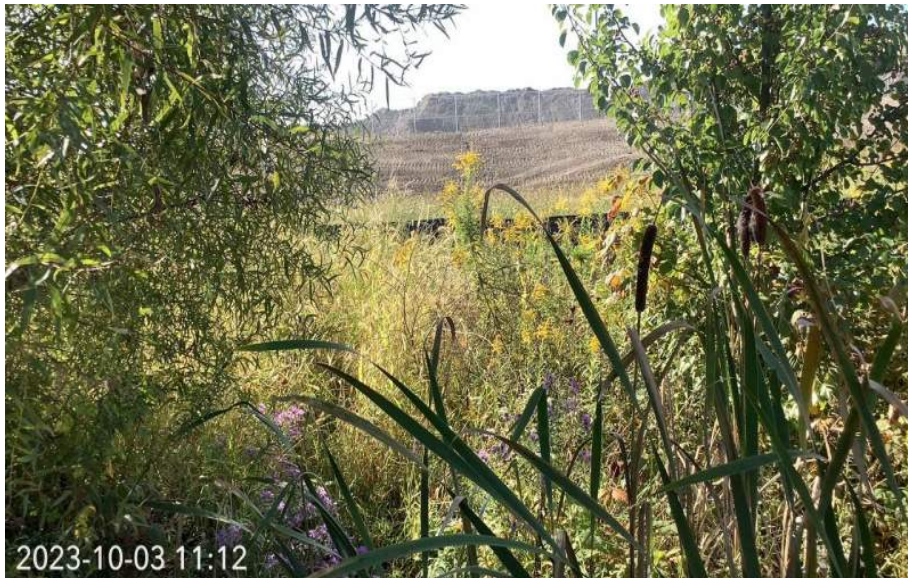
Photo Location 3. View of Wetland 2 at wetland determination sample point location SP03. Photograph taken facing south.

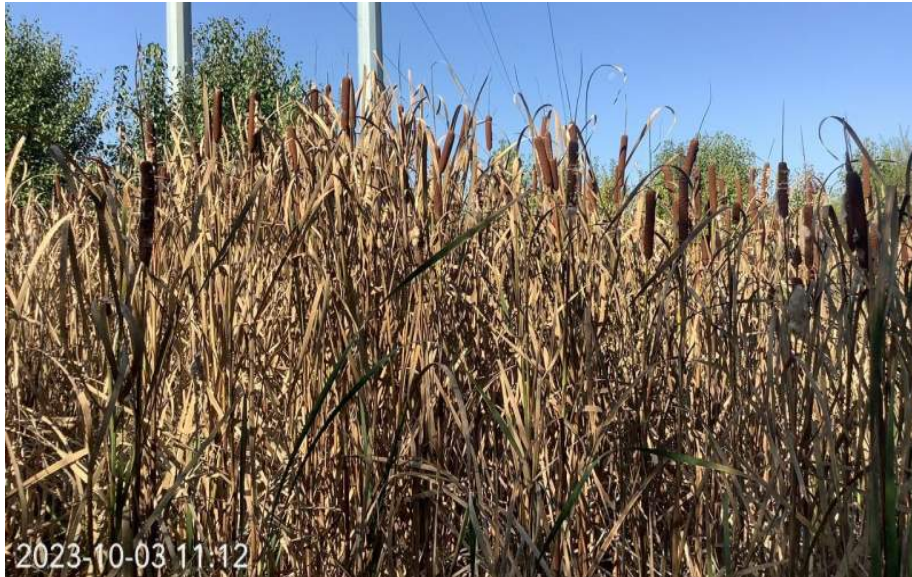
Photo Location 3. View of Wetland 2 at wetland determination sample point location SP03. Photograph taken facing west.

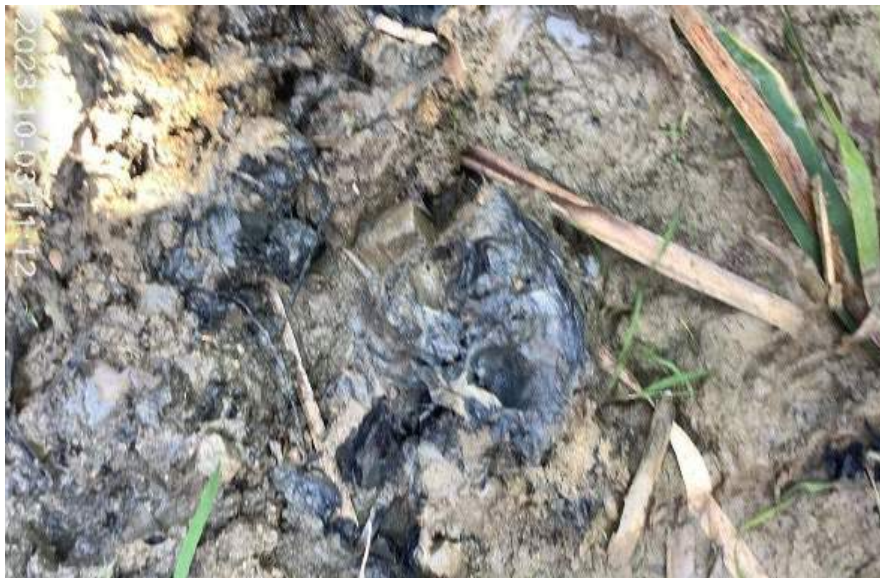
Photo Location 3. View of soil profile at wetland determination sample point location SP03.

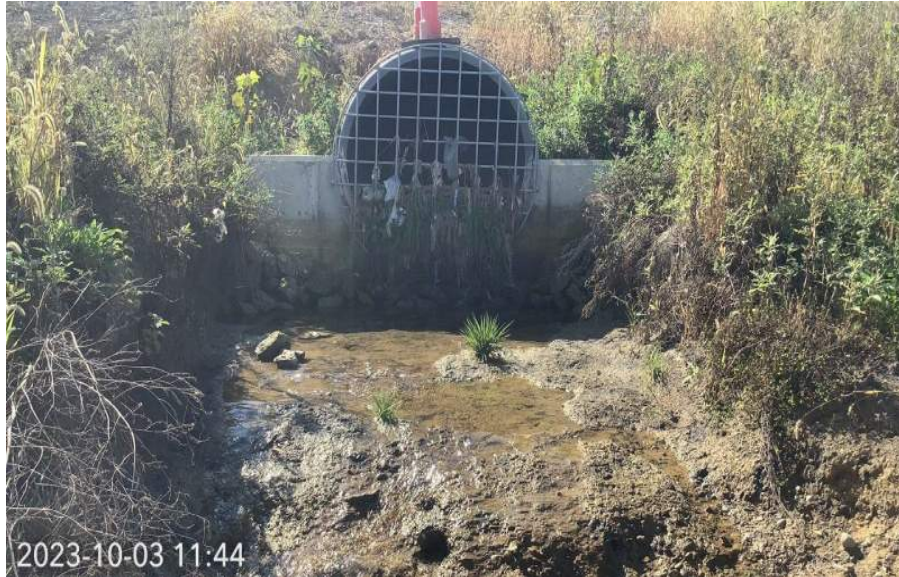
Photo Location 6. View of culvert and manmade upland drainage feature within the Project area. Photograph taken facing southwest.

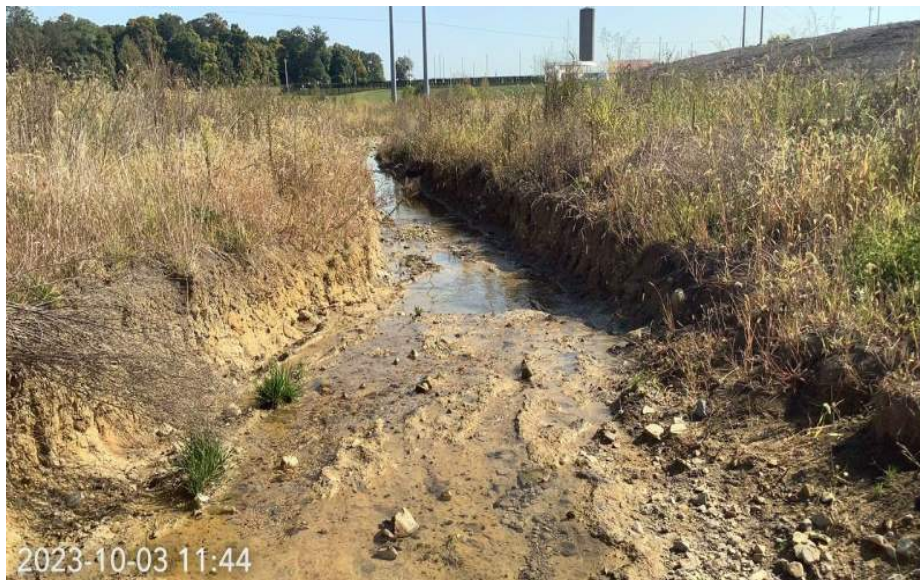
Photo Location 6. View of manmade upland drainage feature within the Project area. Photograph taken facing northeast.

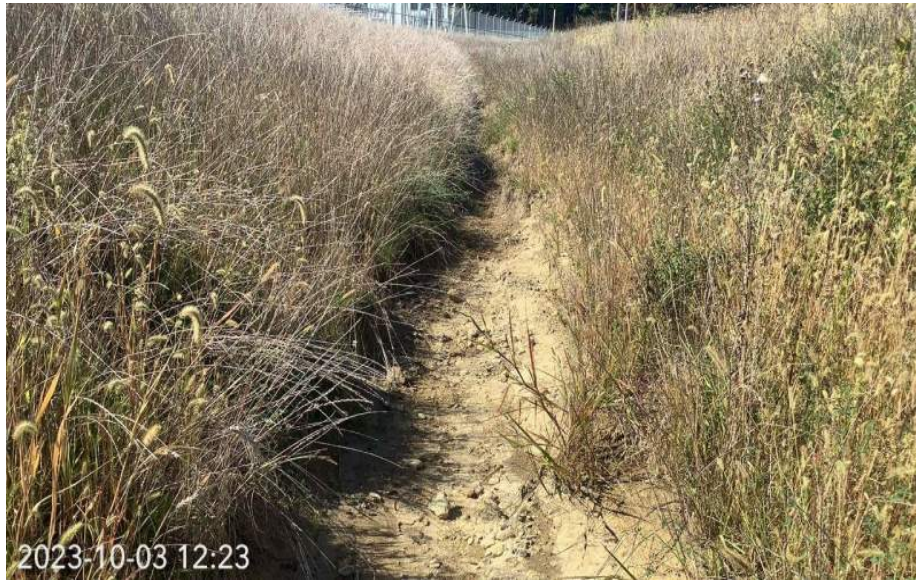
Photo Location 7. View of manmade upland drainage feature within the Project area. Photograph taken facing west.

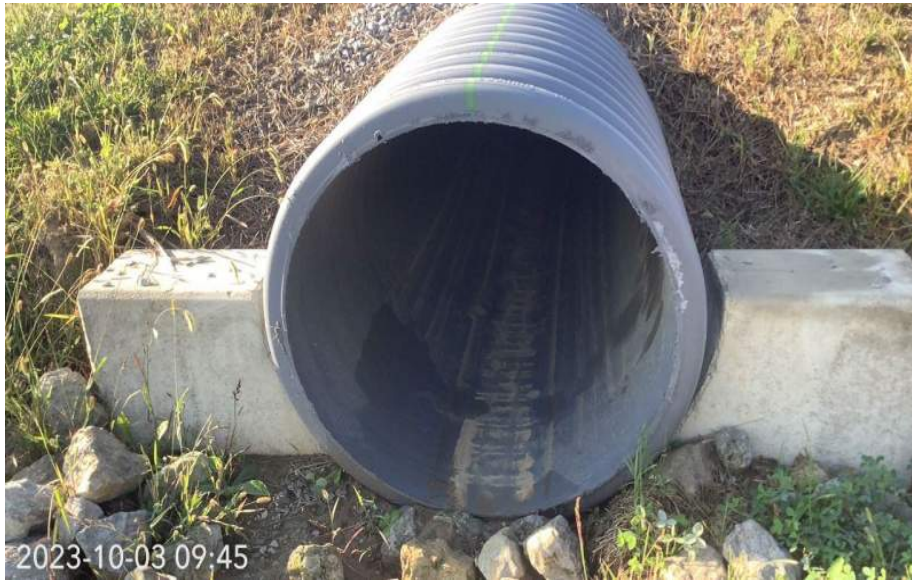
Photo Location 13. View of existing culvert within the project area. Photograph taken facing south.

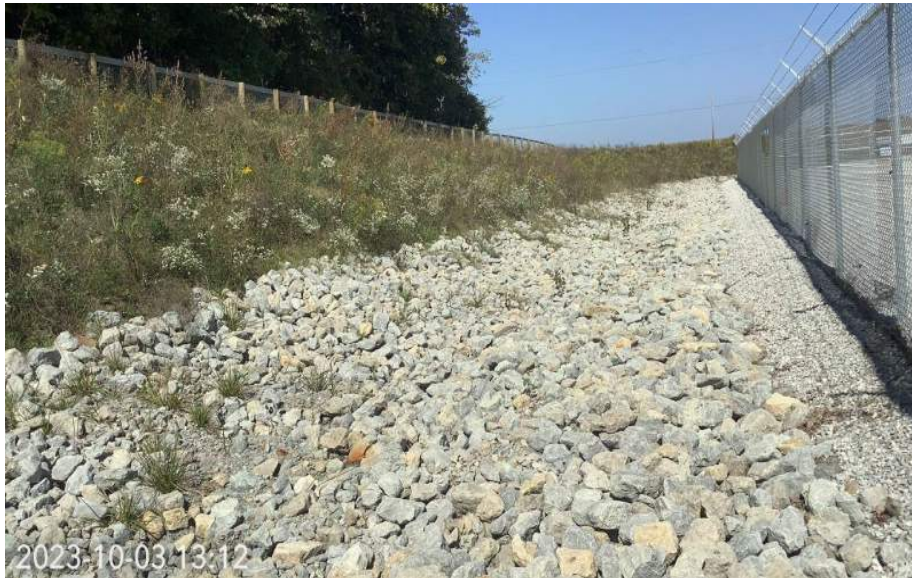
Photo Location 14. View of manmade upland drainage feature found within the Project area. Photograph taken facing west.
