Letter of Notification Hedding Road Switch and West Mount Vernon-North Waldo 138 kV Relocation Project

PUCO Case No. 23-0570-EL-BLN

June 1, 2023

**AEP Ohio Transmission Company, Inc.
Hedding Road Switch and West Mount Vernon-North Waldo 138 kV Transmission Line Relocation Project**

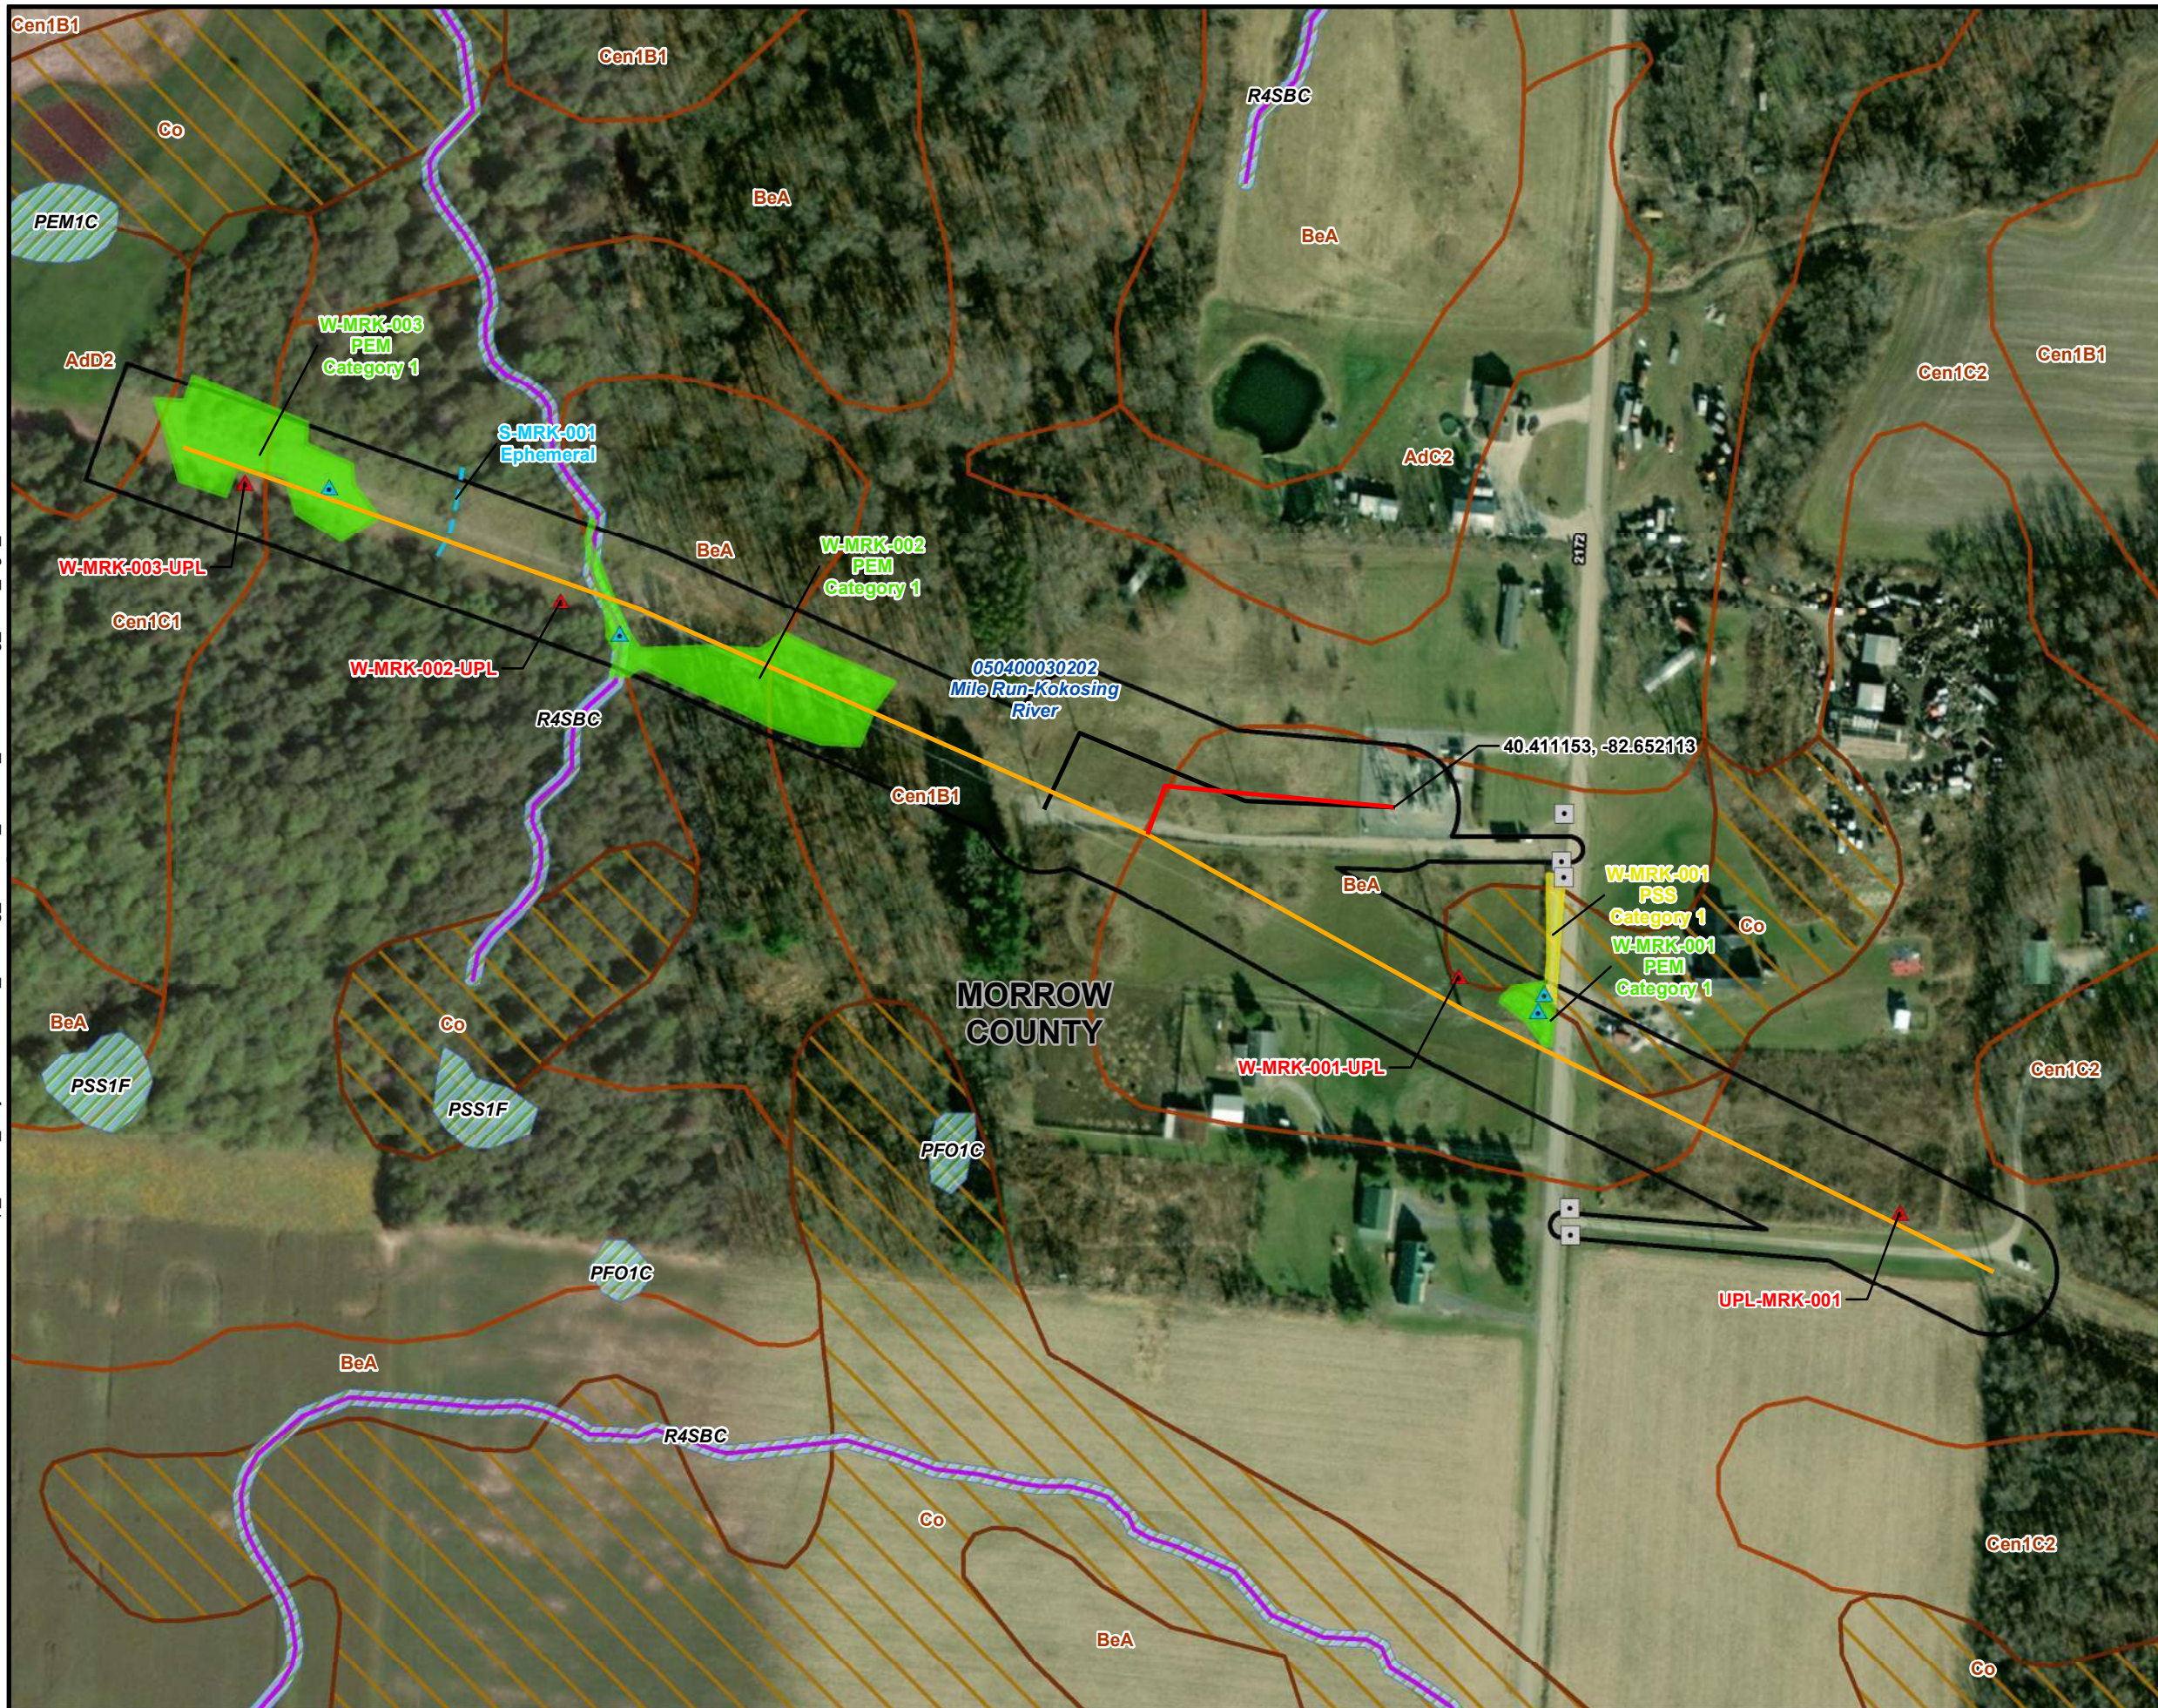
FIGURE 2 SOIL MAP AND NATIONAL WETLAND INVENTORY MAP	
DATE: 10/18/2022	1 INCH = 200 FEET
CREATED BY: PMH	CHECKED BY:
JOB NO. 60693885	AECOM

Cen1C2—Centerburg silt loam, 6 to 12 percent slopes, eroded

Co—Condit silt loam, 0 to 1 percent slopes

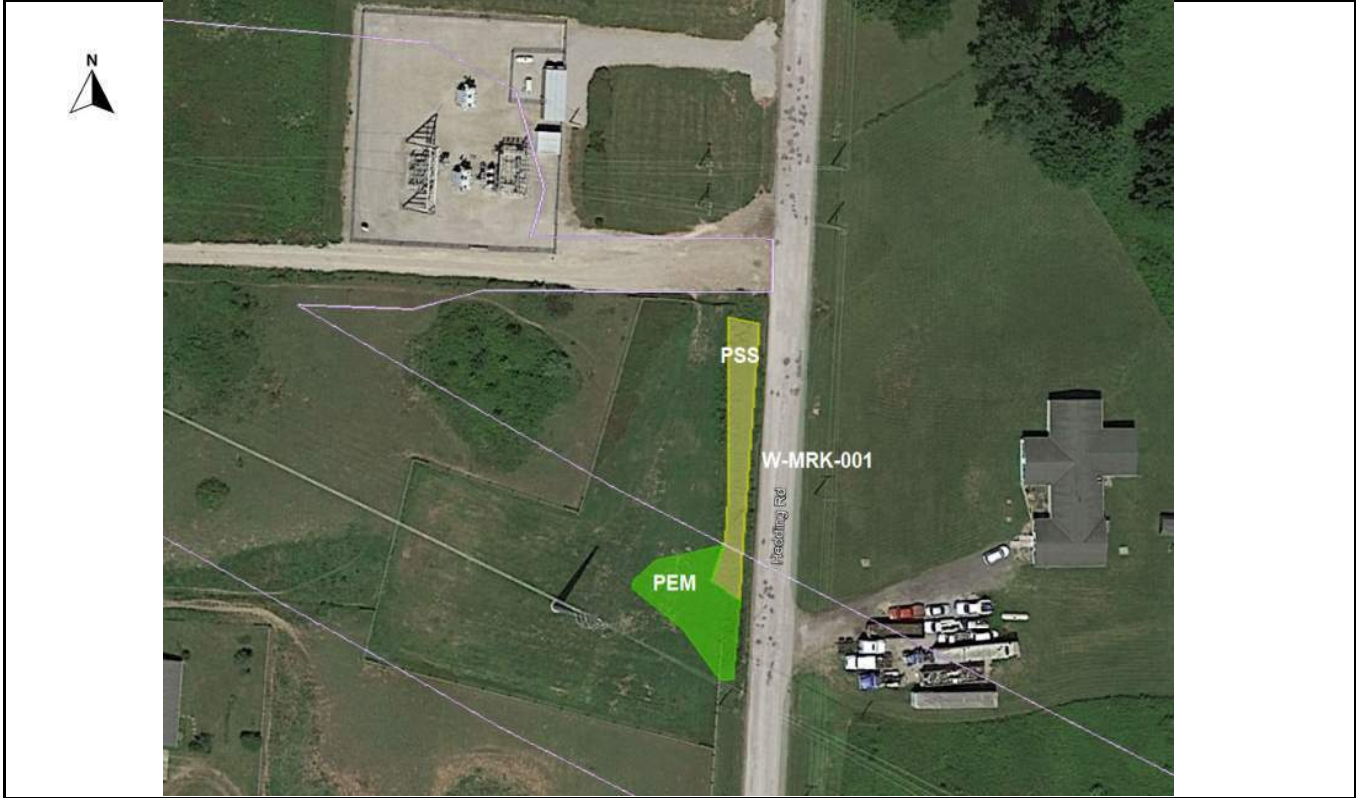
Name of Wetland:	W-MRK-001 PEM/PSS		
Wetland Size (delineated acres):	0.11	Wetland Size (Estimated total acres):	0.11

This PEM/PSS wetland complex begins in a small depression within the existing transmission line right-of-way. Surface runoff drains to the depression and flows into a roadside ditch that directs water away from the area.

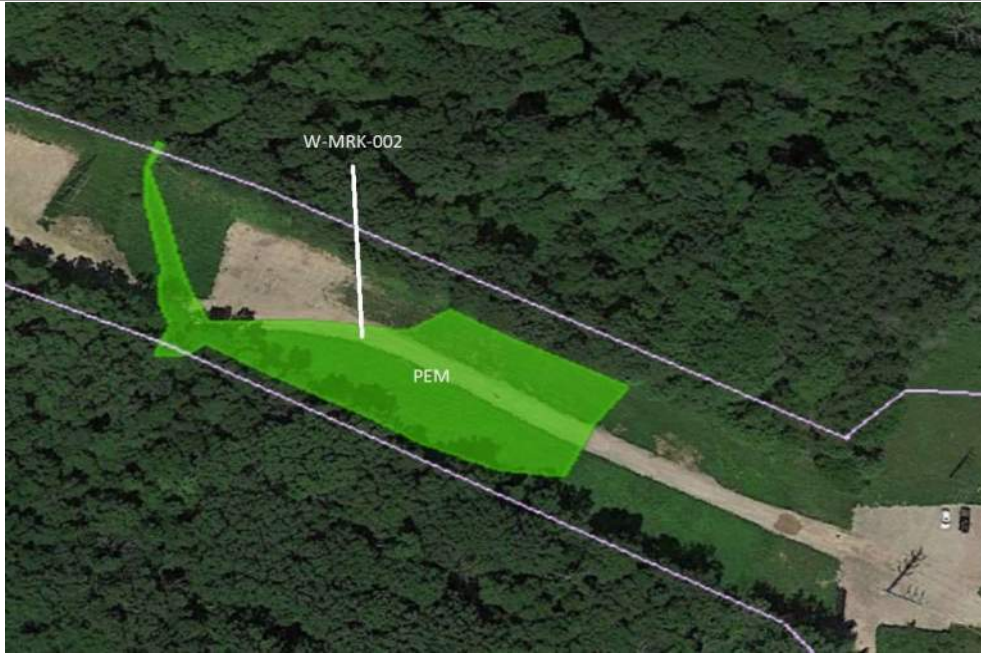
Name of Wetland:	W-MRK-002 PEM		
Wetland Size (delineated acres):	0.58	Wetland Size (Estimated total acres):	0.58

This PEM wetland is located in a swale that crosses the existing transmission line ROW. Water is draining to the swale from a stream located outside of the study area and a depression collecting surface runoff in the ROW.

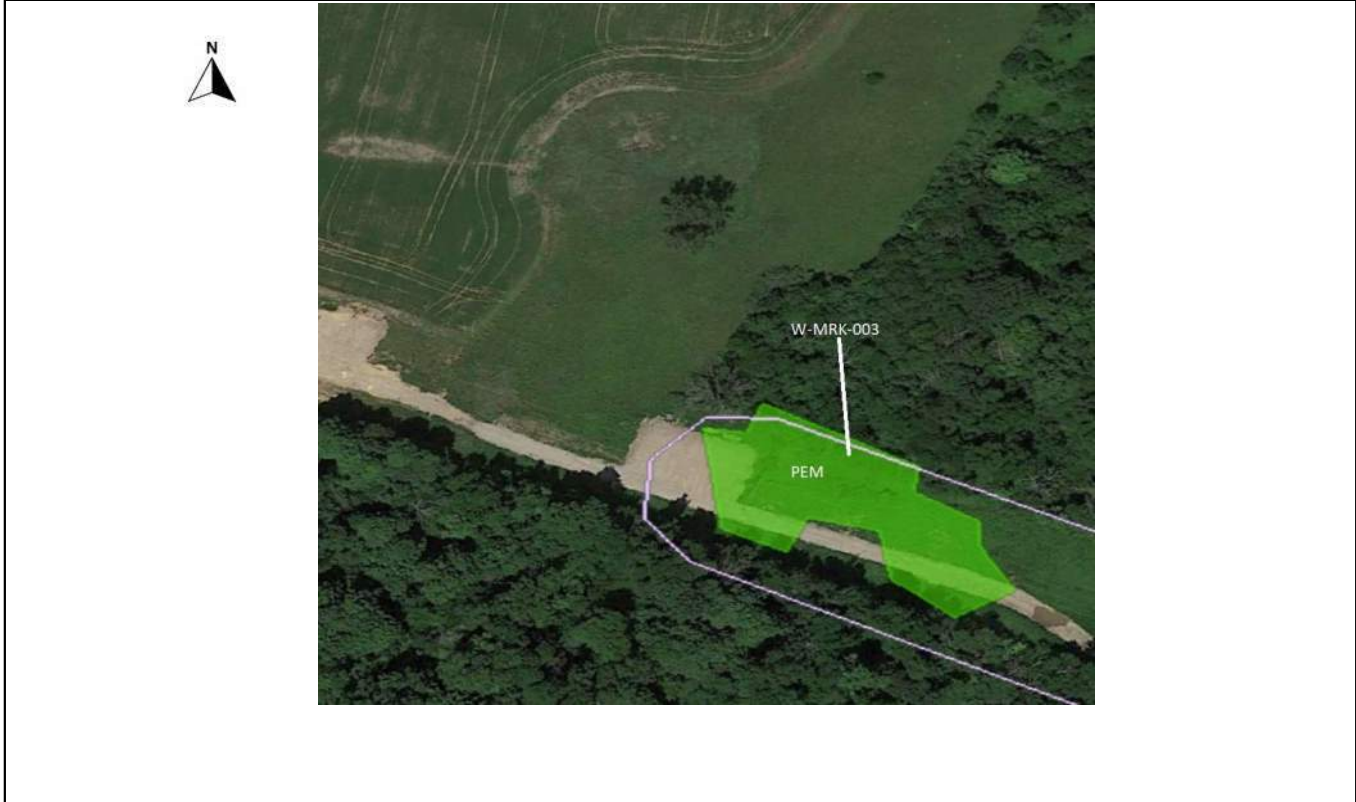
Name of Wetland:	W-MRK-003 PEM		
Wetland Size (delineated acres):	0.58	Wetland Size (Estimated total acres):	0.58

This PEM wetland is located in a hillside depression within the existing transmission line ROW. Water from the hillside spring seeps and surface runoff drain down the slope to the north and outside of the current study area.
