Letter of Notification for the South Canton – Sunnyside 138 kV Transmission Line Project

PUCO Case No. 23-0474-EL-BLN

Submitted by:
AEP Ohio Transmission Company, Inc.

May 12, 2023

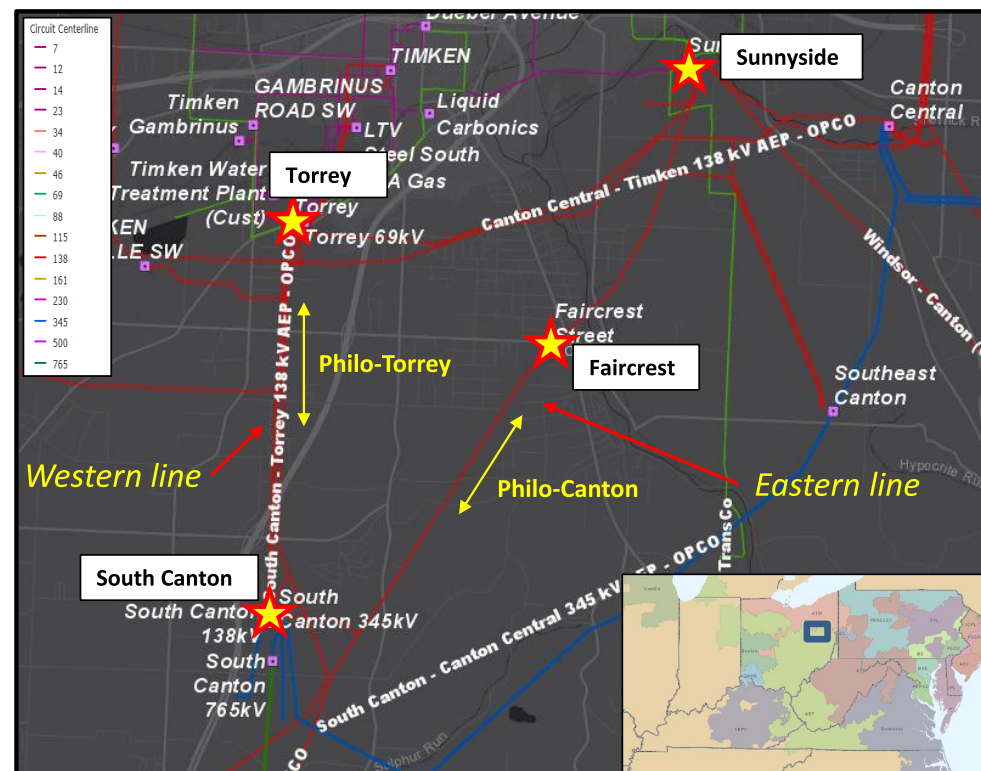
- The protection equipment on the Southeast Canton-Sunnyside 138kV circuit consists of legacy electromechanical relays and pilot wire communications channel. Electromechanical relays lack vendor support, don't have SCADA, and lack fault data collection capabilities. Aging pilot wire is increasingly prone to failure and increased maintenance, leading to risk of having to rely on backup protection methods.

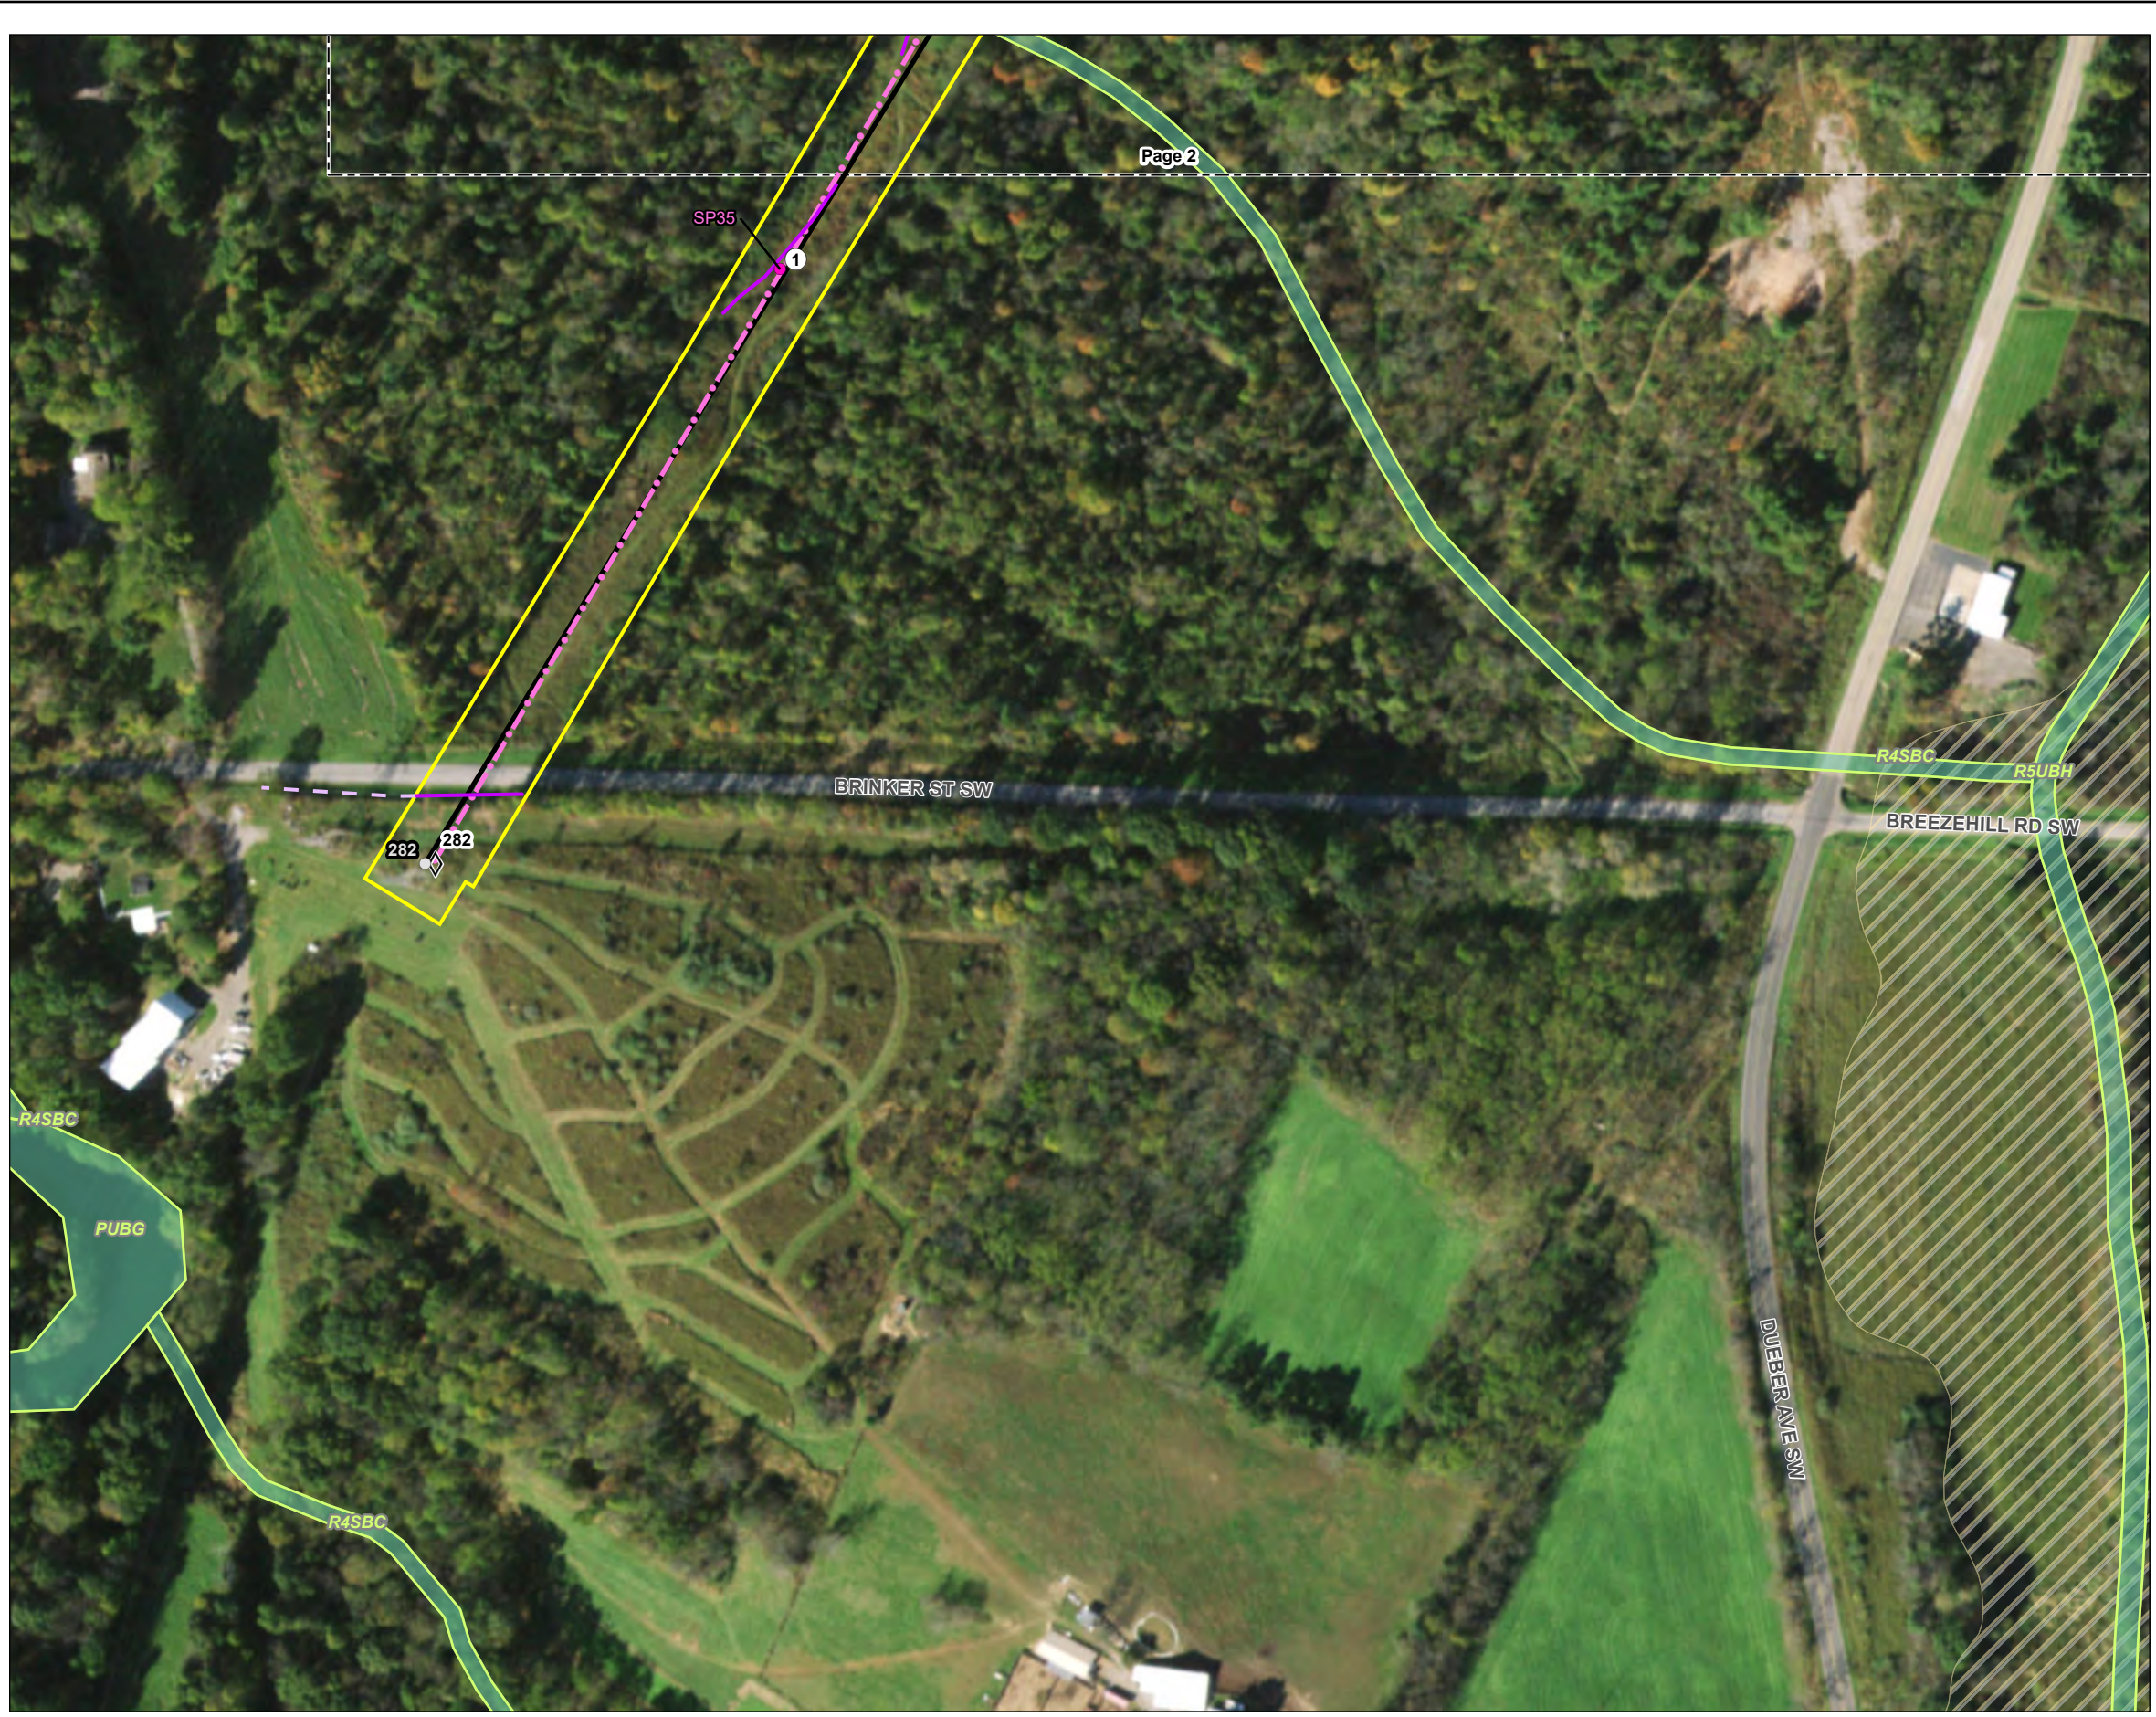
Figure No. **2**
Wetland and Waterbody Delineation Map
