Letter of Notification for the Lee Extension 138 kV Transmission Line Project

PUCO Case No. 22-0752-EL-BLN

Submitted by: AEP Ohio Transmission Company, Inc.

August 5, 2022

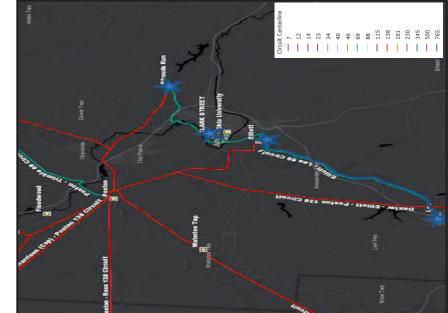
- The Crooksville Poston Strouds Run 138kV circuit is a threeterminal line, which limits sectionalizing and can cause misoperations and over tripping.
- The Dexter Elliot Poston 138kV circuit is a three-terminal line, which limits sectionalizing and can cause mis-operations and over tripping

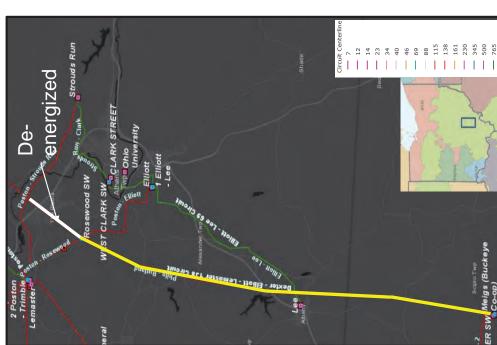
- Length: 8.8 Miles
- Original Construction Type: Aluminum/Steel Lattice
- Original Conductor Type: 397.5 CM ACSR 30/7 (1926 vintage)
- Momentary/Permanent Outages: 3 total outages over last 5 years
- Total structure count: 38
- Please reference needs materials on pre-1930s era lattice lines
- There is an additional 2.5 miles of the 1920's Philo -Rutland lattice line which is deenergized and runs through the middle of The Plains community north of Athens

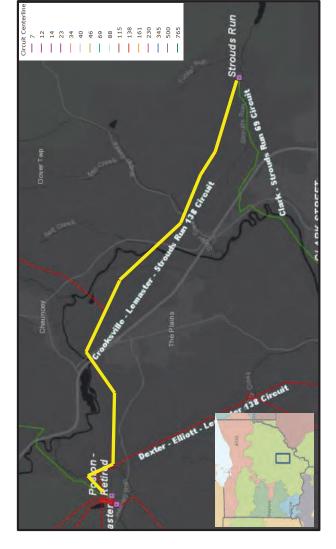
Poston – Shrouds Run 138kV (1965)

- Length 7.52 Miles
- Original Construction Type: Wood H-Frame
- Original Conductor Type: 636 ACSR Conductor (vintage 1966)
- Momentary/Permanent Outages: 3 total outages last 5 years
- Number of open conditions: 62
- Total structure count: 46
- Open conditions include: rot top, woodpecker holes, bowed structures, and burnt poles
- Unique structure count with open conditions: 31

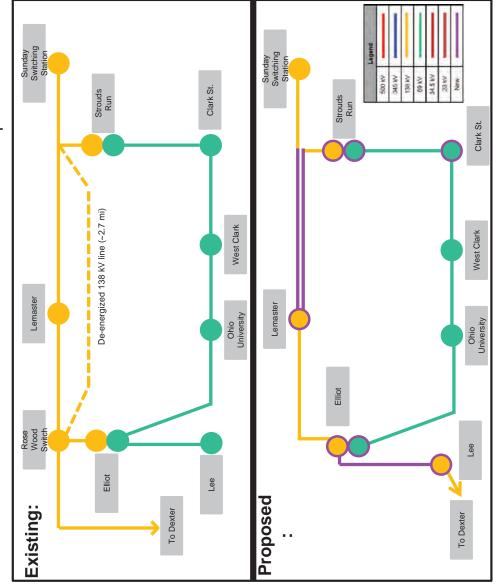
- Convert Lee to 138 kV service and install two line MOABs connected to the 138 kV line between Dexter and Elliot. (S2224.3) Estimated Cost: \$3.0M
- At Clark Street, replace 69 kV circuit breakers "61" & "64" (3000A 40kA). (S2224.4) Estimated Cost: \$2.9M

- At Elliot, install a new 138/69 kV transformer (130 MVA) in addition to high and low side protection (3000 A 40 kA) which will replace transformer #1 at Strouds Run that will be retired. Replace existing 138 kV circuit breaker "102" and 69 kV circuit breakers "61" and "66" (3000A, 40 kA). Install 138 kV circuit breaker (3000A, 40 kA) on the new 138 kV line towards Dexter (via Lee) along with a 138 kV bus-tie breaker (3000, 40 kA). Retire 69 kV circuit breaker "67" due to the conversion of Lee station to 138 kV. (S2224.5) Estimated Cost: \$6.7M

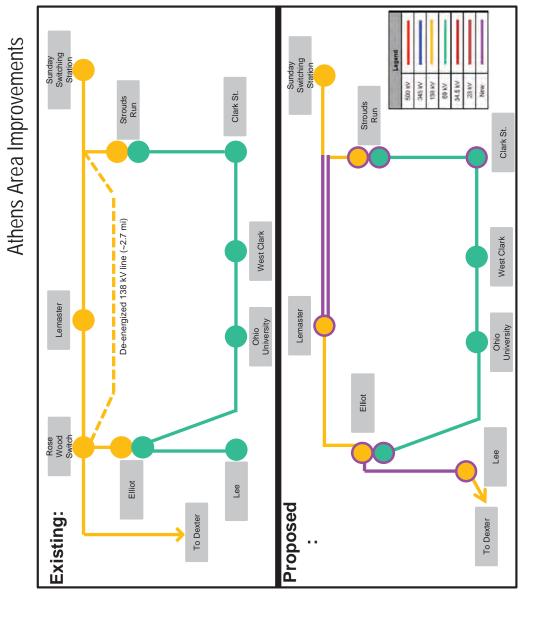
- At Strouds Run, install a 138kV line breaker (3000A 40kA) towards Lemaster. Replace transf #2 high side circuit switcher with a circuit breaker (3000A, 40 kA). Replace the 69kV circuit breaker "66" (3000A, 40kA). Retire 138/69/13 kV 33.6 MVA transf #1, 69 kV circuit breaker "63", and circuit switcher # 1. (S2224.7) Estimated Cost: \$1.6M
- At Lemaster station, install a 138kV breaker (3000A 40kA) to accommodate the new circuit. (S2224.8) Estimated Cost: \$1.0M
- Remove Rosewood switch. (S2224.9) Estimated Cost: \$0.1M
