# Letter of Notification for the Arboles 138 kV Station Project

PUCO Case No. 21-1084-EL-BLN

AEP Ohio Transmission Company, Inc.

December 9, 2021

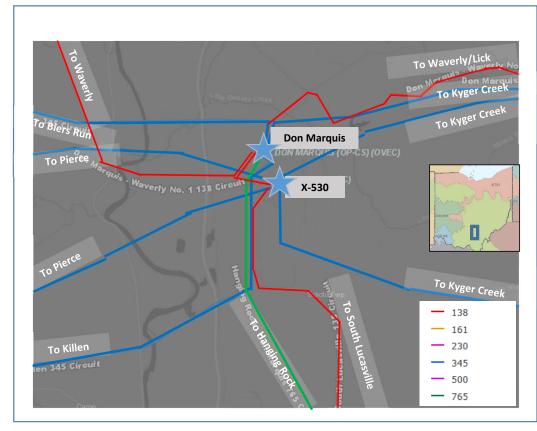
The Ohio Valley Electric Corporation (OVEC) and the US Department of Energy (DOE) are in the process of terminating their connection at Don Marquis. The DOE has informed AEP of its intention to retire its X-530 Substation, adjacent to AEP's Don Marquis Substation and has requested a new delivery point from AEP at the same location. The new load is anticipated to peak near 38MW.

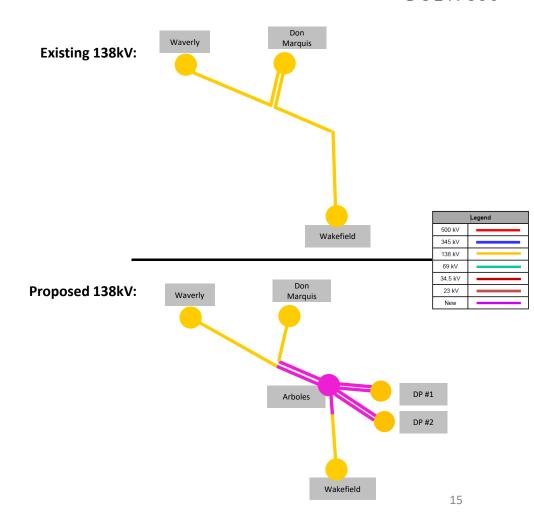
## AEP Transmission Zone M-3 Process DOE X-350

- Construct ~0.3 miles of new line to terminate the South Lucasville circuit into Arboles. (s2213.3) Estimated Cost: \$1.3M (AEP)
- Construct two independent lines to serve the X-555 substation (DP #1). The lines will be ~0.4 miles long each. (s2213.4) Estimated Cost: \$1.7M (AEP)

- Construct two independent lines to serve the X-5001 substation (DP #2). The lines will be ~0.8 miles long each. (s2213.5) Estimated Cost: \$3.5M (AEP)
