Construction Notice Speidel-Barnesville 138 kV Cut-in to Pumpkin Station Project

PUCO Case No. 23-0694-EL-BNR

Submitted to:
The Ohio Power Siting Board
Pursuant to Ohio Administrative Code Section
4906-6-05

Submitted by:
AEP Ohio Transmission Company, Inc.

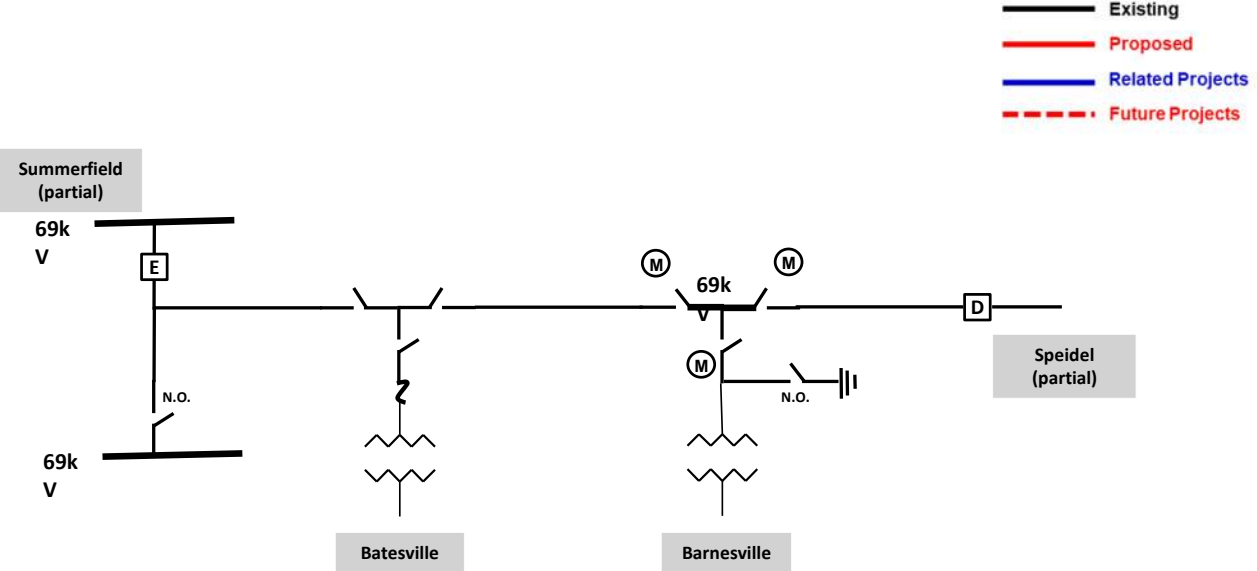
Project System Electrical Diagram (existing)

Include all CPPs in the Master Project. Draw the existing area one line for the buses the project will impact. Include circuits back to every remote end breaker. Snapshots of the Operations switching diagram are not acceptable.

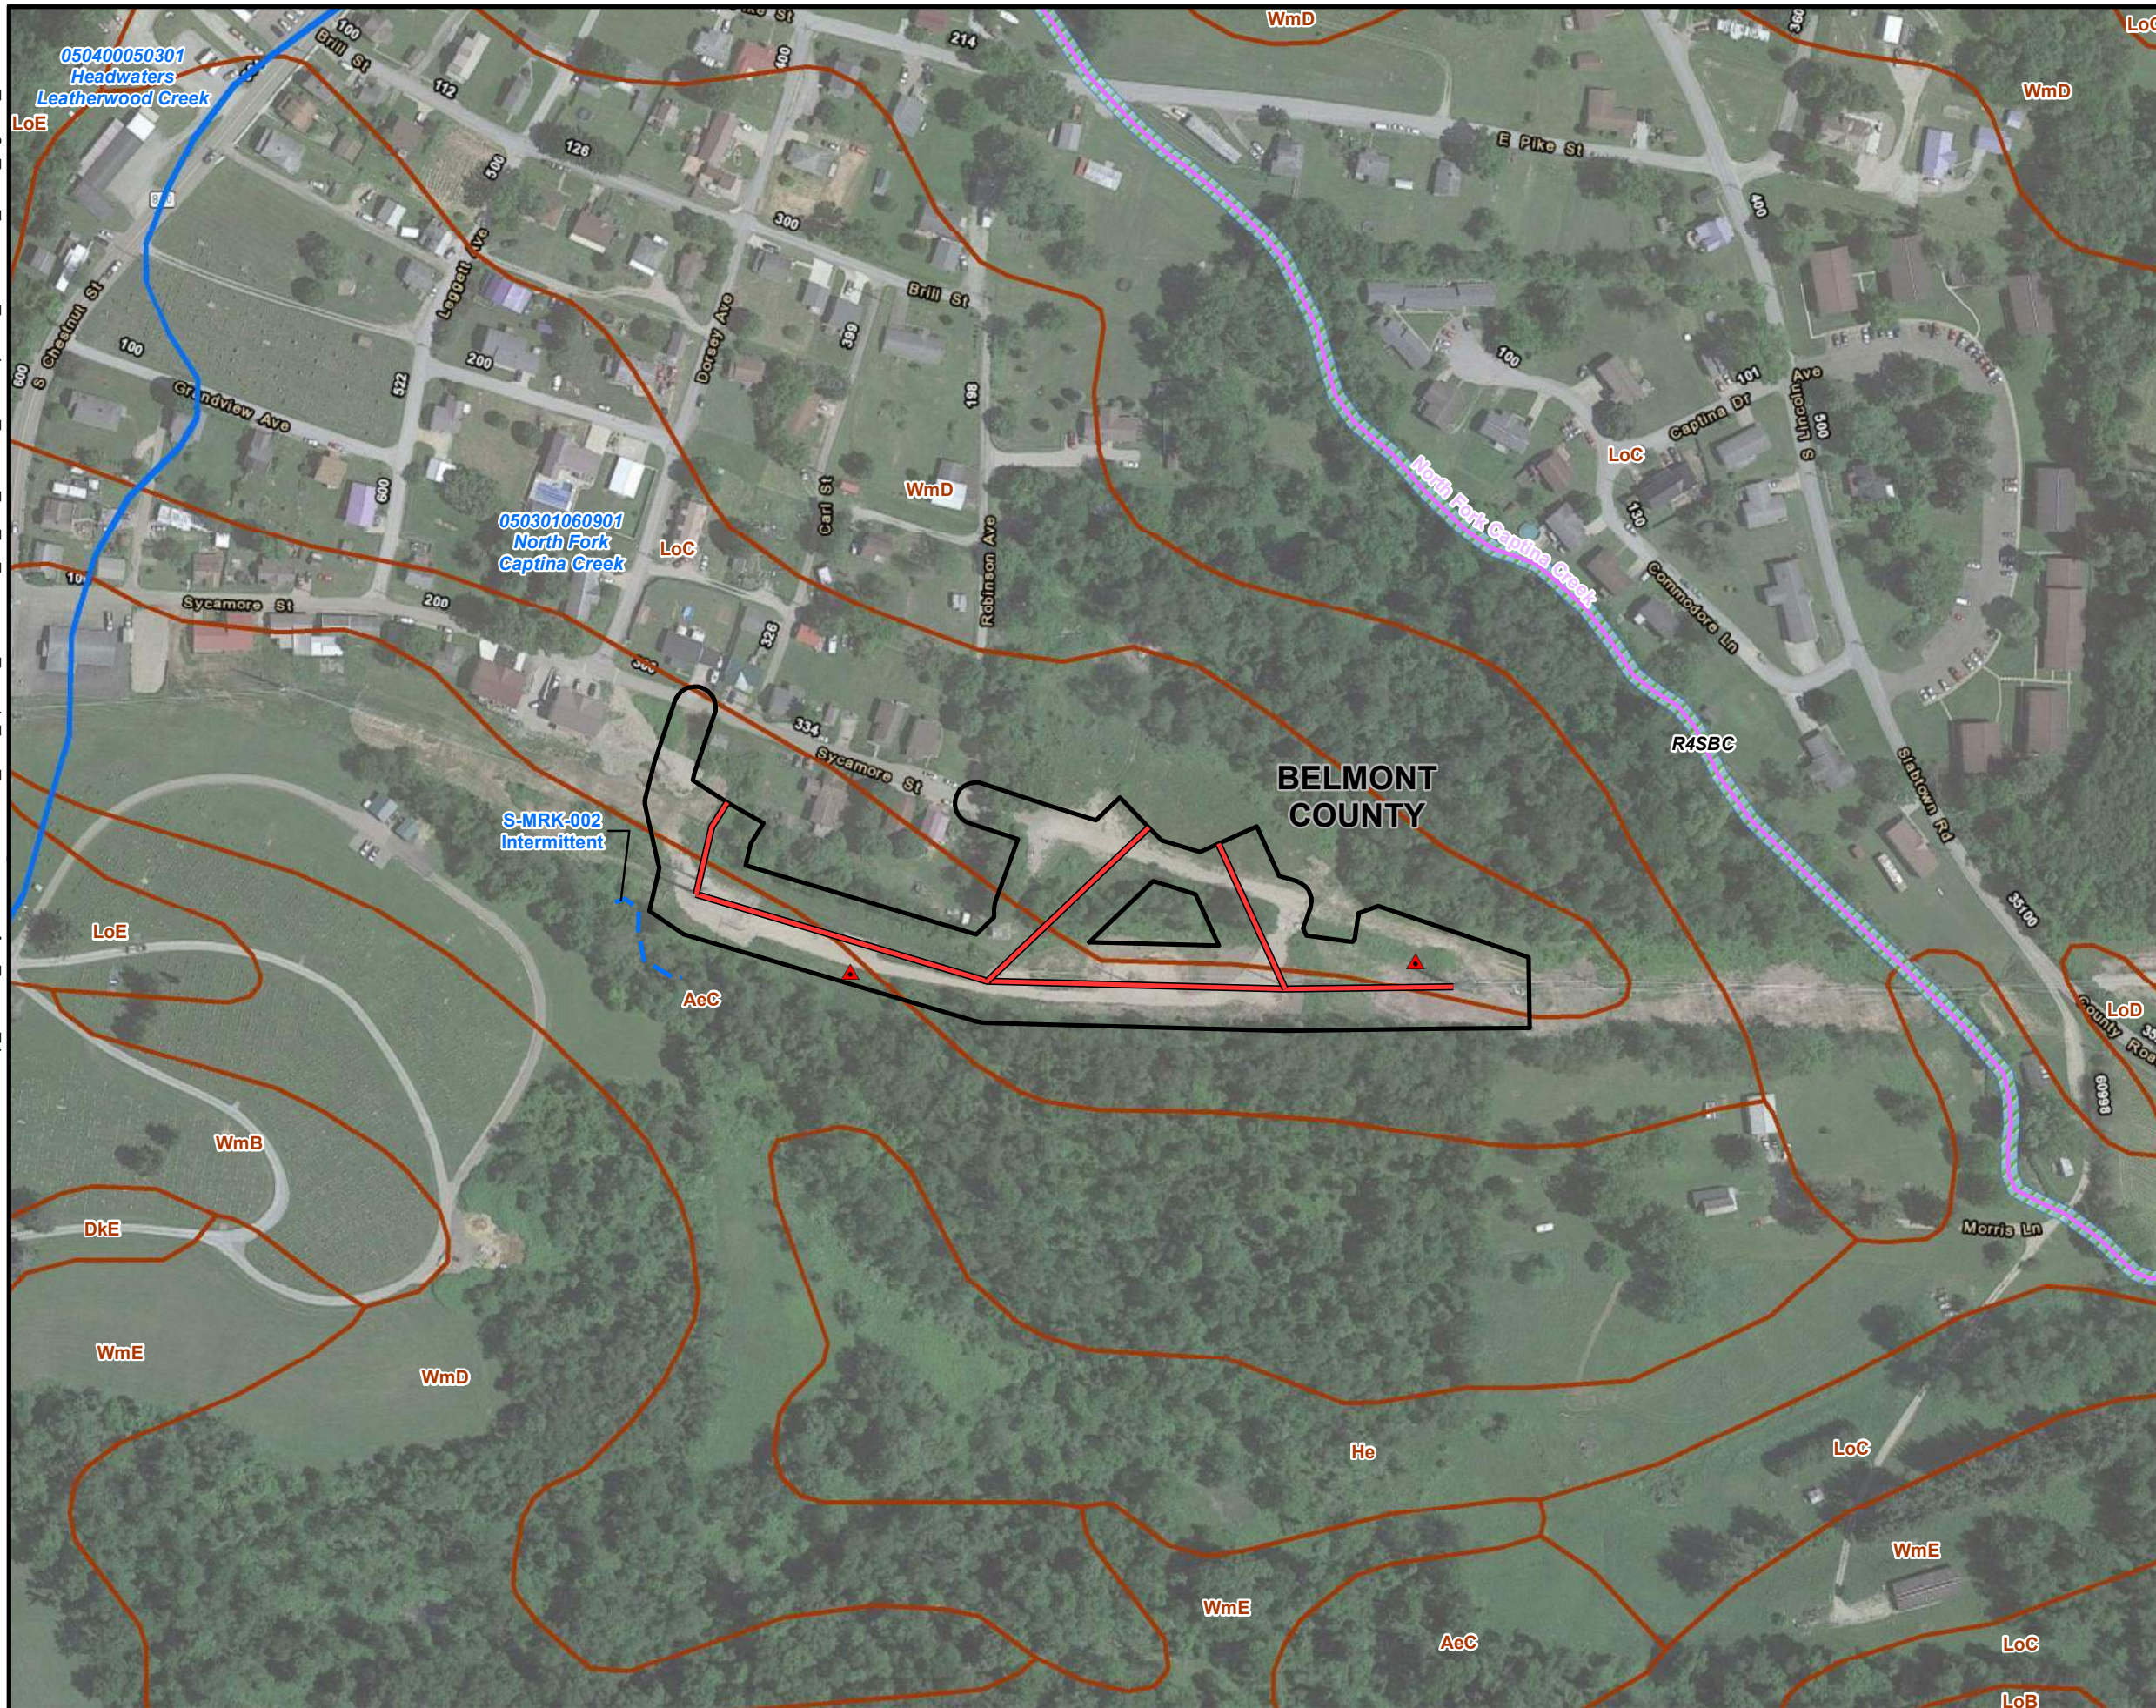
Speidel Barnesville Line Install TR380 Project	
FIGURE 2 SOIL MAP AND NATIONAL WETLAND INVENTORY MAP	
DATE: 11/10/2022	1 INCH = 200 FEET
CREATED BY: PMH	CHECKED BY:
JOB NO. 60688122	AECOM

- ▲ Upland Data Point
- Speidel Barnesville Tie-In
- Delineated Intermittent Stream
- NHD Stream (USGS)
- ▨ NWI Wetland (USFWS)
- Project Survey Area
- HUC 12 (USGS)
- County Boundary
- SSURGO Soil Map Unit (NRCS)

Soils in delineated wetlands were observed and documented as part of the delineation methodology. According to the USDA/NRCS Web Soil Survey, three soil series are mapped within the Project survey area (USDA NRCS 2021a and 2021b). Of these, no soil map units are identified as hydric. **Table 1** below provides a detailed overview of all soil series and soil map units present within the Project survey area. Soil map units located in the Project survey area and vicinity are shown on **Figure 2**.

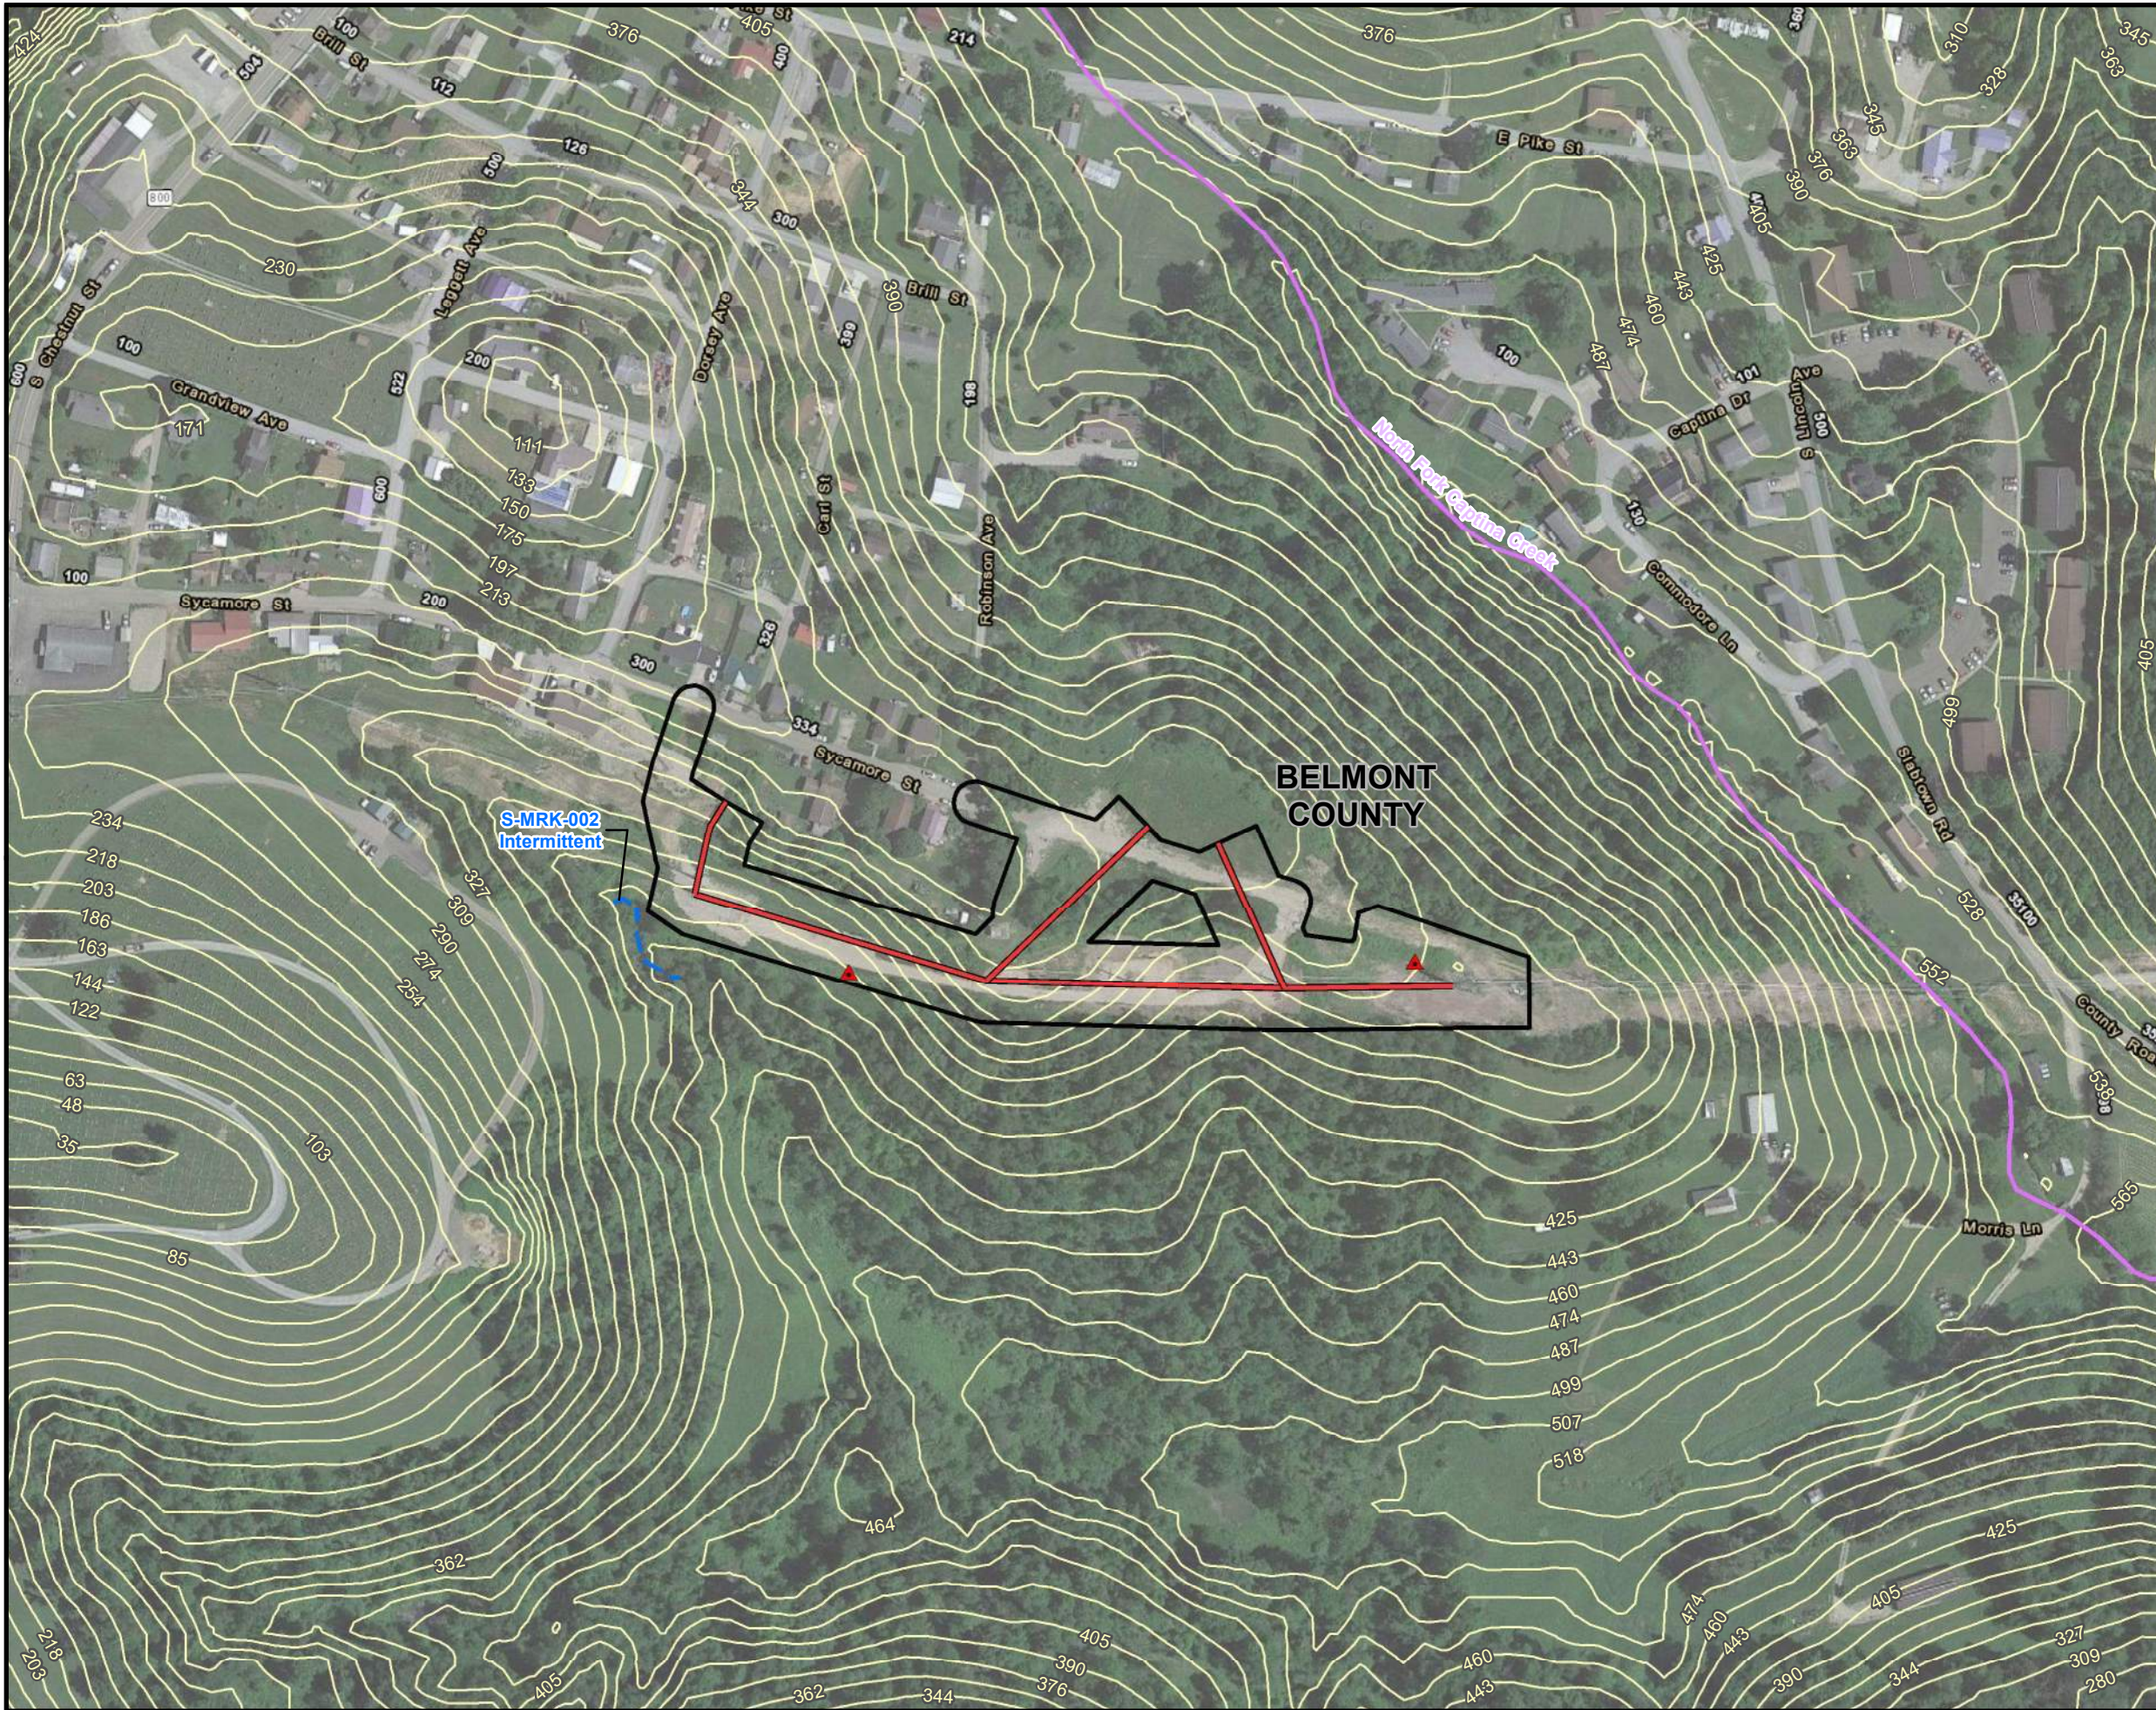
FIGURE 3	
WETLAND DELINEATION AND STREAM ASSESSMENT MAP	
DATE: 11/10/2022	1 INCH = 200 FEET
CREATED BY: PMH	CHECKED BY:
JOB NO. 60688122	AECOM

- ▲ Upland Data Point
- Speidel Barnesville Tie-In
- Contour (5-Ft)
- NHD Stream (USGS)
- Delineated Intermittent Stream
- Project Survey Area
- County Boundary

AECOM has provided a provisional determination that all delineated streams within the Project survey area appear to be jurisdictional (i.e., WOTUS), based on their observed or presumed confluence with downstream waters. Final jurisdictional status can only be determined by the USACE, and AECOM assessments are provisional. A summary of the delineated streams is provided in **Table 2**. Stream data forms and photographs of each delineated stream resource are provided in **Appendix B**.

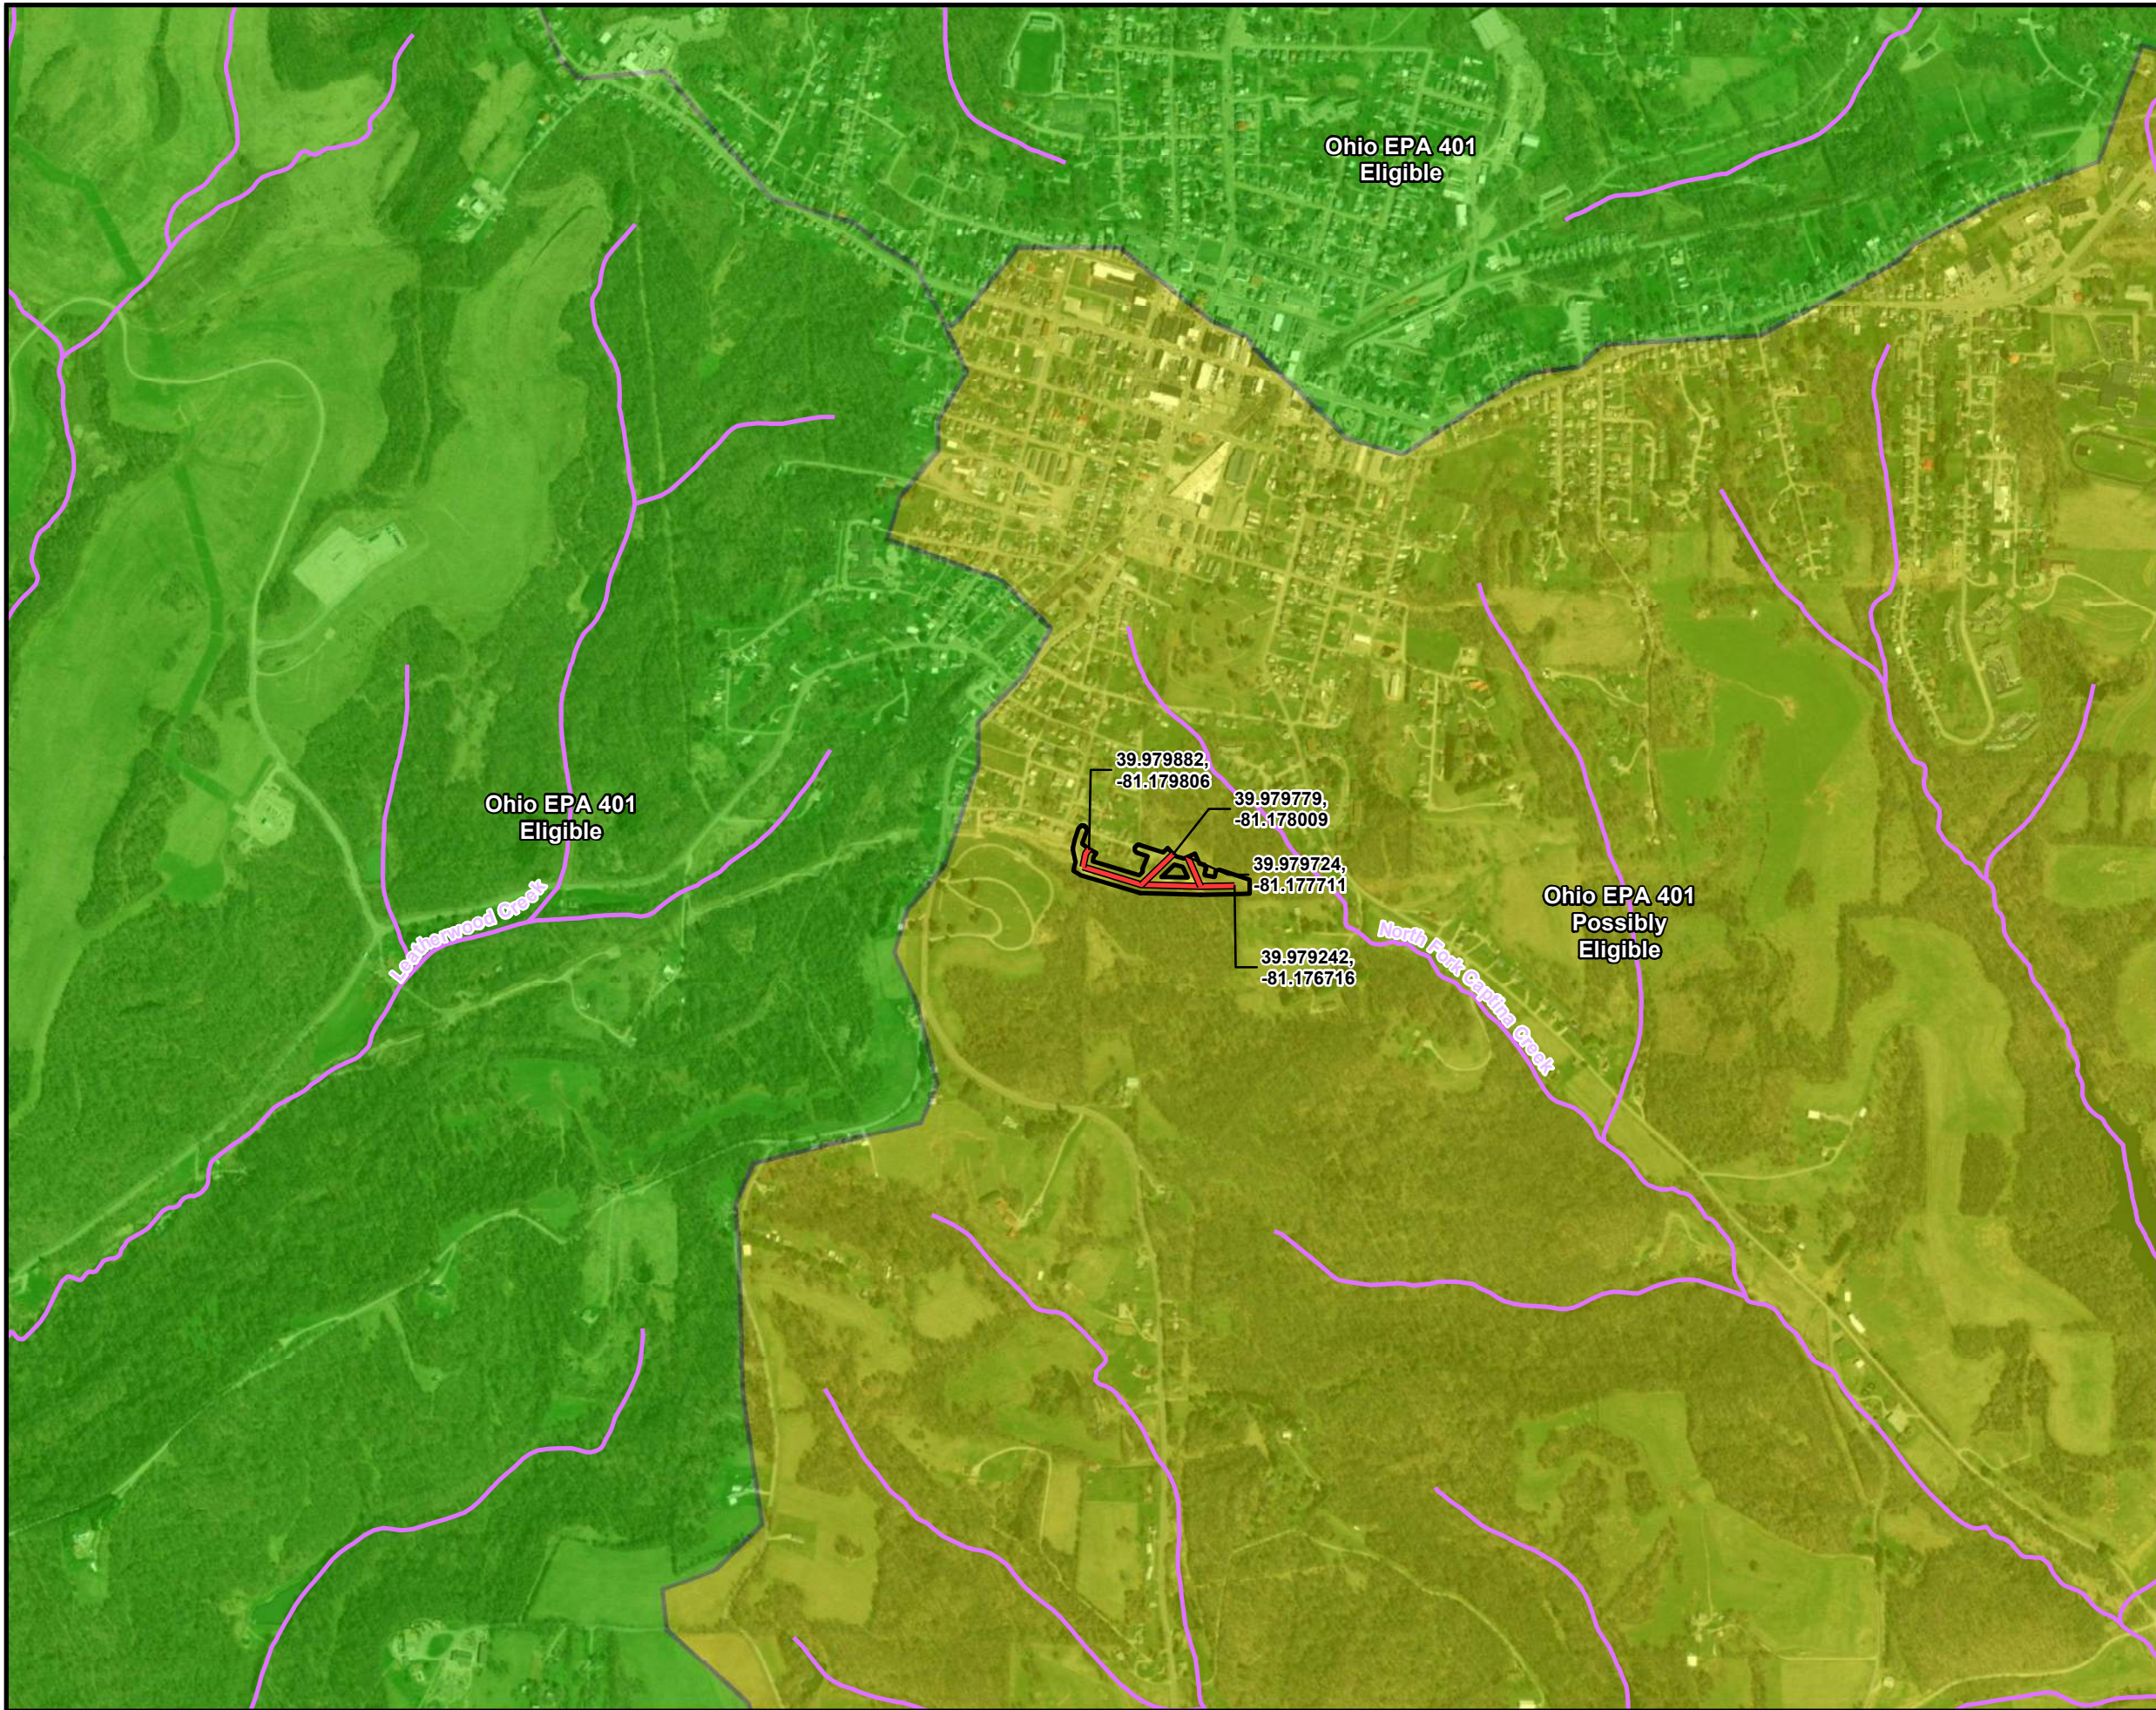
The ecological survey of the Project survey area identified one intermittent stream and was identified as a Class 1 PHW, this feature can be seen on **Figure 3**. The AECOM has preliminary determined that the assessed streams within the Project survey area appear to be jurisdictional (i.e., WOTUS). The reported results of the ecological survey conducted by AECOM on this Project are limited to the areas within the Project survey area provided in **Figure 3**. Areas that fall outside of the Project survey area were not evaluated in the field and are not included in the reporting of this survey.

The reported results of the ecological survey conducted by AECOM on this Project are limited to the areas within the Project survey area provided in Figure 3. Areas that fall outside of the Project survey area were not evaluated in the field and are not included in the reporting of this survey.

During the field survey, AECOM did not identify any wetlands. Representative uplands were taken to characterize the study area. These points are provided on **Figure 3**. Completed USACE data each upland are provided in **Appendix A**.

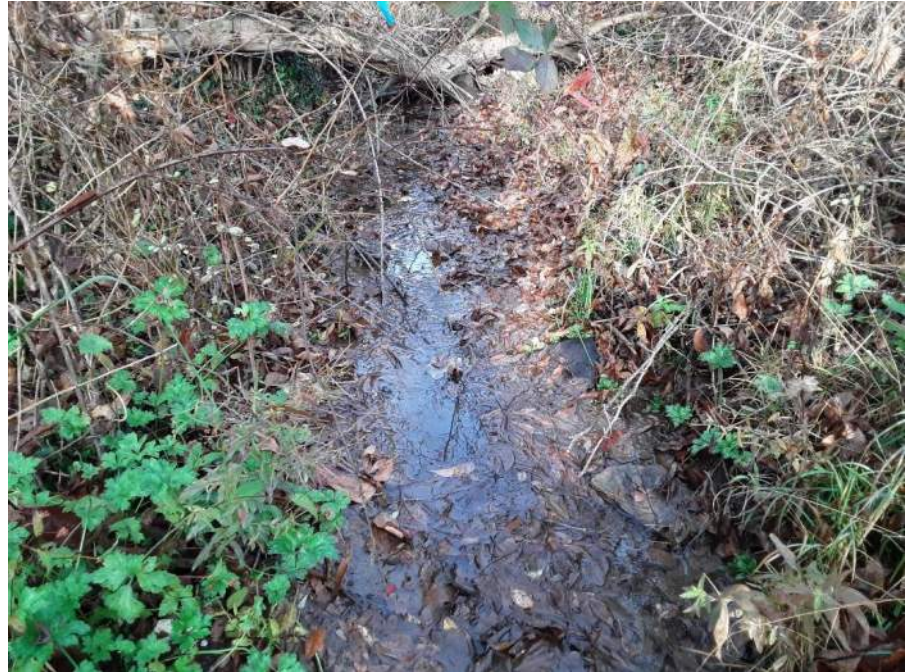
S-MRK-002
Date: November 02, 2022
Description: Intermittent Facing Upstream

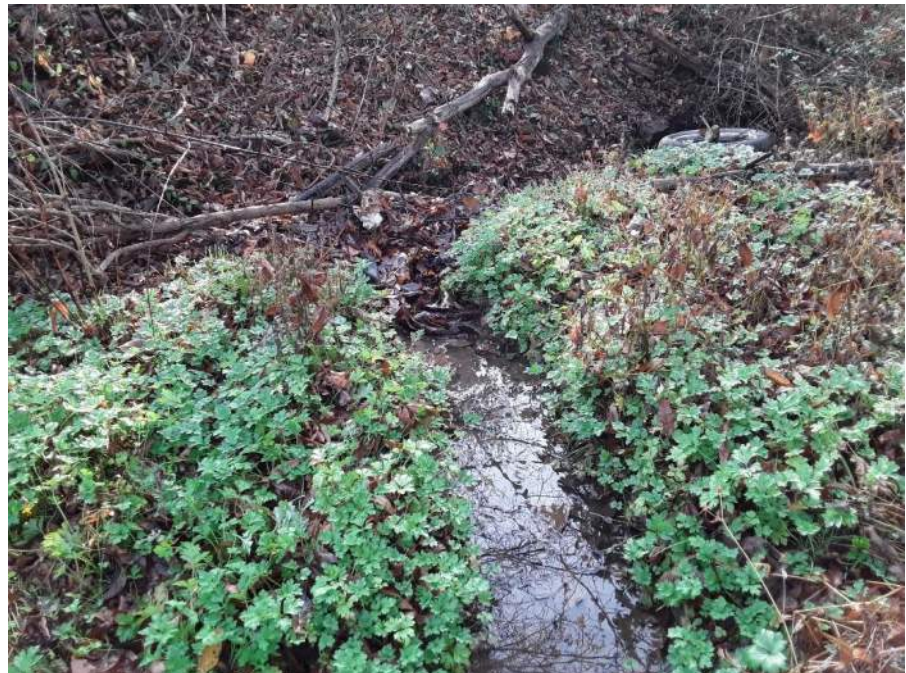
S-MRK-002
Date: November 02, 2022
Description: Intermittent Facing Downstream

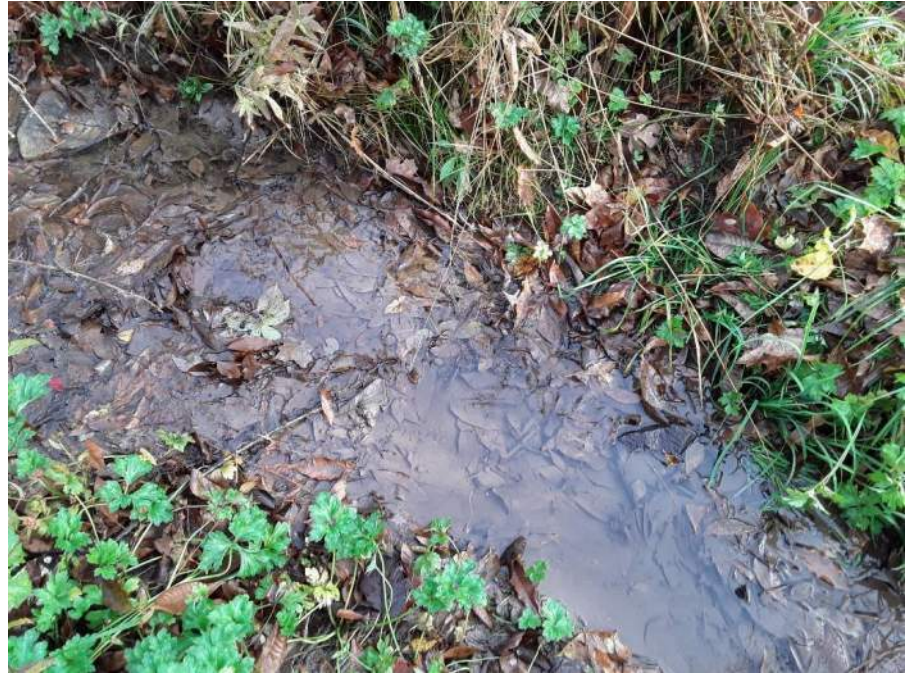
S-MRK-002
Date: November 02, 2022
Description: Intermittent Facing Substrate

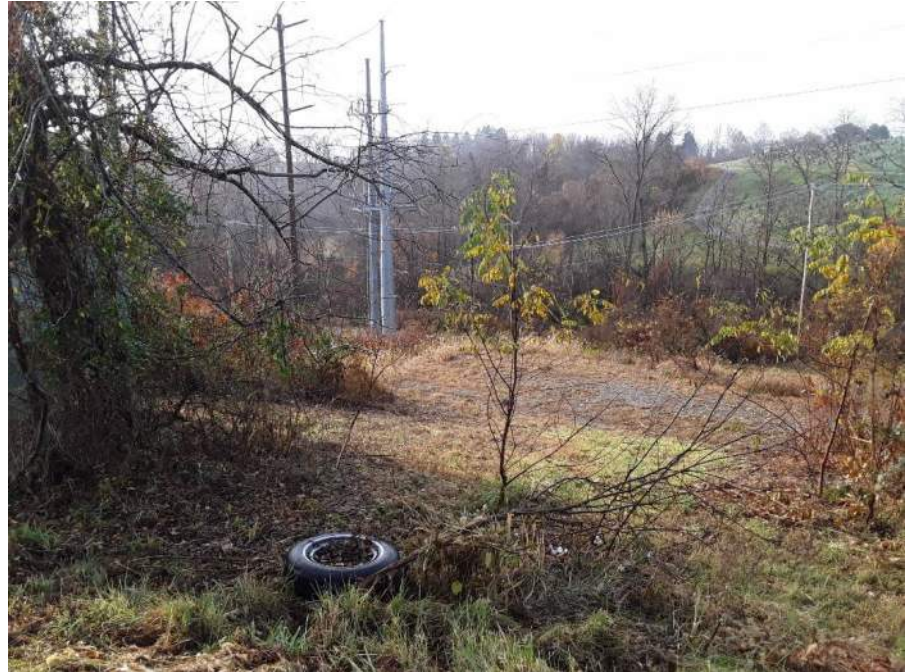
PH-01
Date: November 02, 2022
Description: Old Field Habitat Facing South

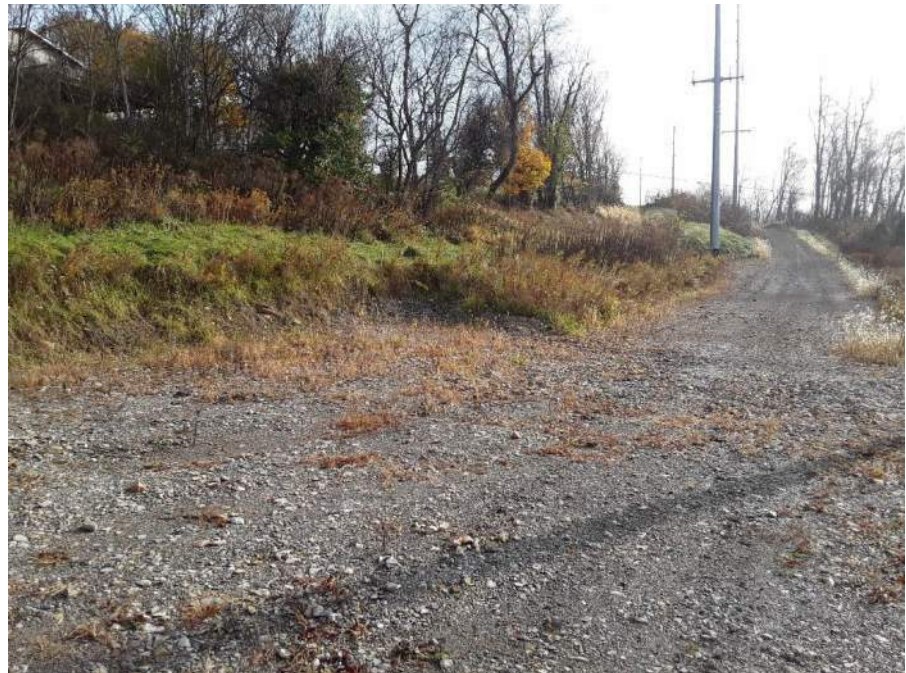
PH-02
Date: November 02, 2022
Description: Urban Habitat Facing East

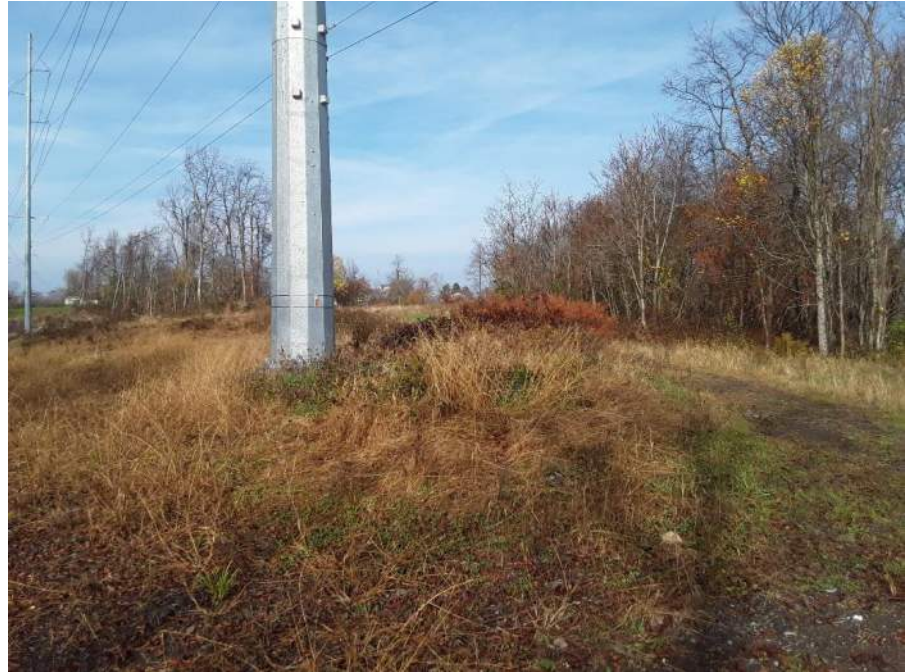
PH-03
Date: November 02, 2022
Description: Old Field Habitat Facing North

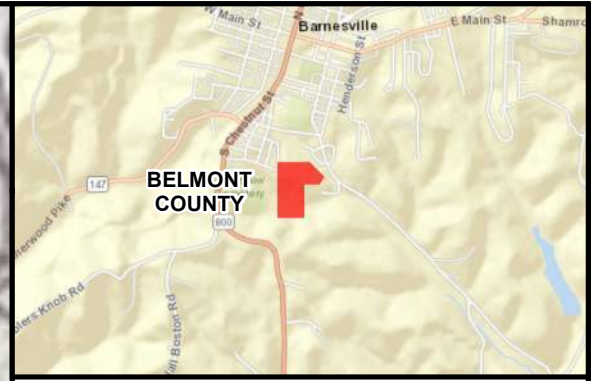
No mining activities, karst features, and/or sink holes are within the extent of the map frame. The closest feature is 0.45 miles west of the Project area.

AECOM completed a desktop review of publicly available data to identify underground voids which could be potential hibernation sites for overwintering bats (hibernacula) within 0.25-miles of the Project area. The data sources utilized include USGS topographical maps, aerial photography, and ODNR's Division of Mineral Resources and Geological Survey Data for Known Mining Activity and Karst Geology/Sinkholes as shown on Figure 1 and 2. Based on the available desktop resources, no abandoned underground and surface mines or documented mine entrances/openings are located within 0.25-mile of the Project. No karst features were identified within 0.25-mile of the Project. The closest feature is located approximately 0.45-mile west of the Project area.

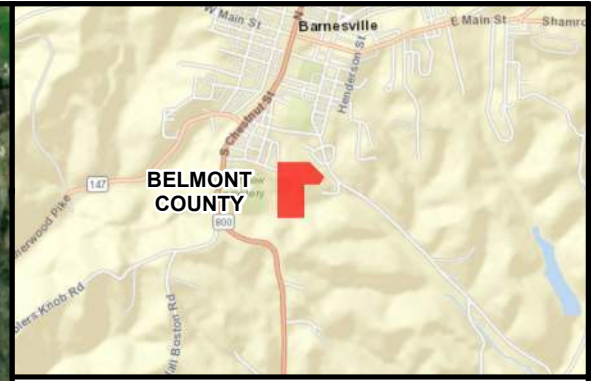
No mining activities, karst features, and/or sink holes are within the extent of the map frame. The closest feature is 0.45 miles west of the Project area.
