Construction Notice Kammer – Dumont 765 kV Transmission Line Raise Project

PUCO Case No. 23-0538-EL-BNR

Construction Notice for Kammer – Dumont 765 kV Transmission Line Raise Project

Ohio Power Company Kammer – Dumont 765 kV Transmission Line Raise

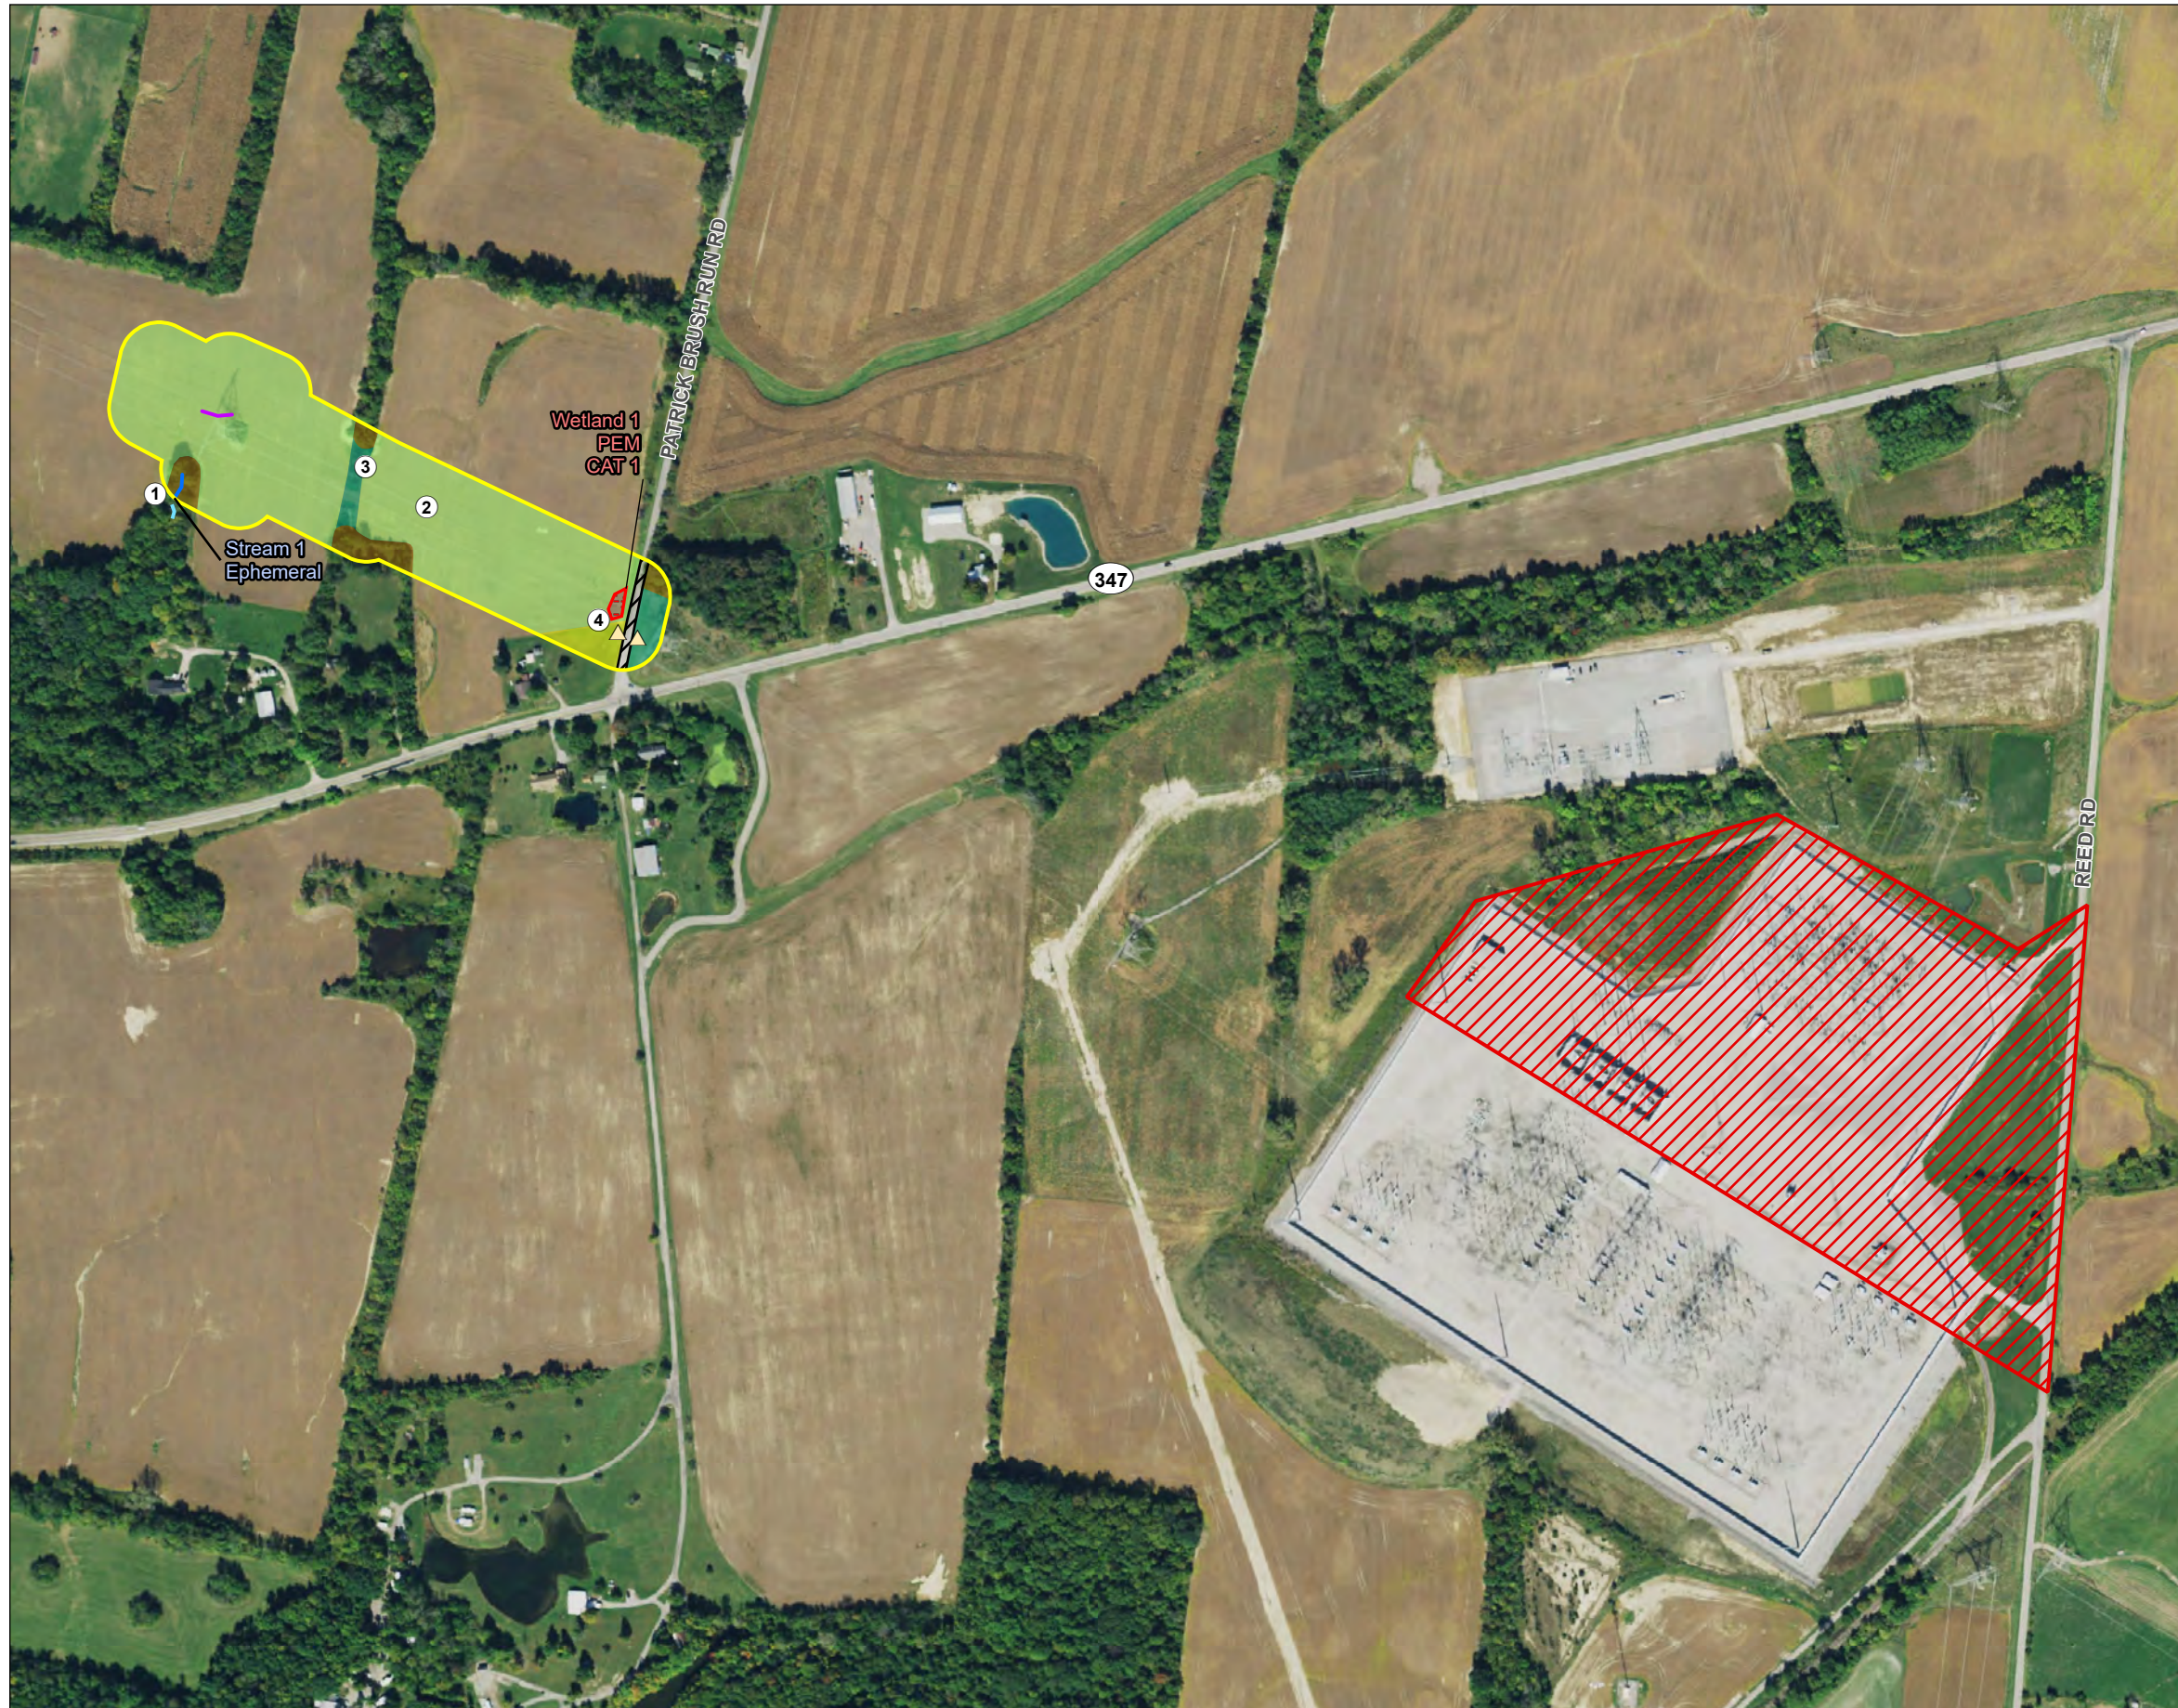
A.3 FIGURE 3 – HABITAT ASSESSMENT MAP

Stantec completed field surveys on January 5, 2023, for threatened and endangered species or their habitats. Figure 3 (Appendix A) shows the vegetation communities/habitats identified within the Project area and the locations of any identified rare, threatened, or endangered species habitat observed within the Project area during the time of the habitat assessment surveys. Representative photographs of the vegetation communities/habitats and land cover types identified within the Project area are included in Appendix C of this report (photo locations are shown on Figure 3, Appendix A). Information regarding the vegetation communities/habitats/land cover types identified within the Project area is provided in Table 1.

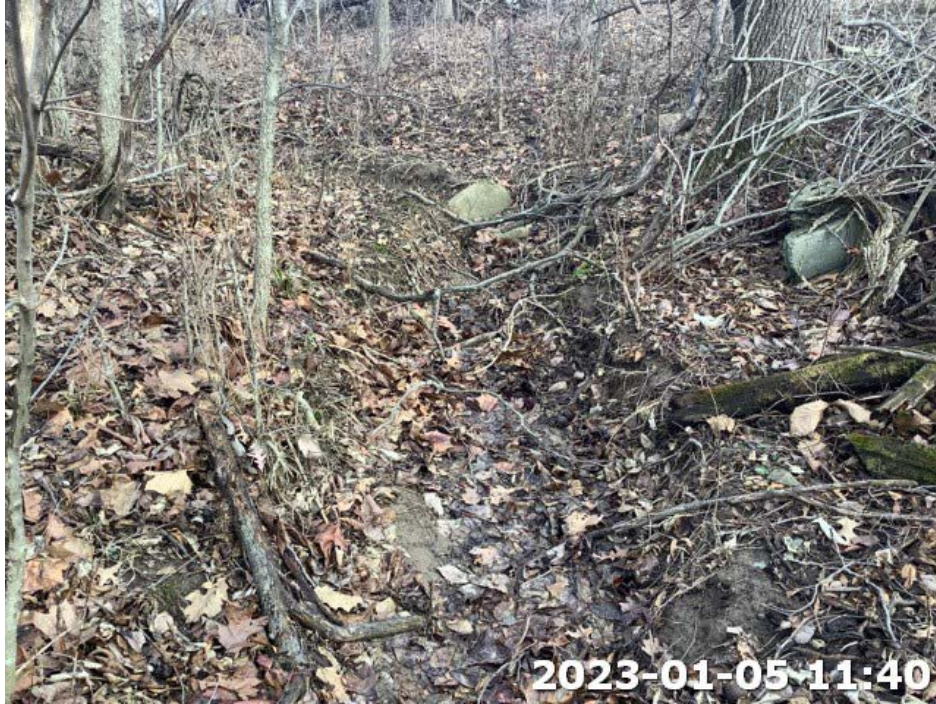
Photograph Location 1. View of Stream 1. Photograph taken facing upstream/north.

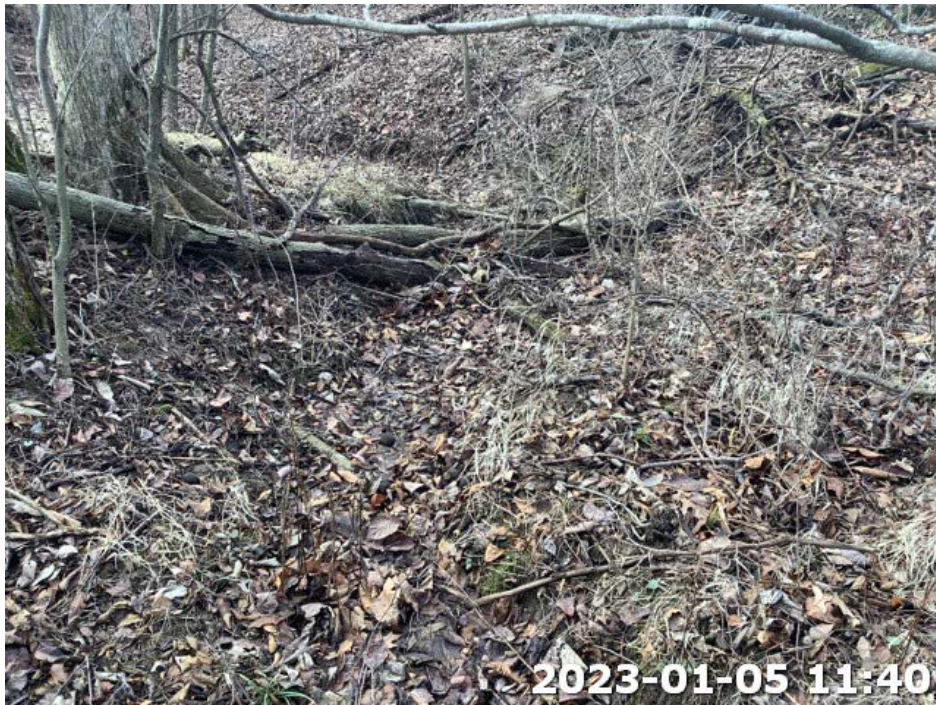
Photograph Location 1. View of Stream 1. Photograph taken facing downstream/south.

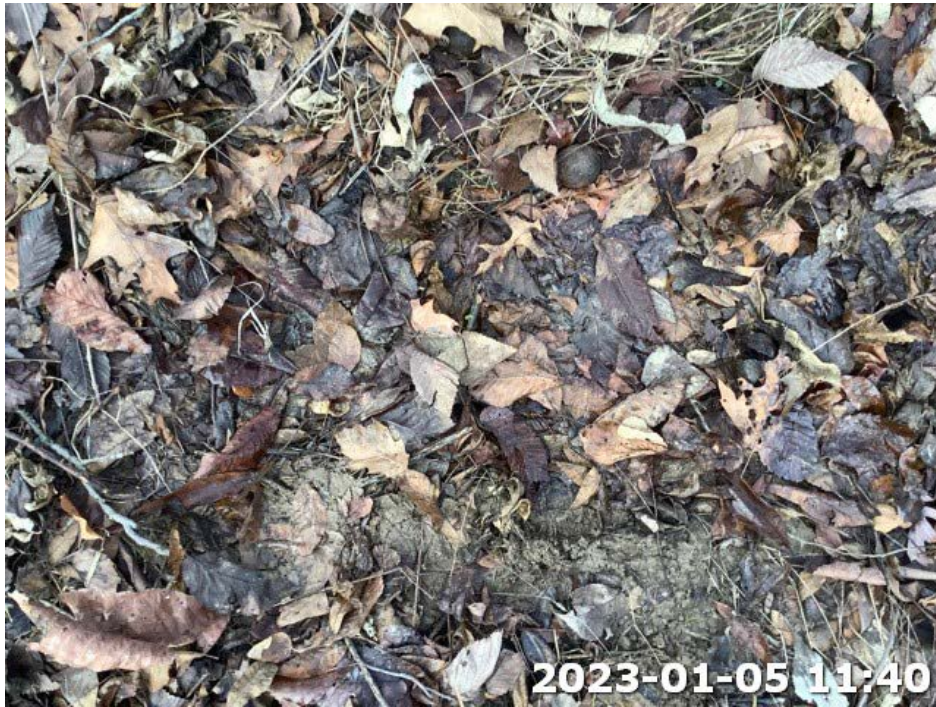
Photograph Location 1. View of substrates of Stream 1.

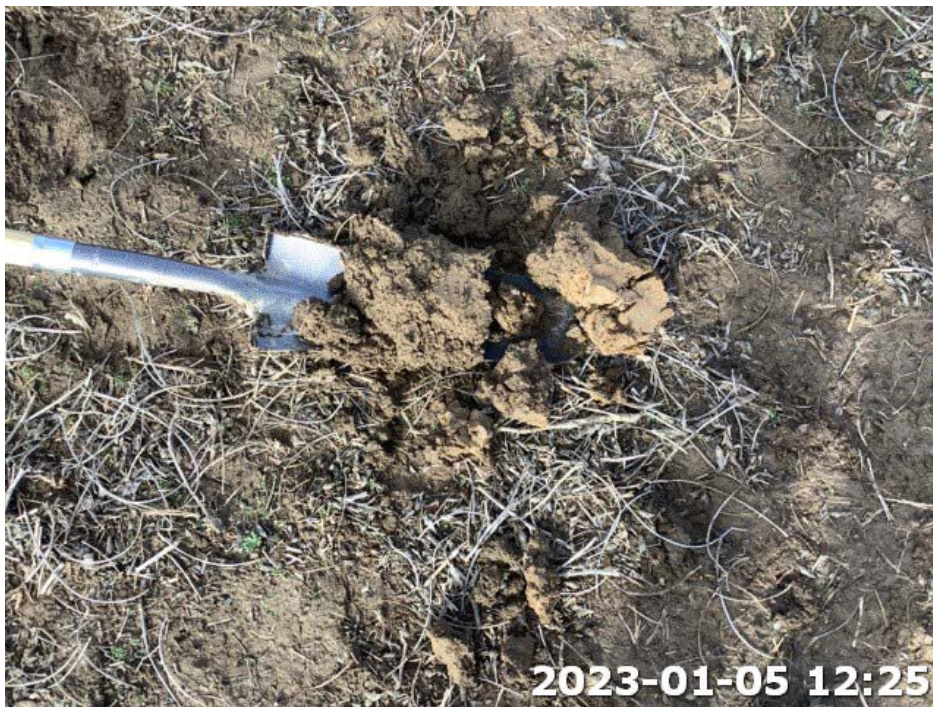
Photograph Location 2. View of soil profile at wetland determination sample point location SP01.

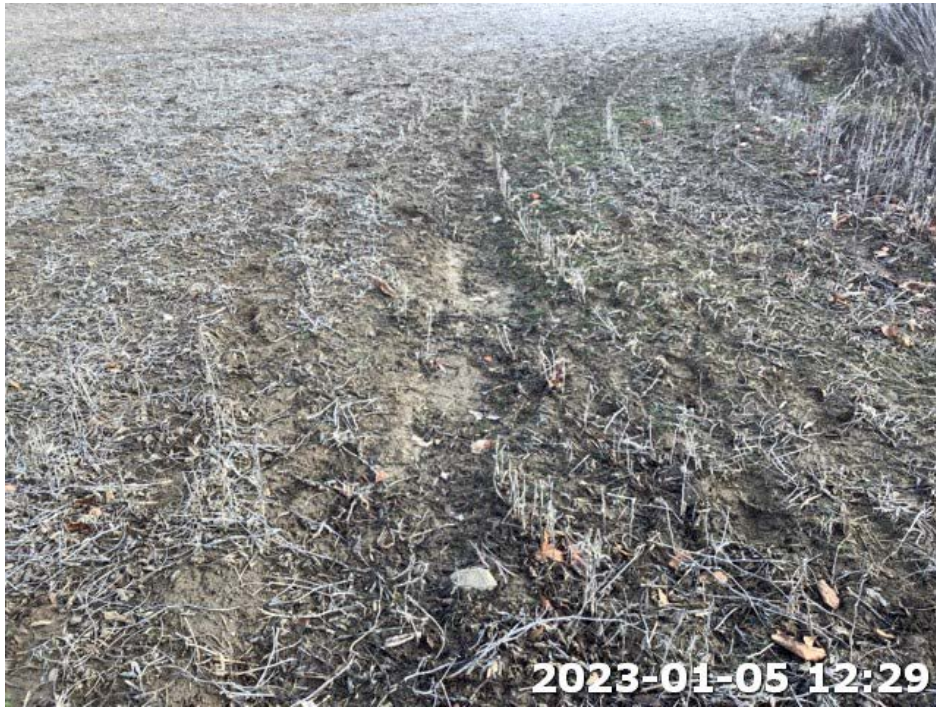
Photograph Location 3. Representative view of an upland drainage feature within the Project area. Photograph taken facing east.

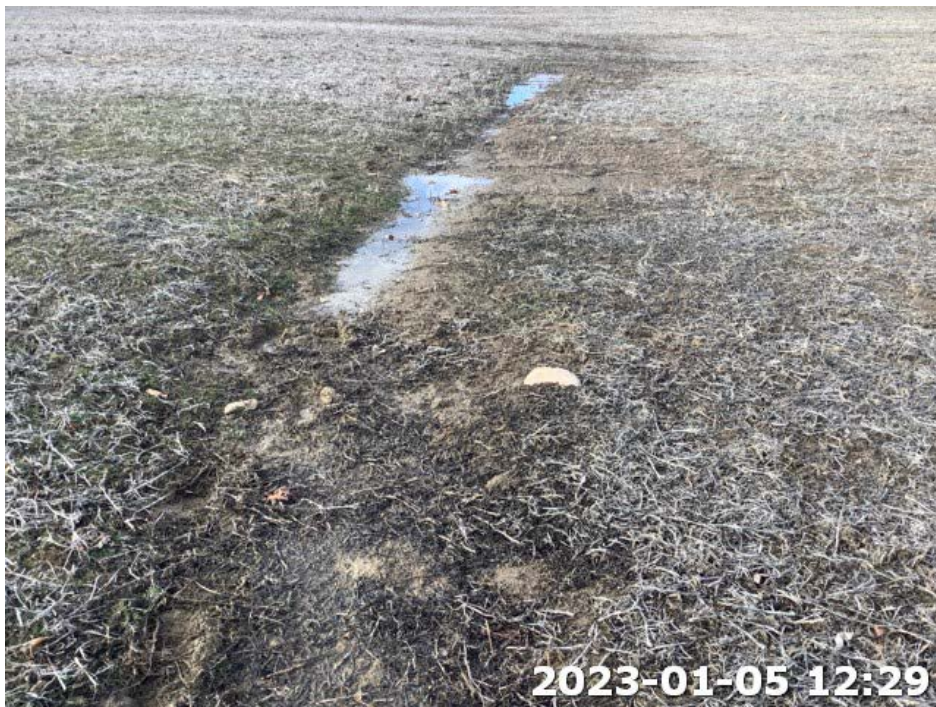
Photograph Location 3. Representative view of an upland drainage feature within the Project area. Photograph taken facing west.

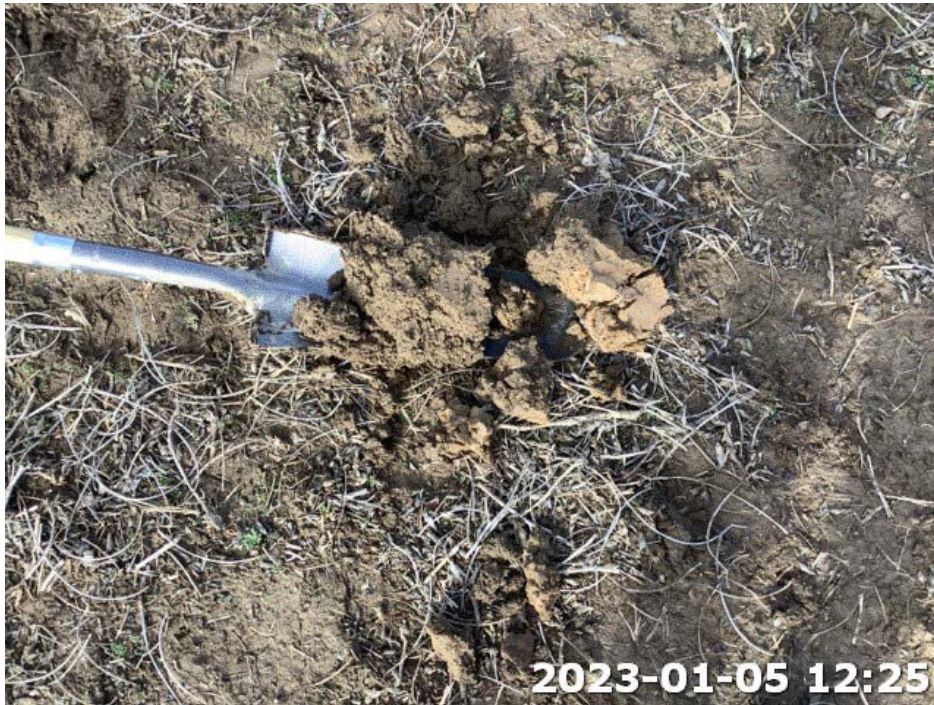
Photograph Location 4. View of soil profile at wetland determination sample point location SP02.

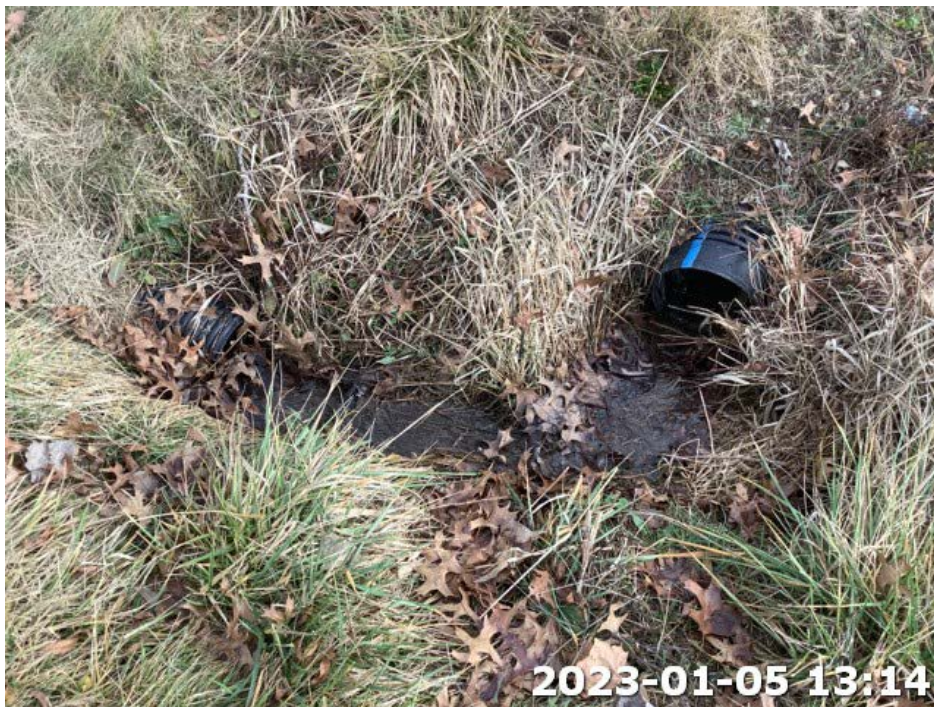
Photograph Location 5. Representative view of existing culvert within the Project area.
Photograph taken facing east.

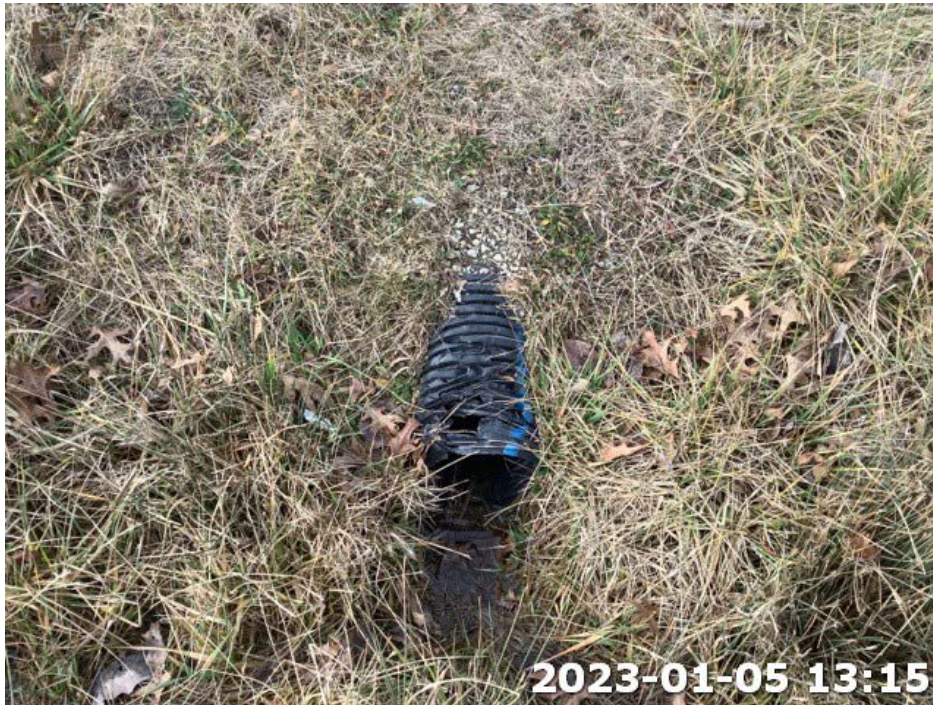
Photograph Location 5. Representative view of existing culvert within the Project area.
Photograph taken facing west.

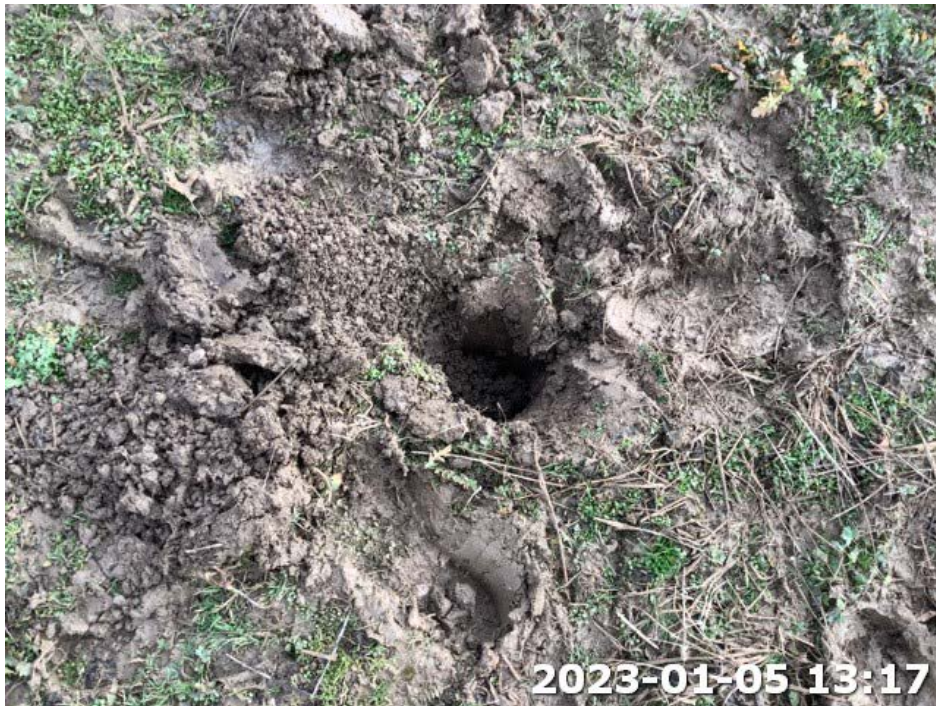
Photograph Location 6. View of soil profile at wetland determination sample point location SP03.

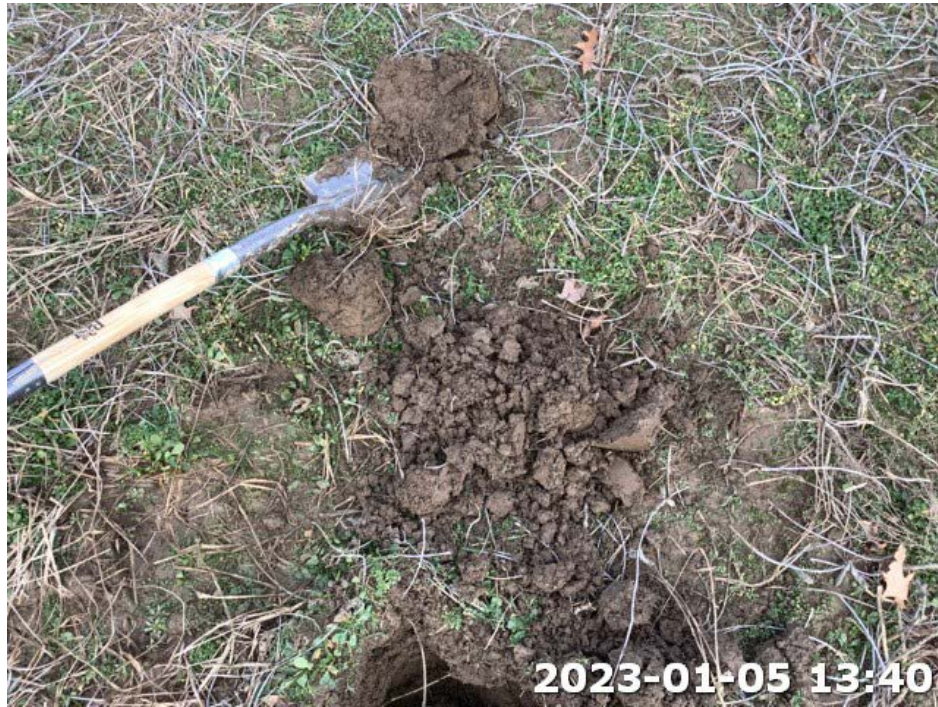
Photograph Location 7. View of soil profile at wetland determination sample point location SP04.
