Letter of Notification for the South Canton – Torrey 138 kV Transmission Line Project

PUCO Case No. 23-0475-EL-BLN

Submitted to:
The Ohio Power Siting Board
Pursuant to Ohio Administrative Code
Section 4906-6-05

Submitted by:
AEP Ohio Transmission Company, Inc.

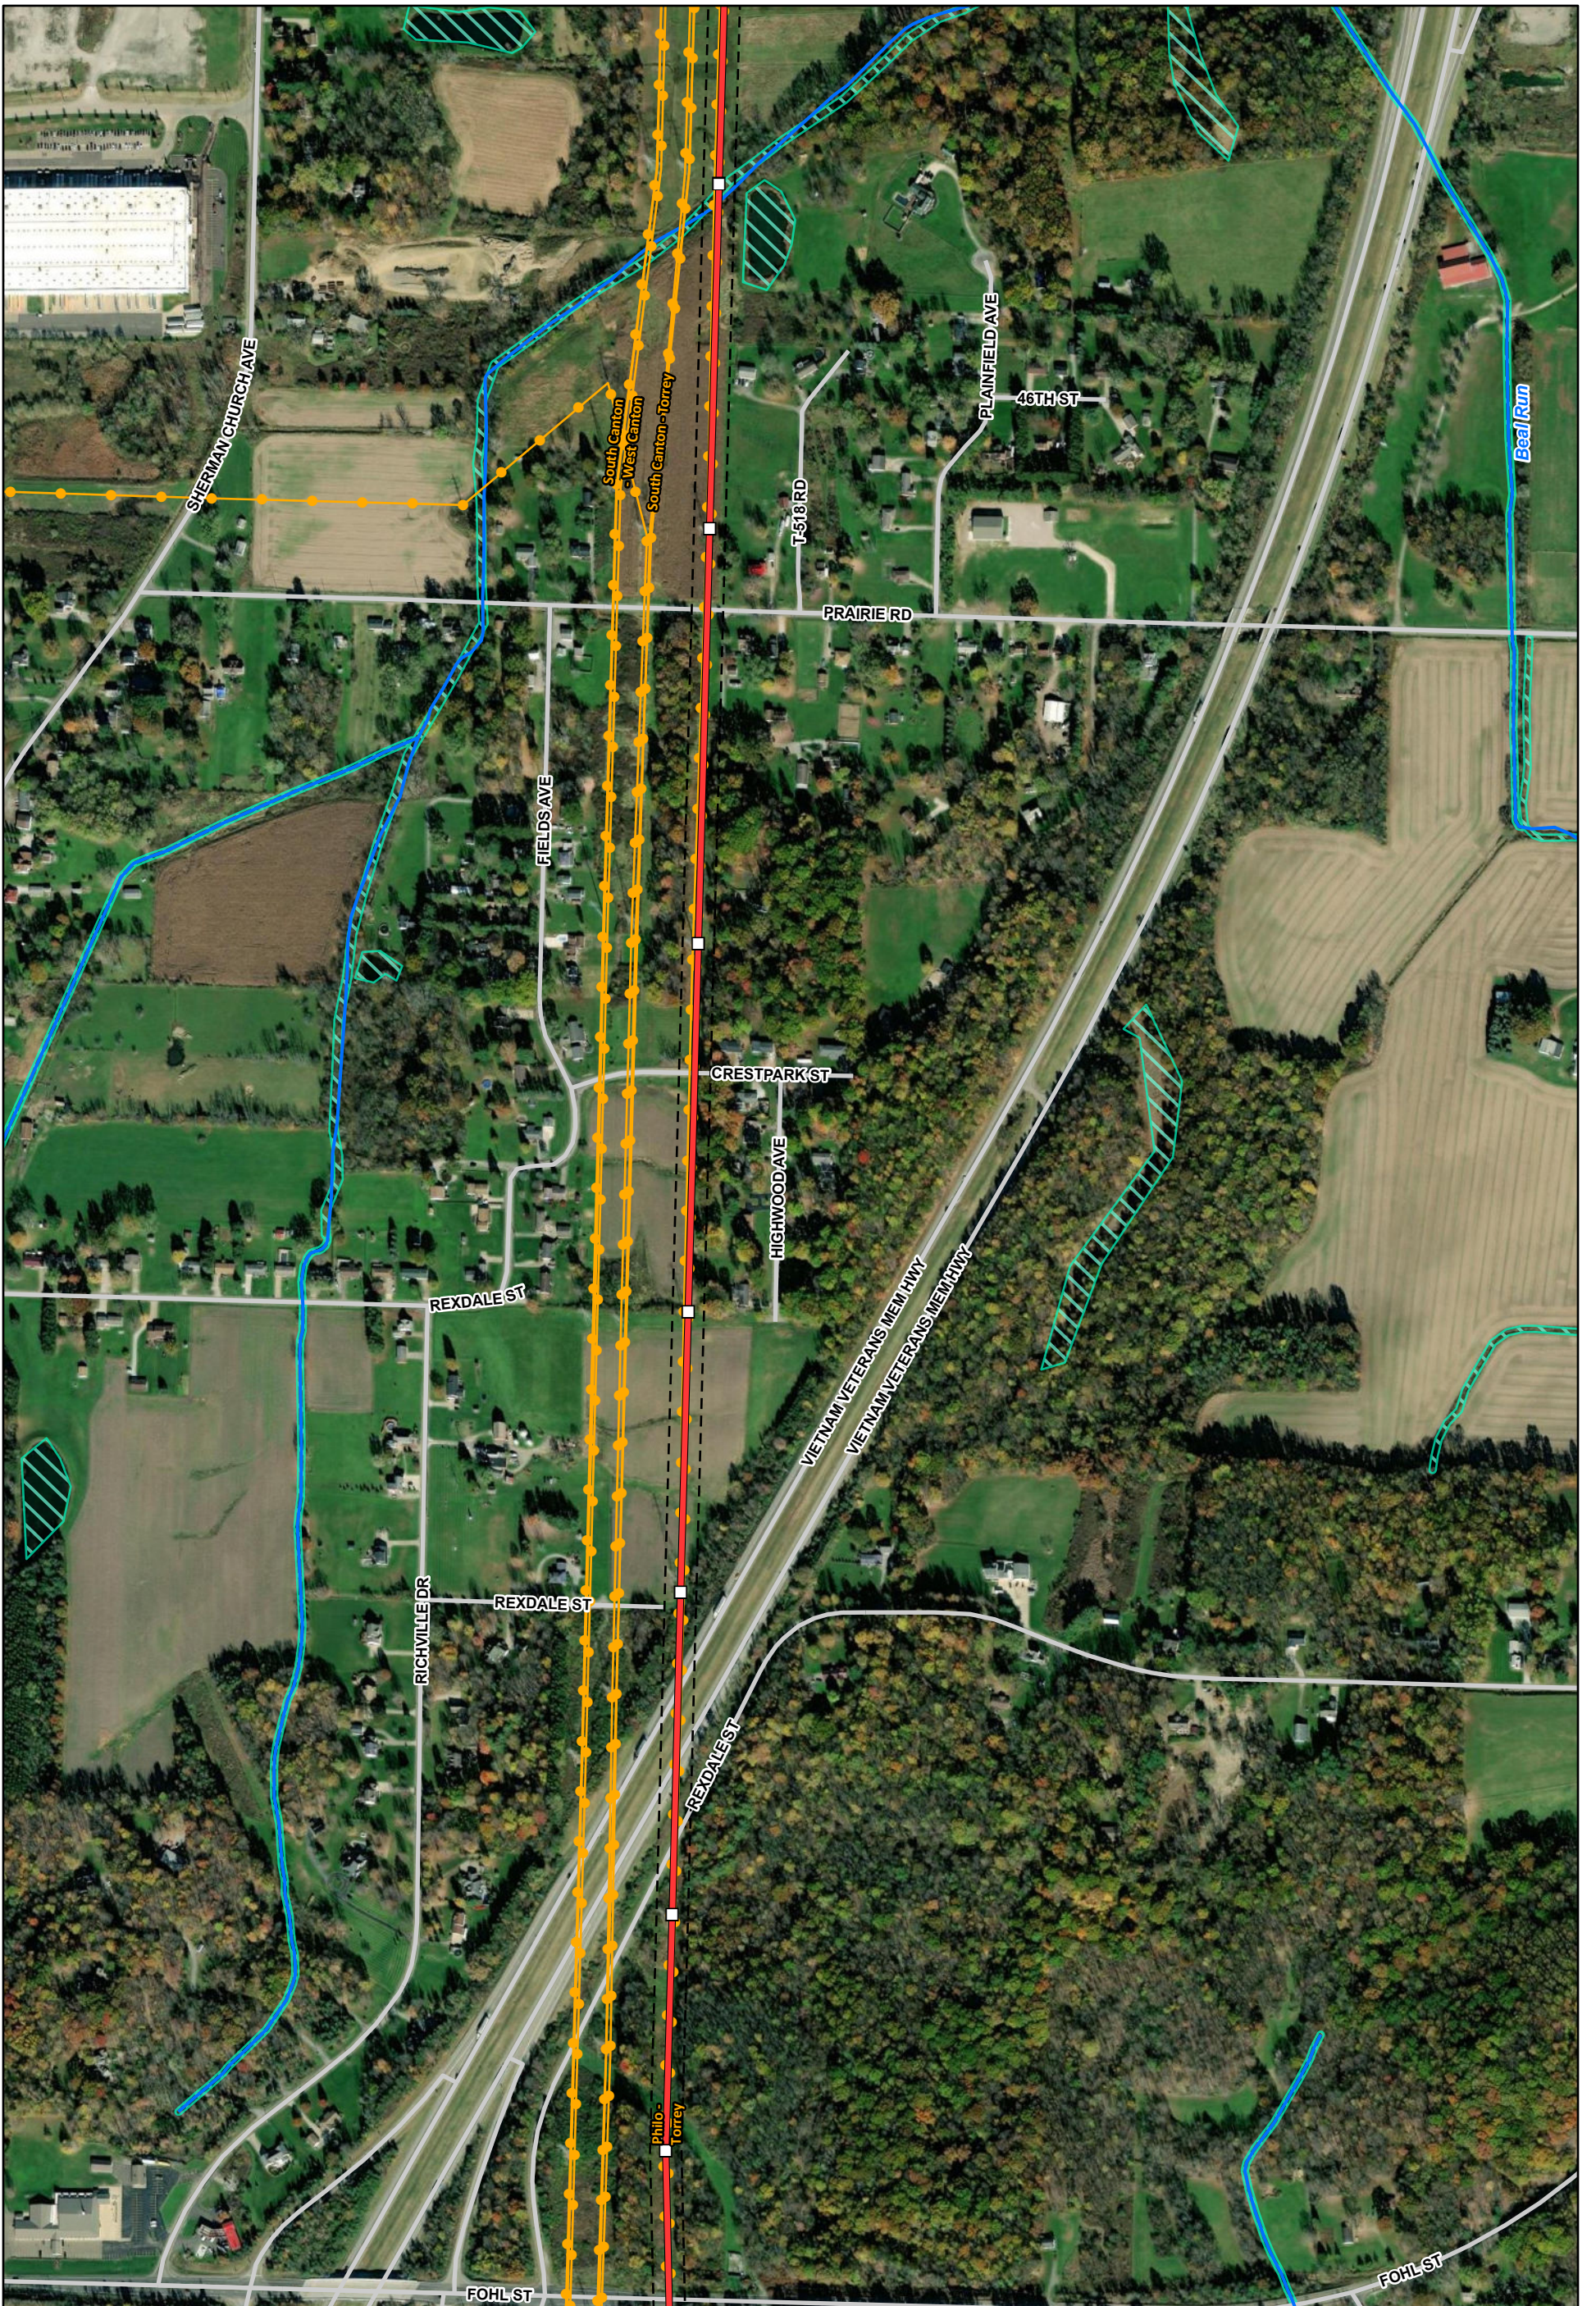
<p>Figure 2 AERIAL MAP</p> <p>AEP OHIO TRANSMISSION COMPANY An AEP Company BOUNDLESS ENERGY</p> <p>South Canton - Torrey 138 kV Transmission Line Project Stark County, OH</p> <p>0 500 1,000 Feet</p>
--	---	---	---	---

<p>Legend</p> <ul style="list-style-type: none"> □ Proposed Structure Location — Proposed Transmission Line ▭ Right of Way ● Existing 138 kV Transmission Line — Road — NHD Stream ▨ NWI Wetland 	<p>Base Map Source: ESRI World Imagery (2020/2021)</p> <p>Coordinate System: State Plane Ohio South FIPS 3402 (US Feet) Datum: NAD 1983 Scale: 1:10,000</p> <p>May 10, 2023</p>

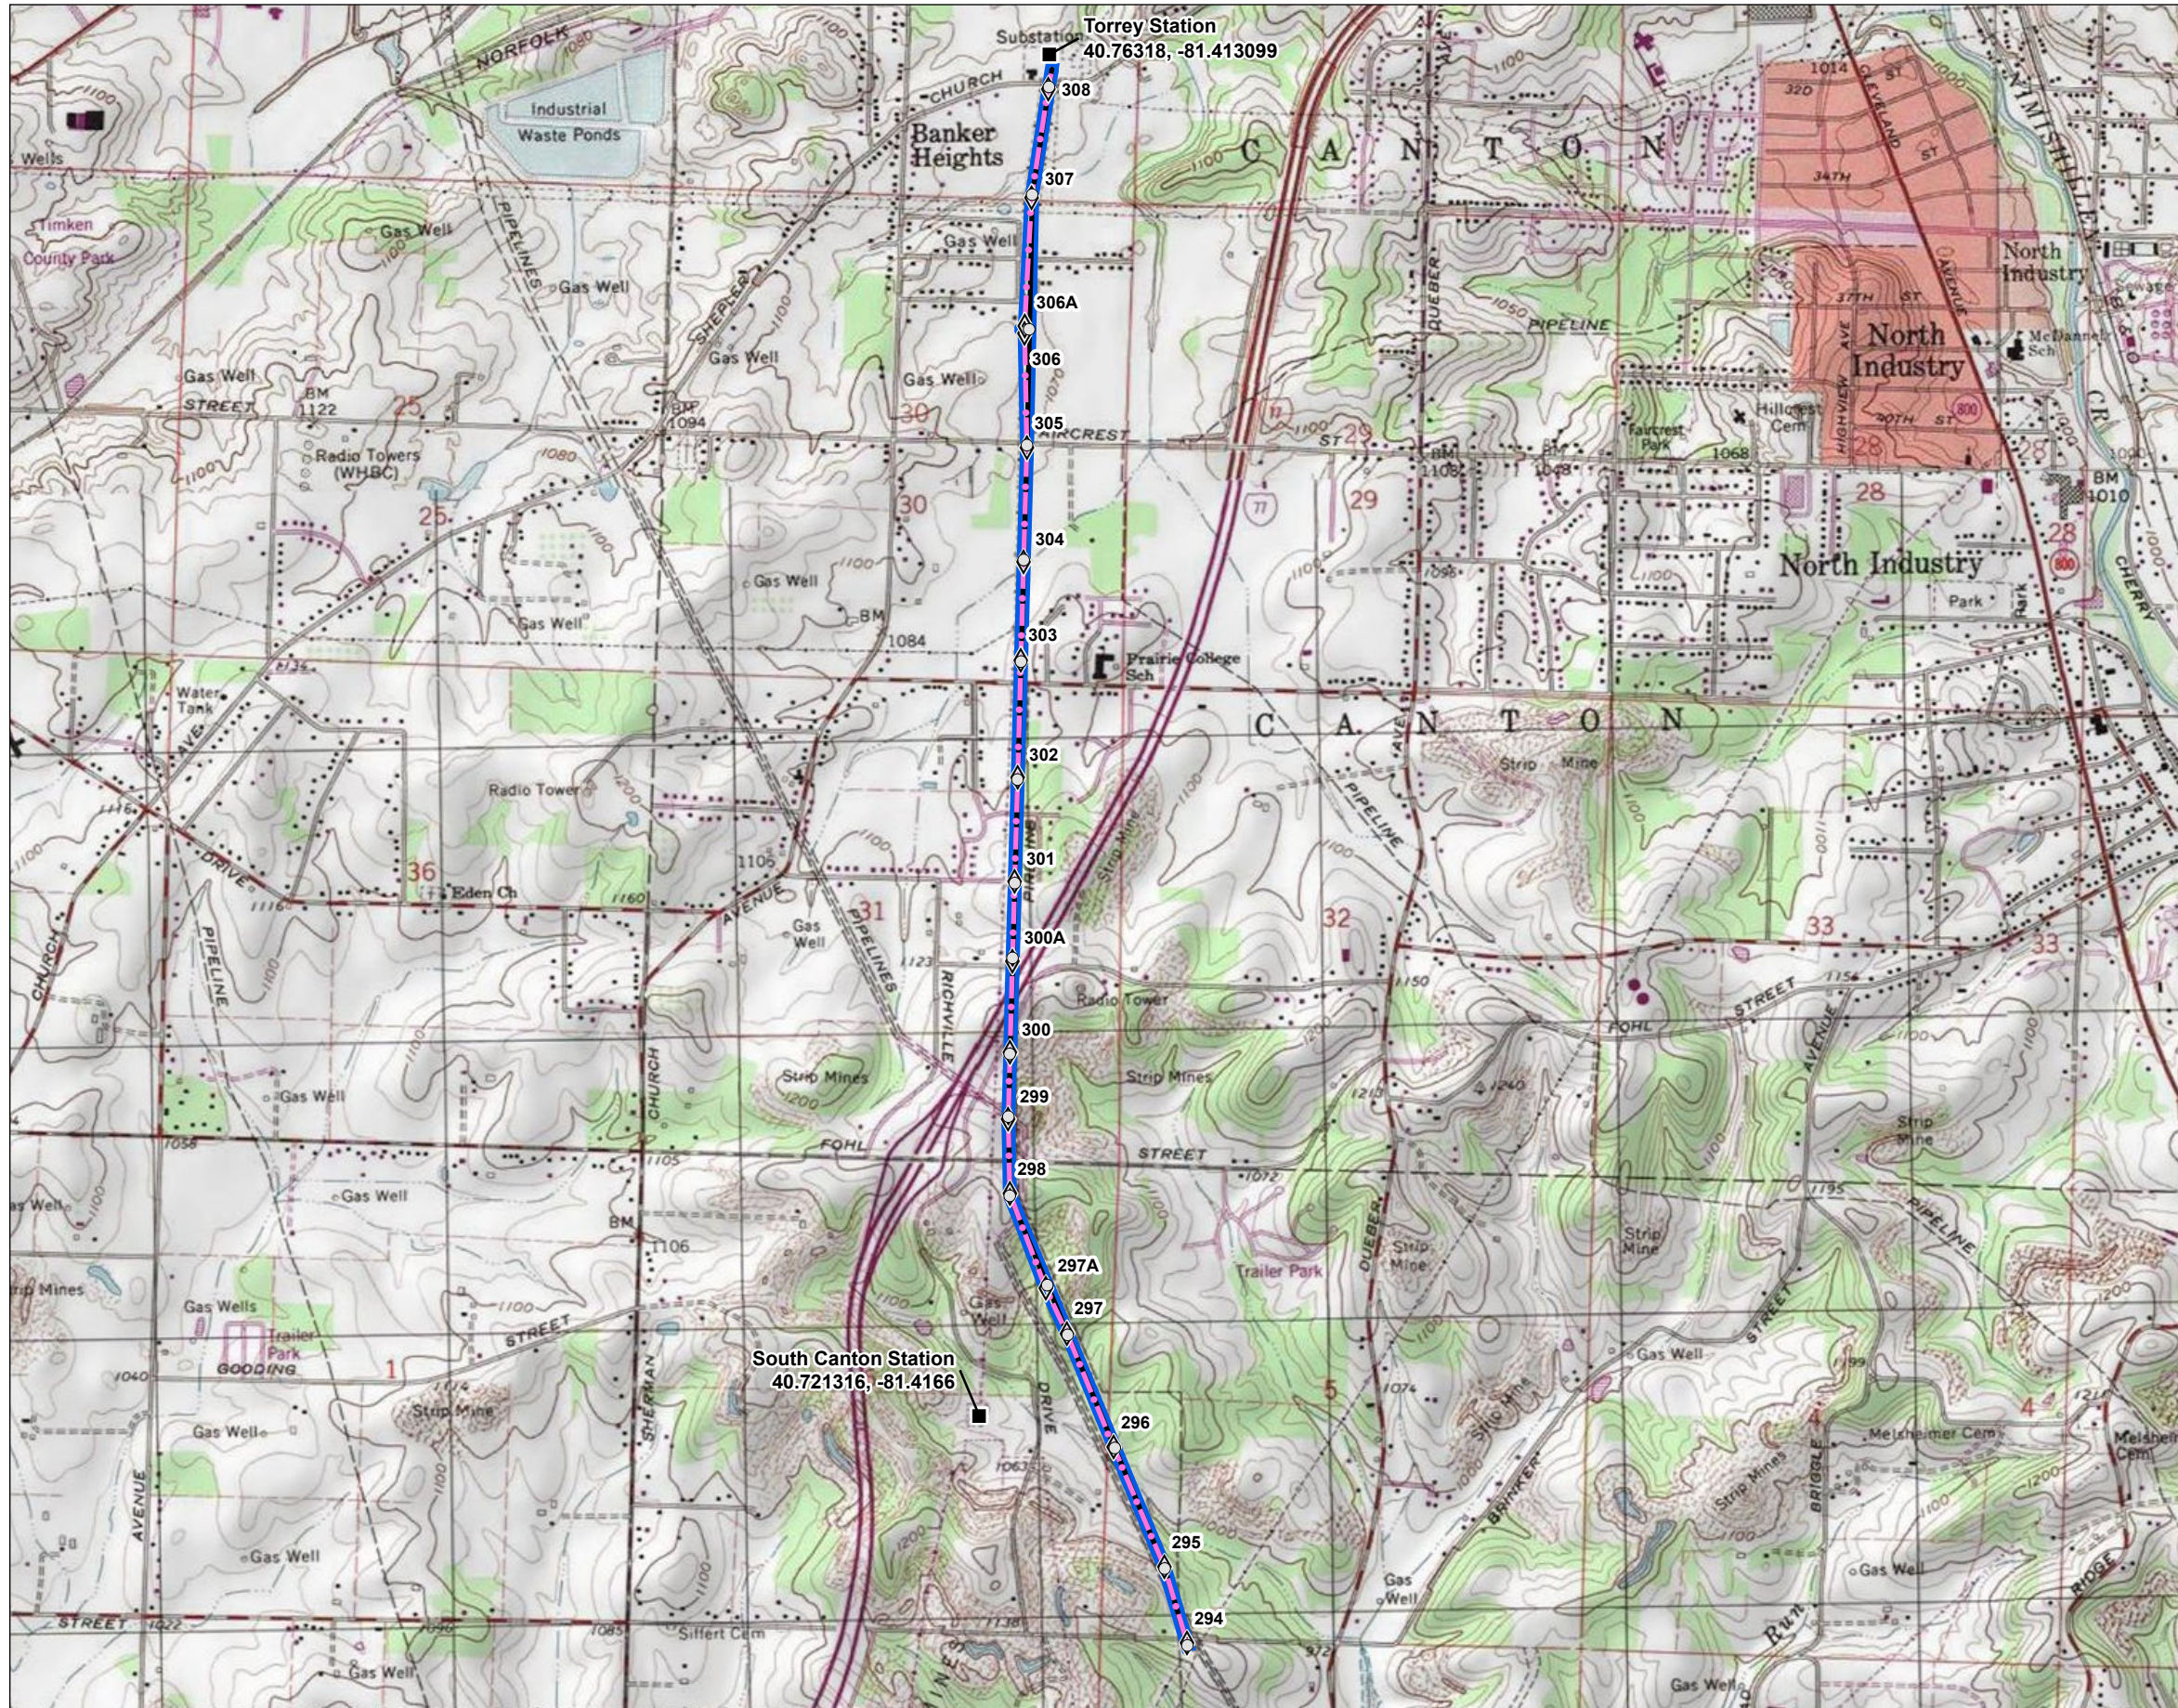
A.1 FIGURE 1 – PROJECT LOCATION MAP

- AEP Substation
- Existing Structure to be Replaced
- ◇ Proposed Structure
- Existing 138 kV Transmission Line to be Rebuilt
- - - Proposed 138 kV Transmission Line
- ▭ Project Area
