Construction Notice for the Pattonsville Switch 138 kV Extension Project

PUCO Case No. 25-0449-EL-BNR

Submitted to:
The Ohio Power Siting Board
Pursuant to Ohio Administrative Code
Section 4906-6-05

Submitted by:
Ohio Power Company

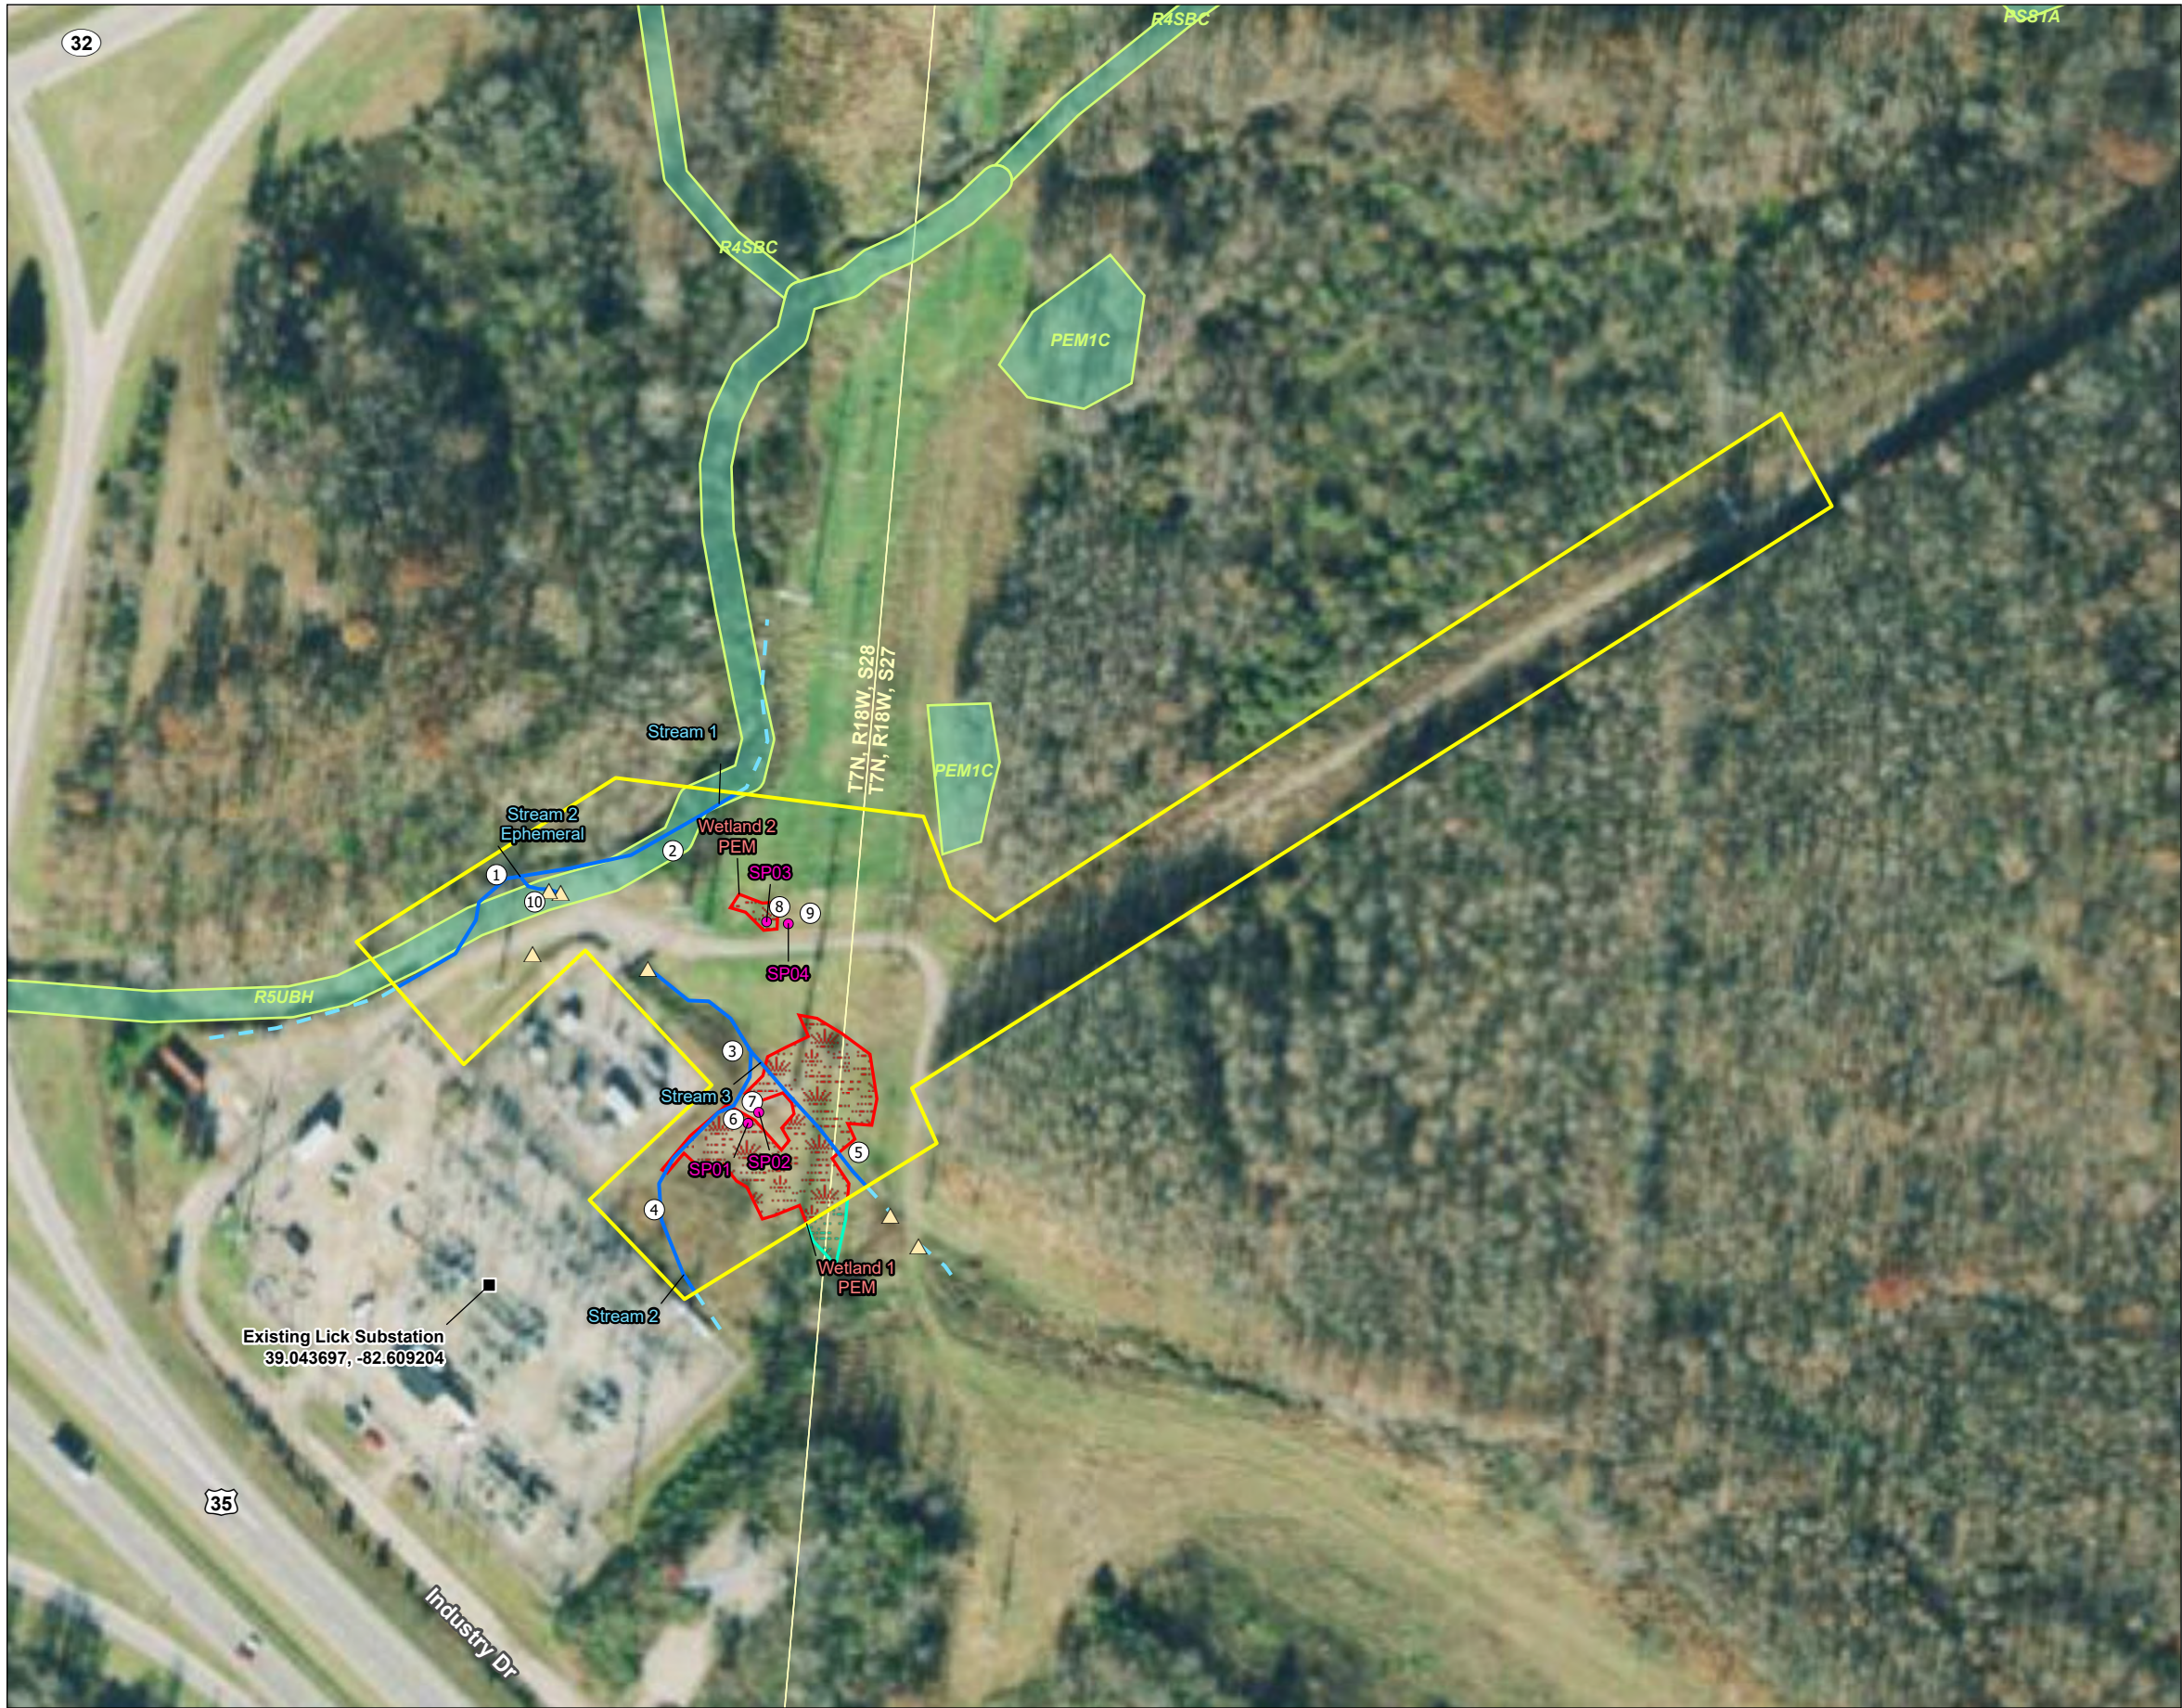
Figure No.
2

Title
Wetland & Waterbody Delineation Map

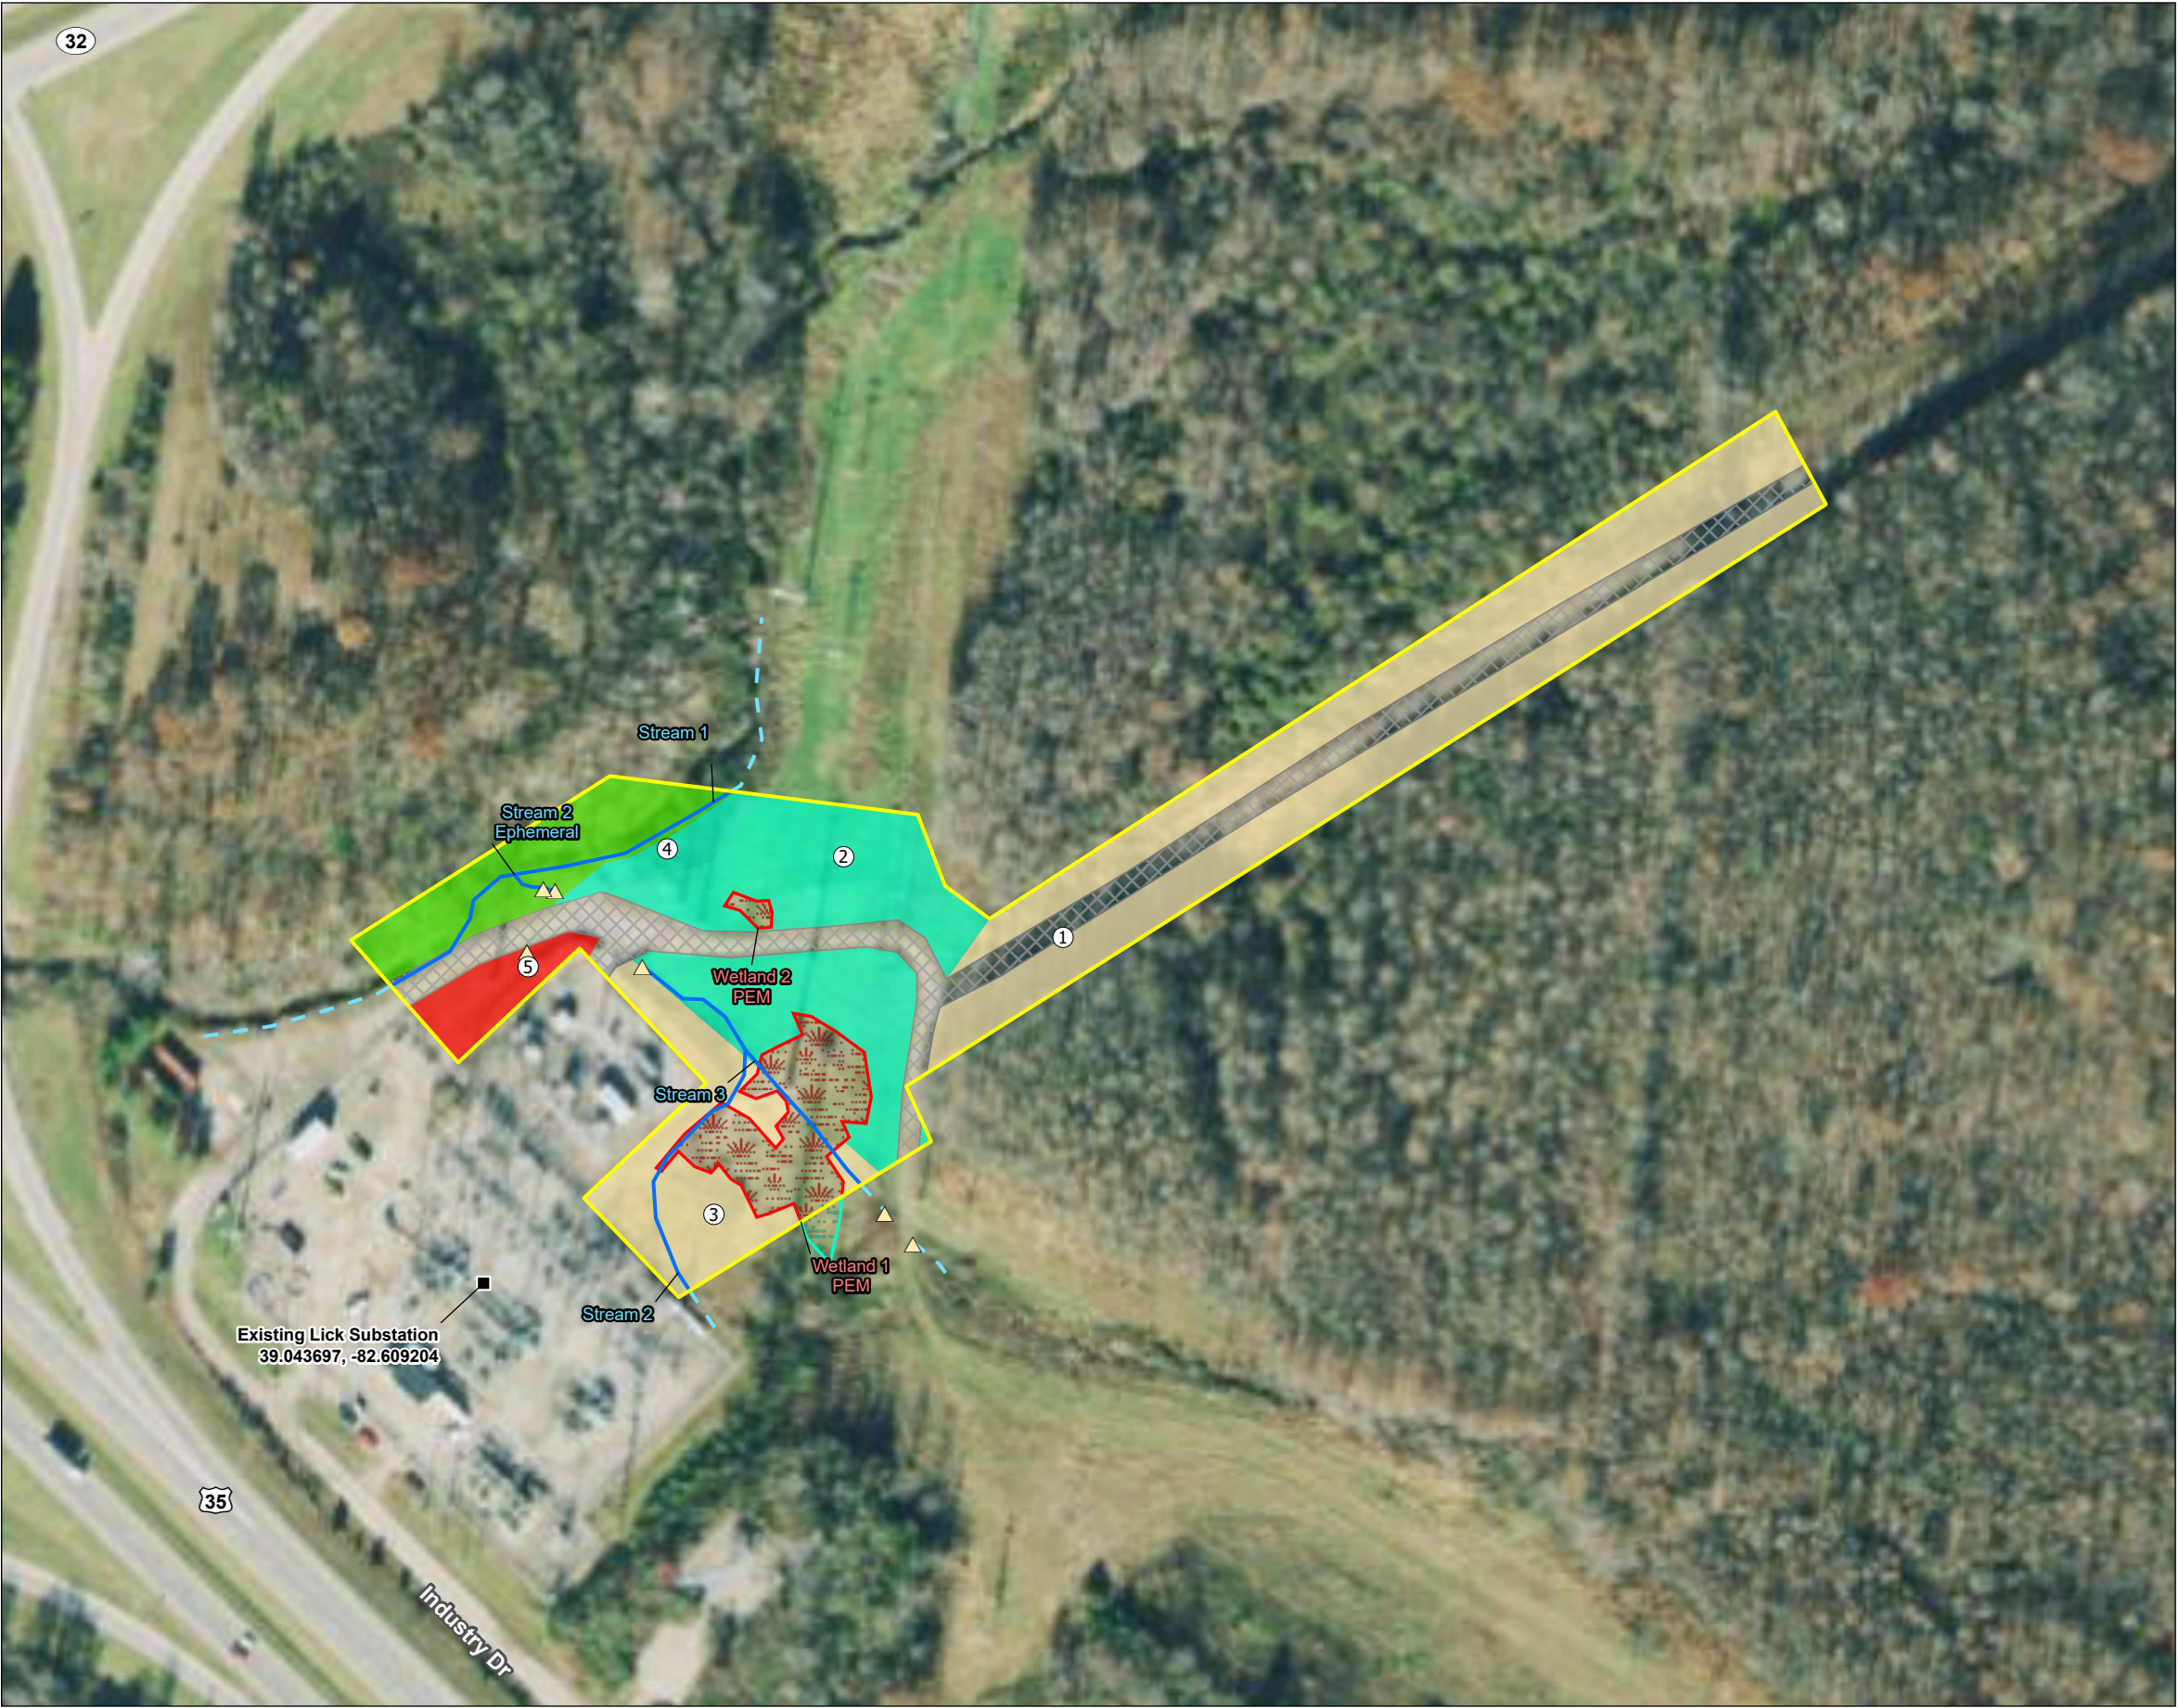
Figure No.
3

Title
Habitat Assessment Map

- Existing Gravel Road
- Industrial Land
- Mixed Early Successional / Second Growth Deciduous Forest
- New Field
- Old Field

Stantec completed field surveys for threatened and endangered species or their habitats on May 3, 2023. Figure 3 (Appendix A) shows the vegetation communities/habitats and land cover types identified within the Project area and the locations of any identified rare, threatened, or endangered species habitat observed within the Project area during the time of the habitat assessment surveys. Representative photographs of the vegetation communities/habitats and land cover types identified within the Project area are included in Appendix C of this report (photo locations are shown on Figure 3, Appendix A). Information regarding the vegetation communities/habitats/land cover types identified within the Project area is provided in Table 1.

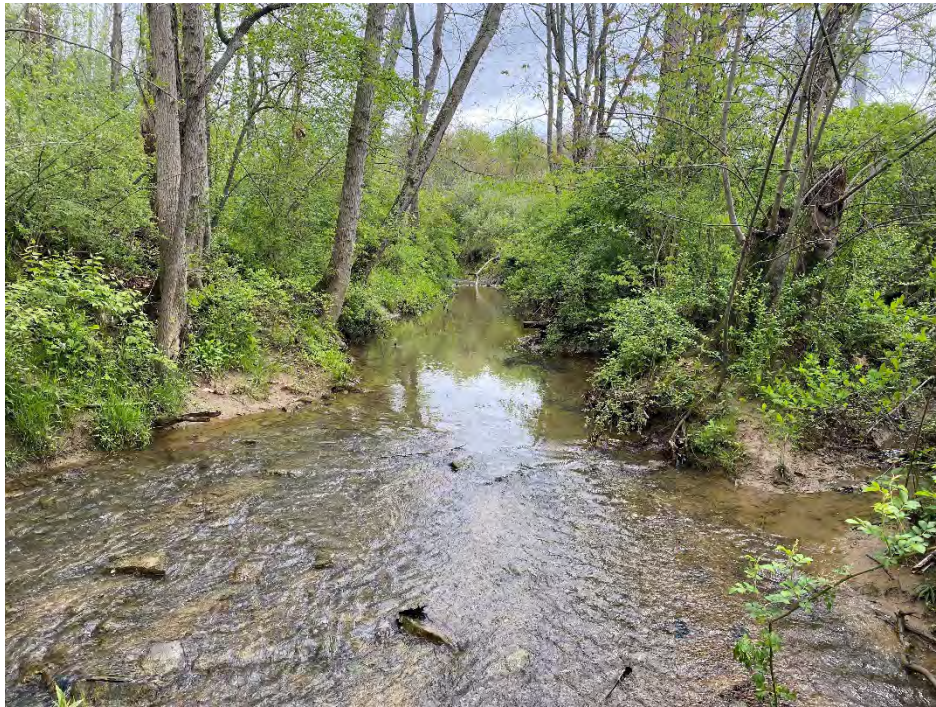
Photograph Location 1. View of Stream 1. Photograph taken facing upstream/northeast.

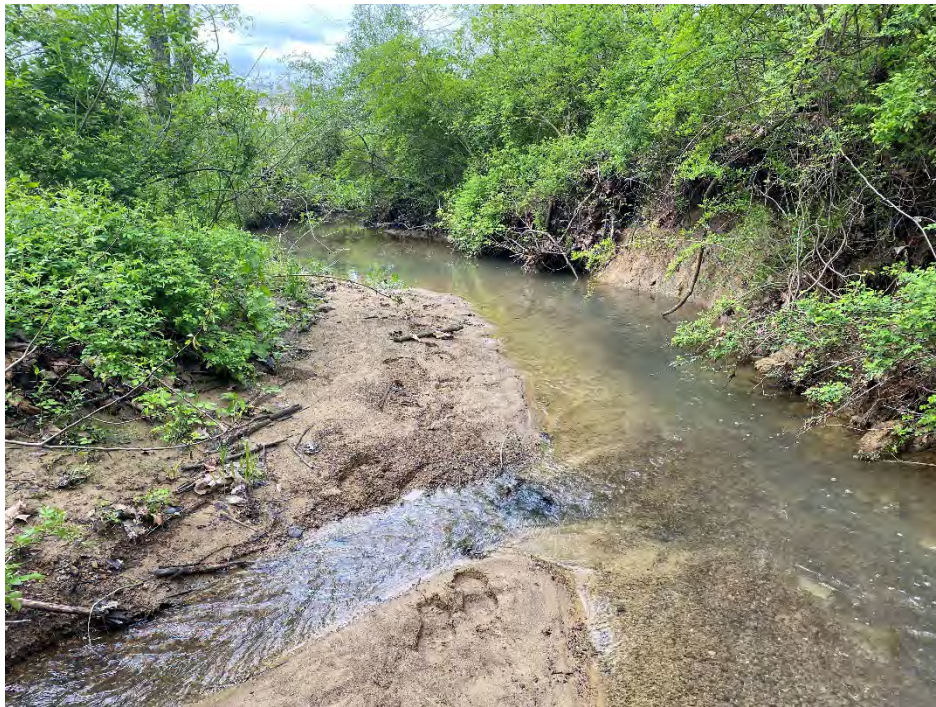
Photograph Location 1. View of Stream 1. Photograph taken facing downstream/southwest.

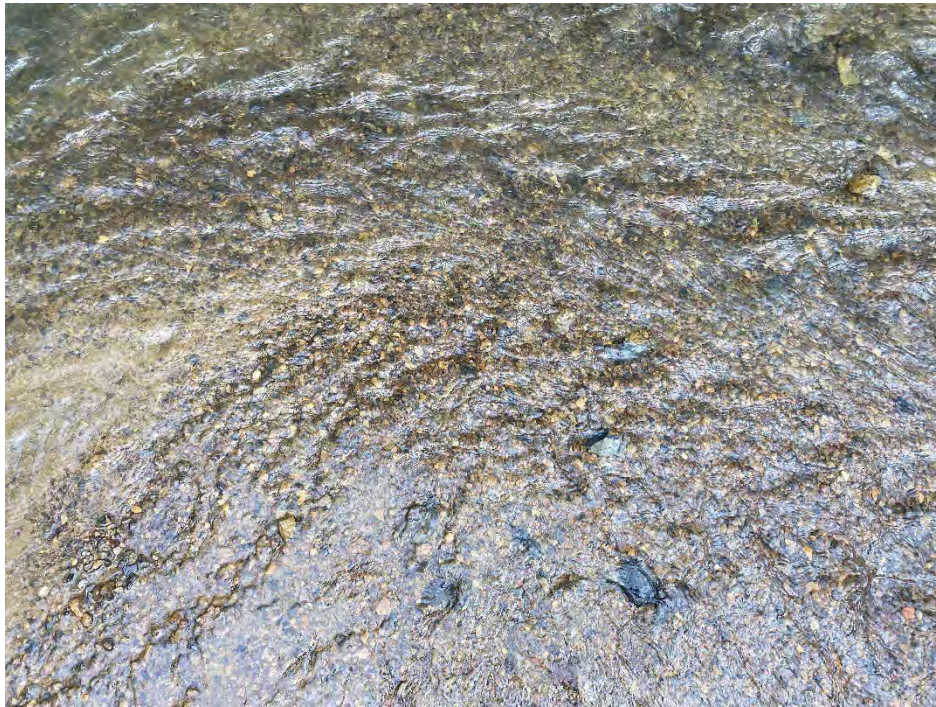
Photograph Location 1. View of the substrates of Stream 1.

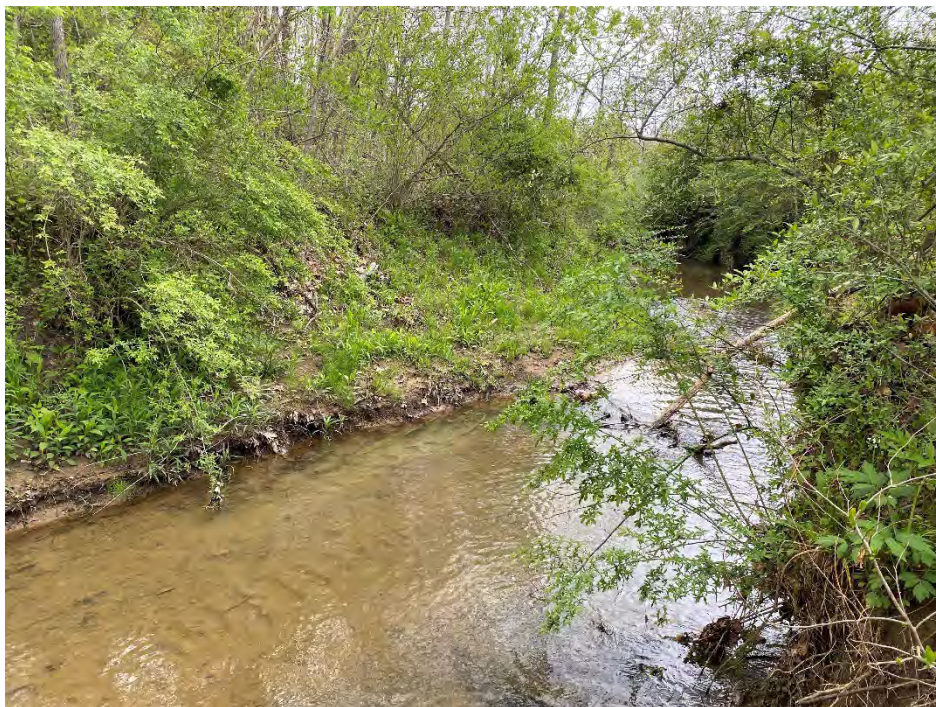
Photograph Location 2. View of Stream 1. Photograph taken facing upstream/northeast.

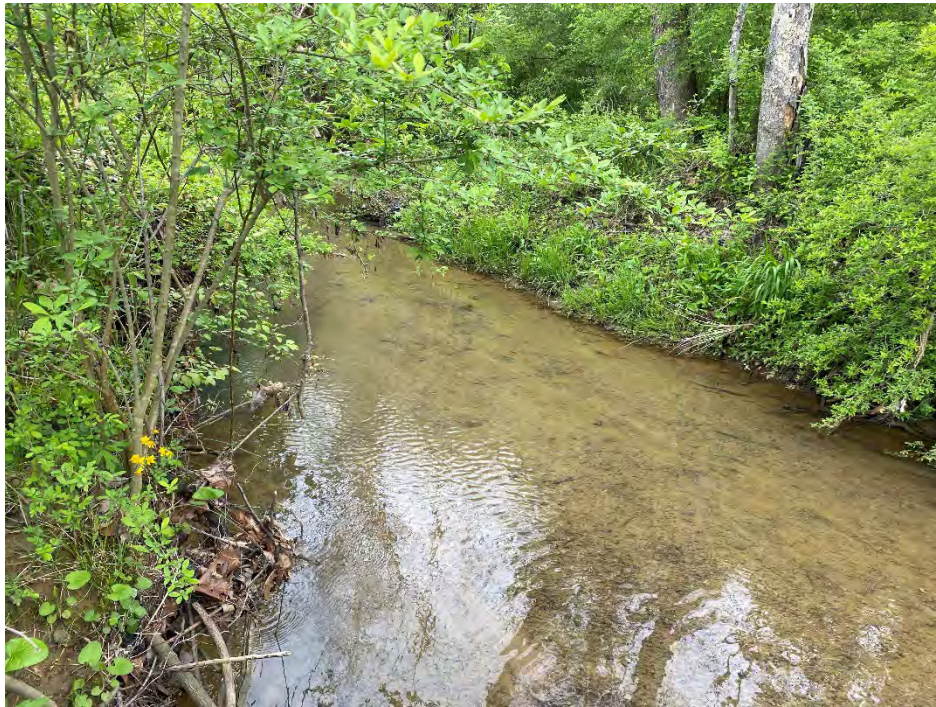
Photograph Location 2. View of Stream 1. Photograph taken facing downstream/southwest.

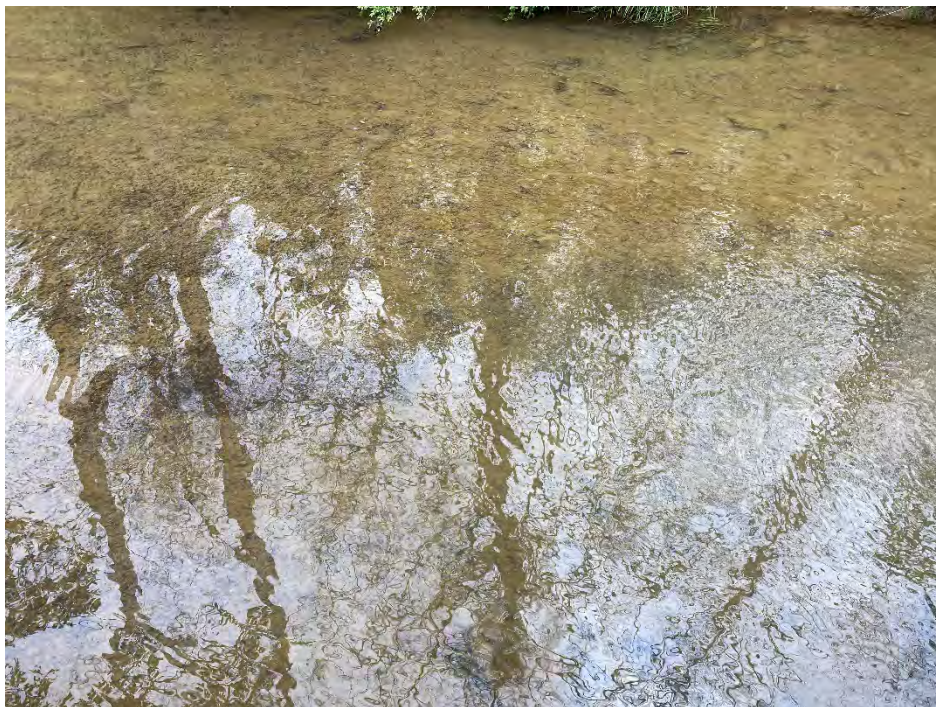
Photograph Location 2. View of substrates of Stream 1.

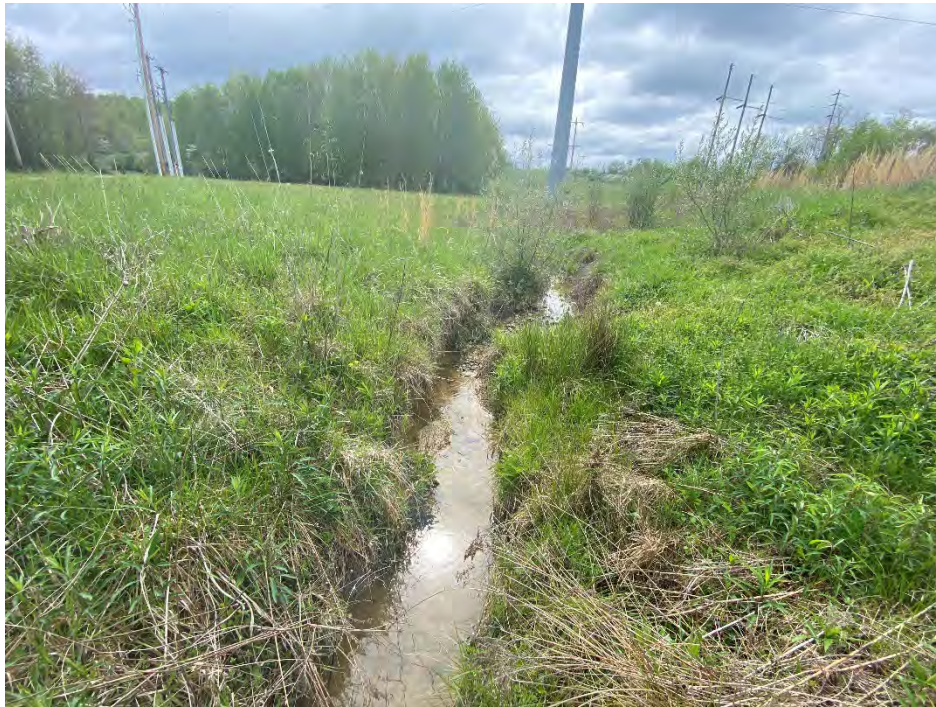
Photograph Location 3. View of Stream 2. Photograph taken facing upstream/east.

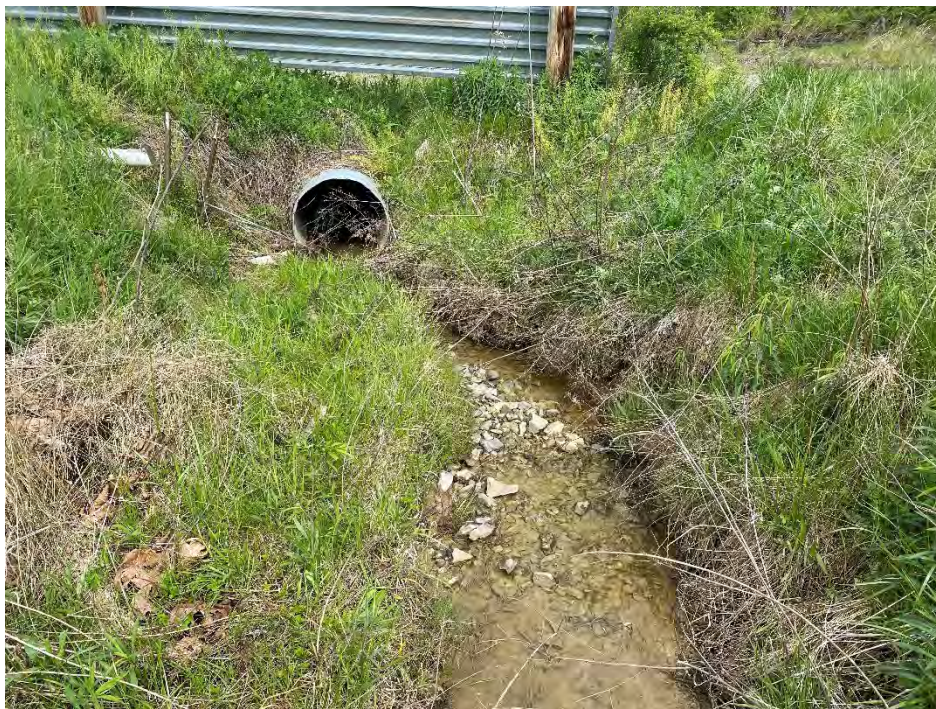
Photograph Location 3. View of Stream 2. Photograph taken facing downstream/west.

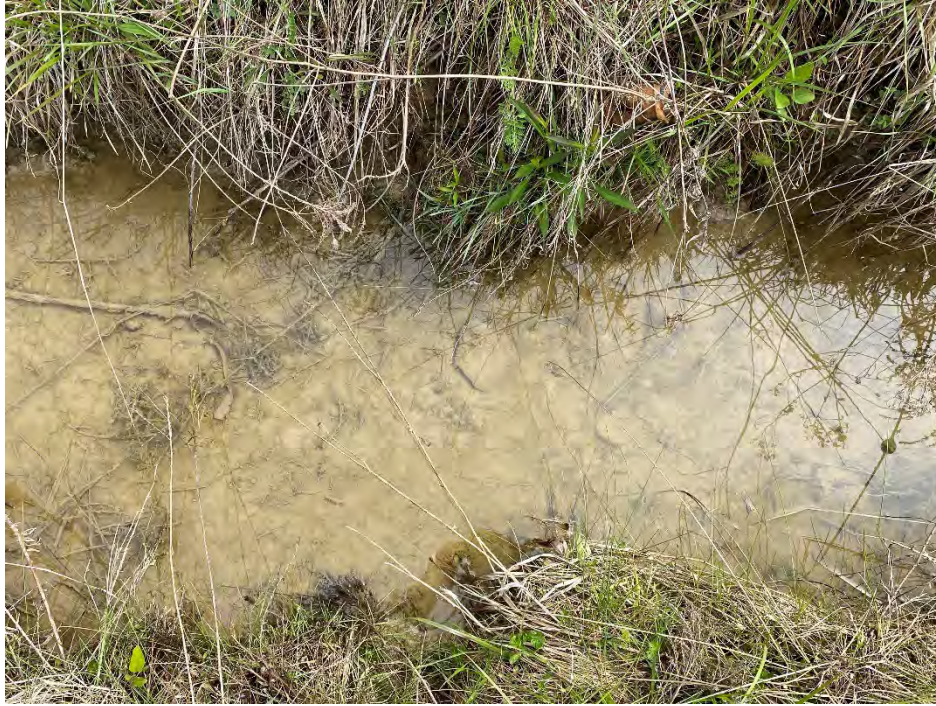
Photograph Location 3. View of substrates of Stream 2.

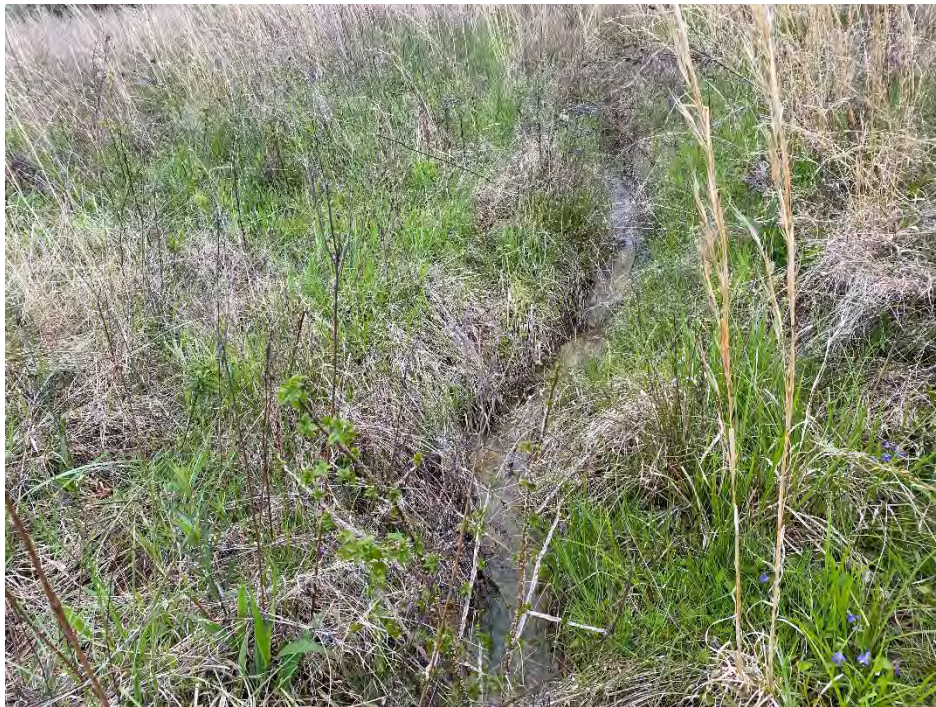
Photograph Location 4. View of Stream 2. Photograph taken facing upstream/south.

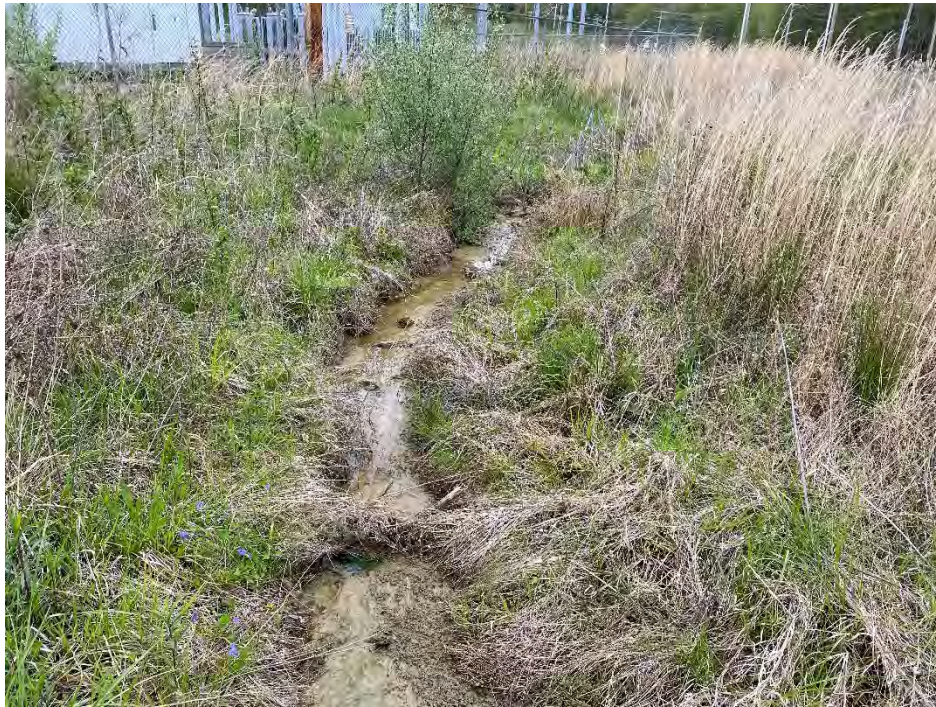
Photograph Location 4. View of Stream 2. Photograph taken facing downstream/north.

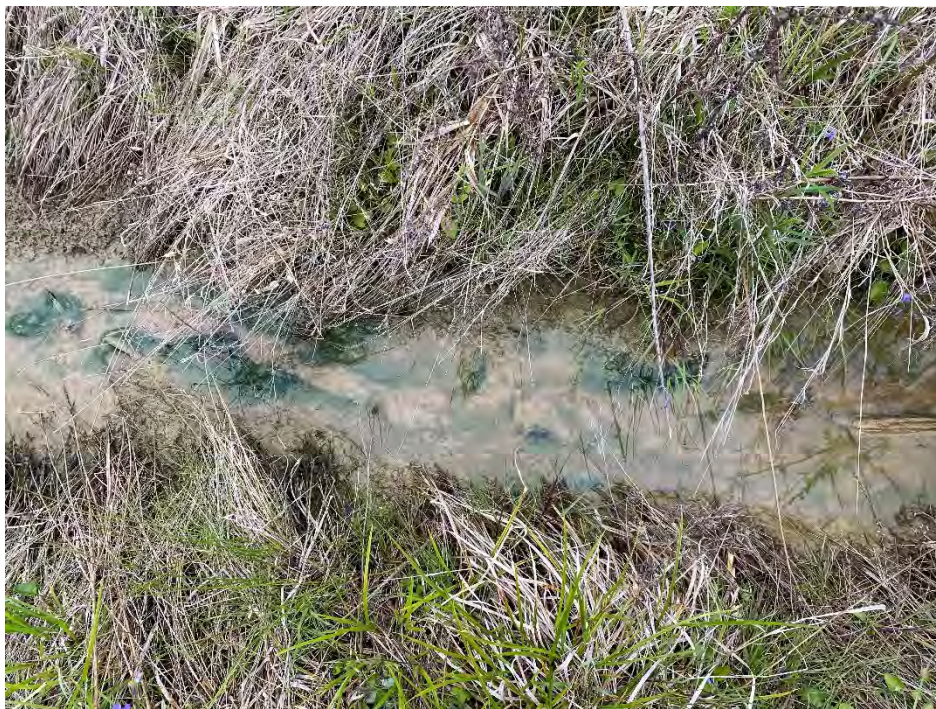
Photograph Location 4. View of substrates of Stream 2.

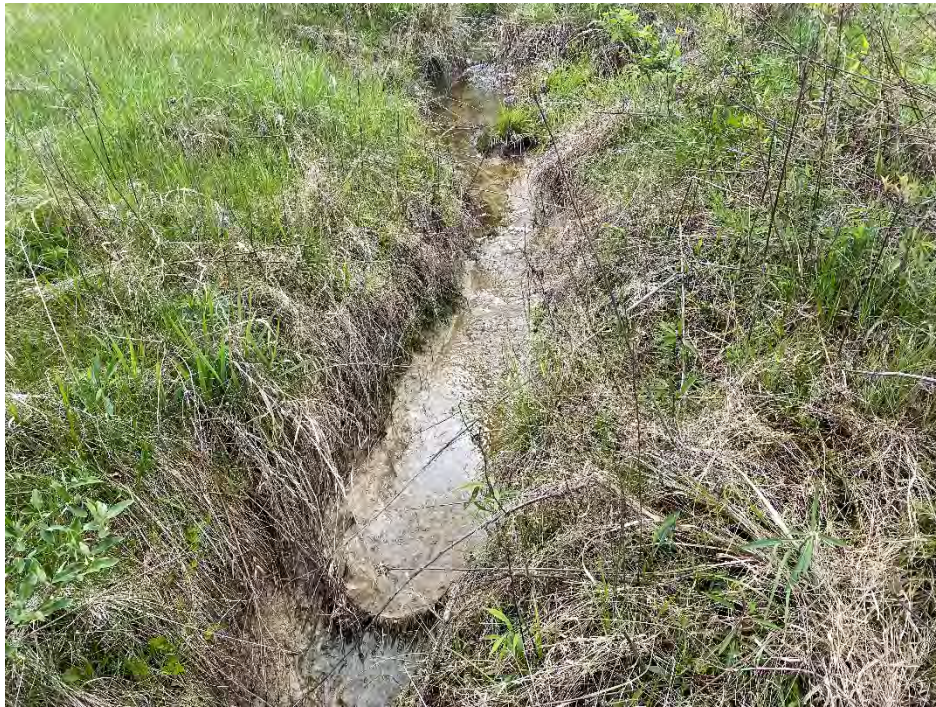
Photograph Location 5. View of Stream 3. Photograph taken facing upstream/east.

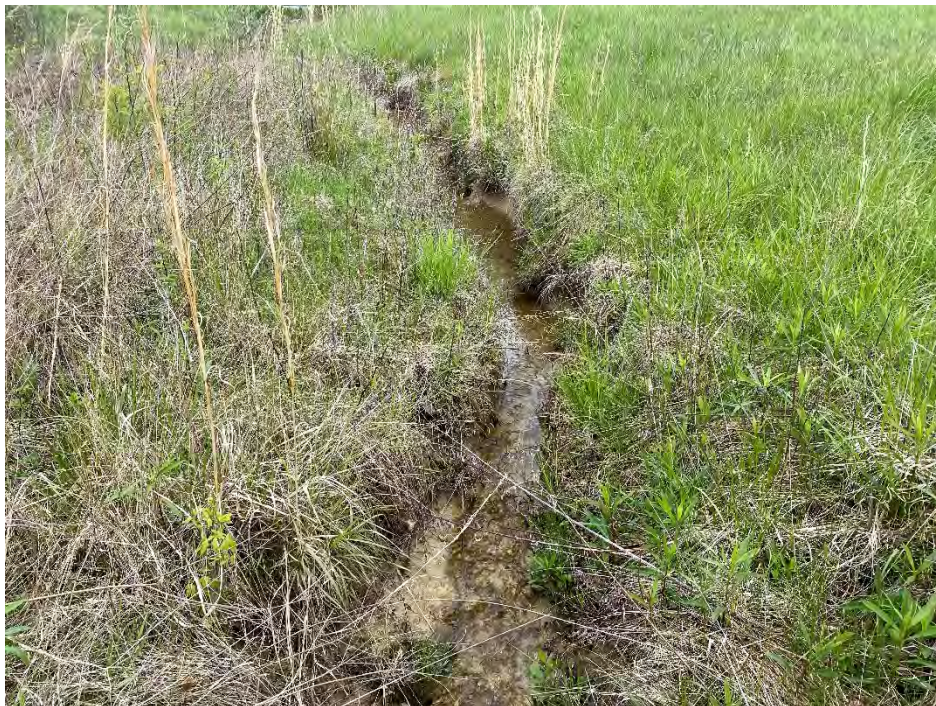
Photograph Location 5. View of Stream 3. Photograph taken facing downstream/west.

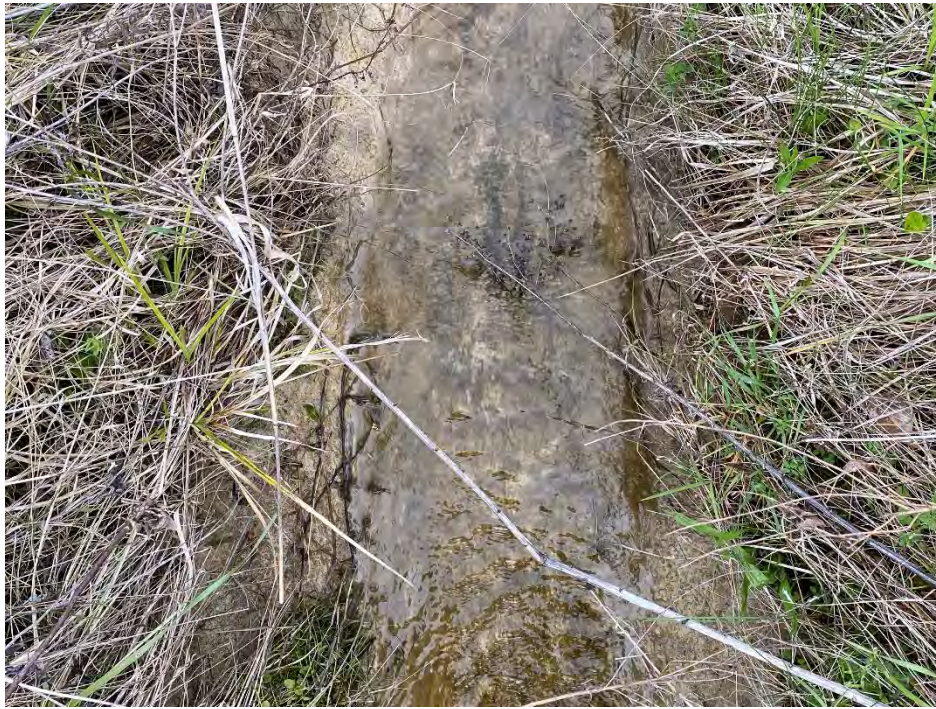
Photograph Location 5. View of substrates of Stream 3.

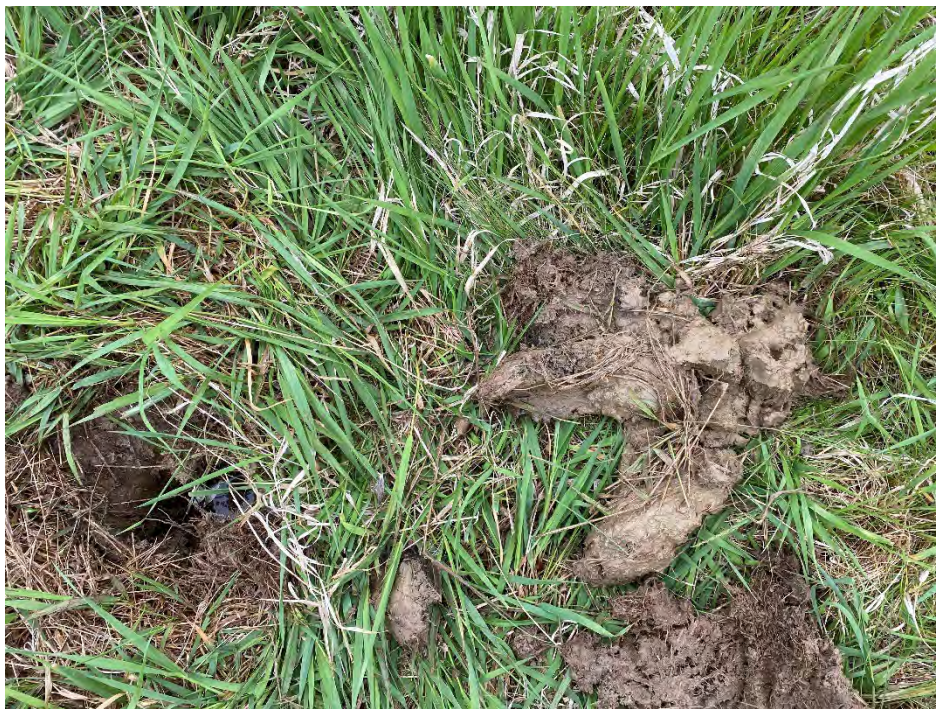
Photograph Location 6. View of soil profile at wetland determination sample point location SP01.

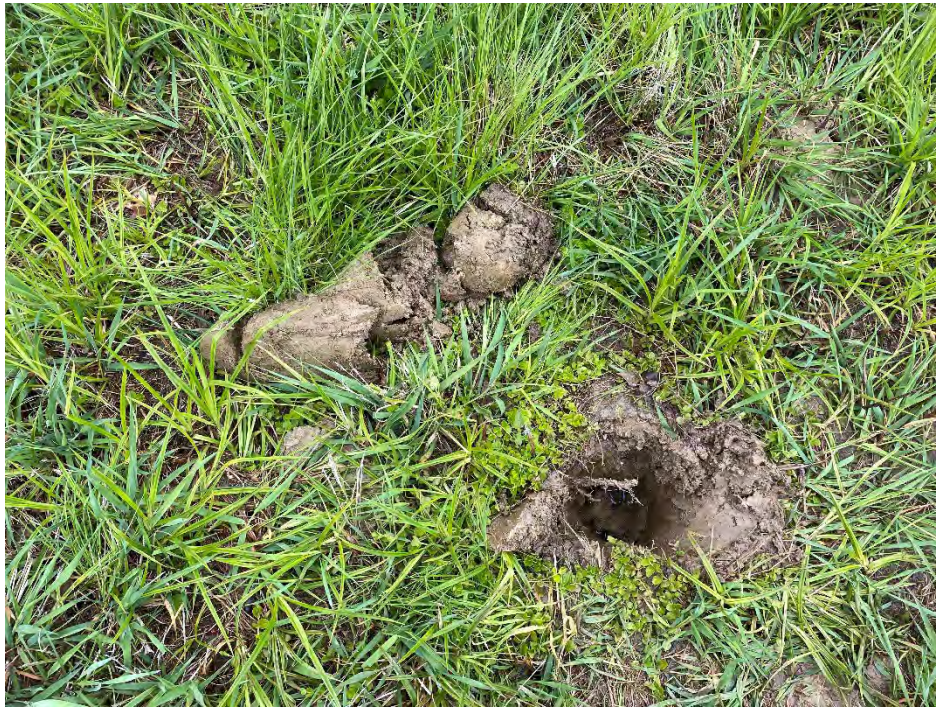
Photograph Location 8. View of soil profile at wetland determination sample point location SP03.

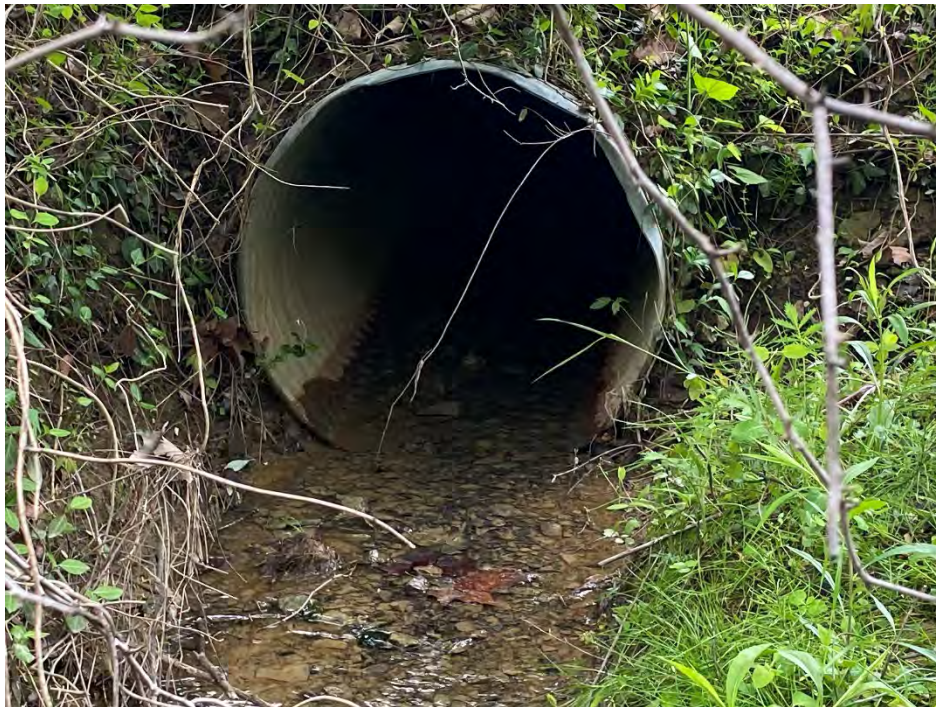
Photograph Location 10. Representative view of existing culvert within the Project area.
Photograph taken facing east.

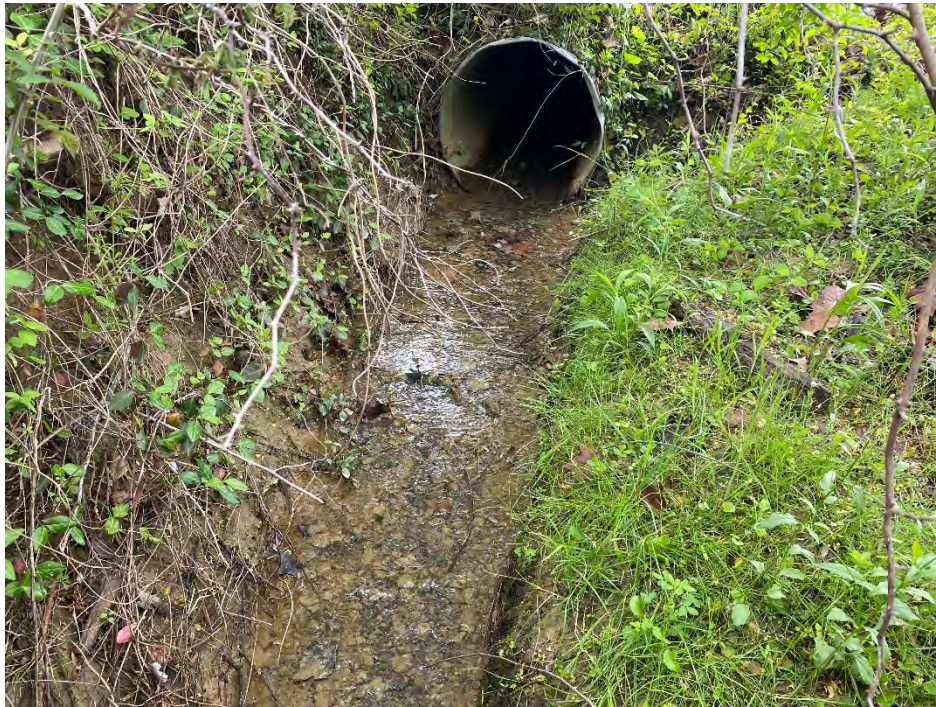
Photograph Location 10. Representative view of existing culvert within the Project area.
Photograph taken facing east.

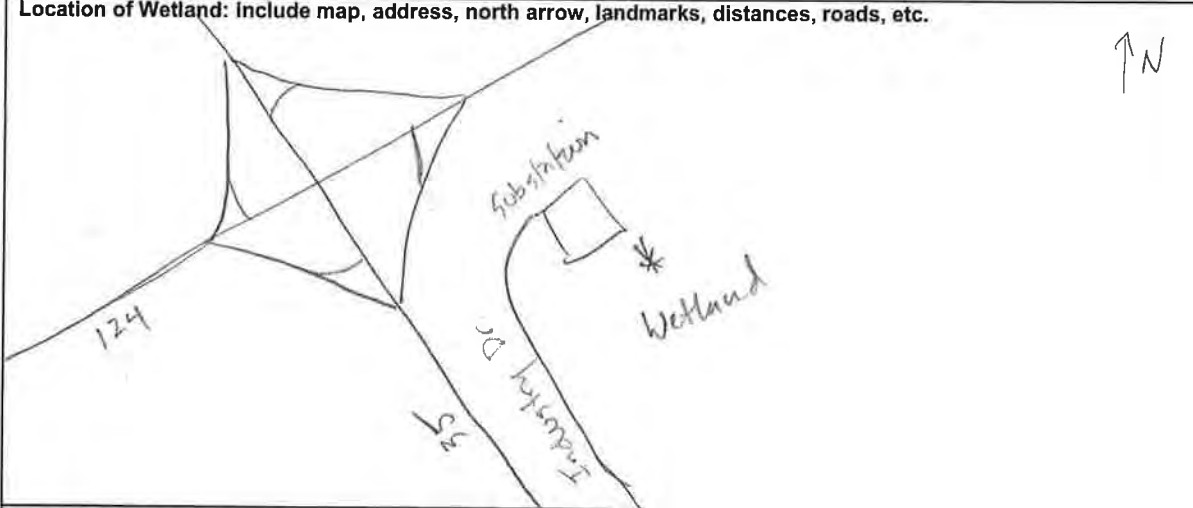
Name of Wetland: <u>Wetland 1</u>		
Wetland Size (<u>acres</u> , hectares):		0.35
Sketch: Include north arrow, relationship with other surface waters, vegetation zones, etc.		
<p>The sketch is a hand-drawn map. In the center, a rectangular area is labeled 'Substation'. To its right, an asterisk (*) is labeled 'Wetland'. A line labeled 'Perennial Stream' flows from the top left towards the substation. Above the stream, the word 'Field' is written. To the right of the wetland, a curved line is labeled 'Gravel Road'. Further right, another 'Gravel Road' is shown, with 'Forest' written above and below it. In the bottom left, a line is labeled 'Highway 35'. In the bottom right, a line is labeled 'Industry Dr.'.</p>		
Comments, Narrative Discussion, Justification of Category Changes:		
<p>Final score : 27</p> <p>Category: 1</p>

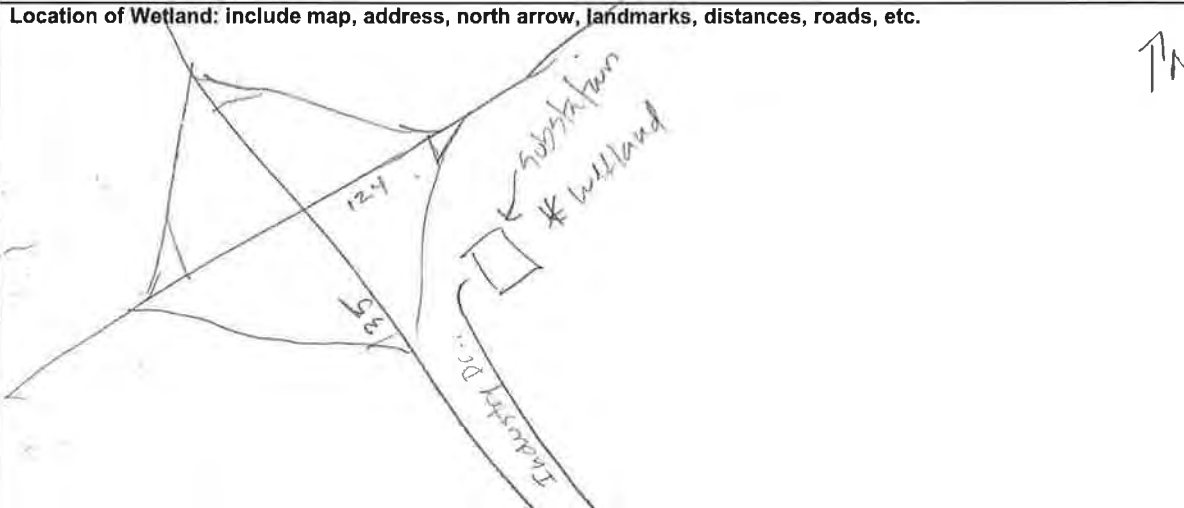
Name of Wetland: <u>Wetland 2</u>	
Wetland Size (acres, hectares):	0.015
Sketch: Include north arrow, relationship with other surface waters, vegetation zones, etc.	
Comments, Narrative Discussion, Justification of Category Changes:	
Final score : 21	Category: 1
