Construction Notice for Cole-Pleasant Prairie Solar 345 kV Generation Tie Line Project

PUCO Case No. 25-0030-EL-BNR

Submitted by:
AEP Ohio Transmission Company, Inc.

February 4, 2025

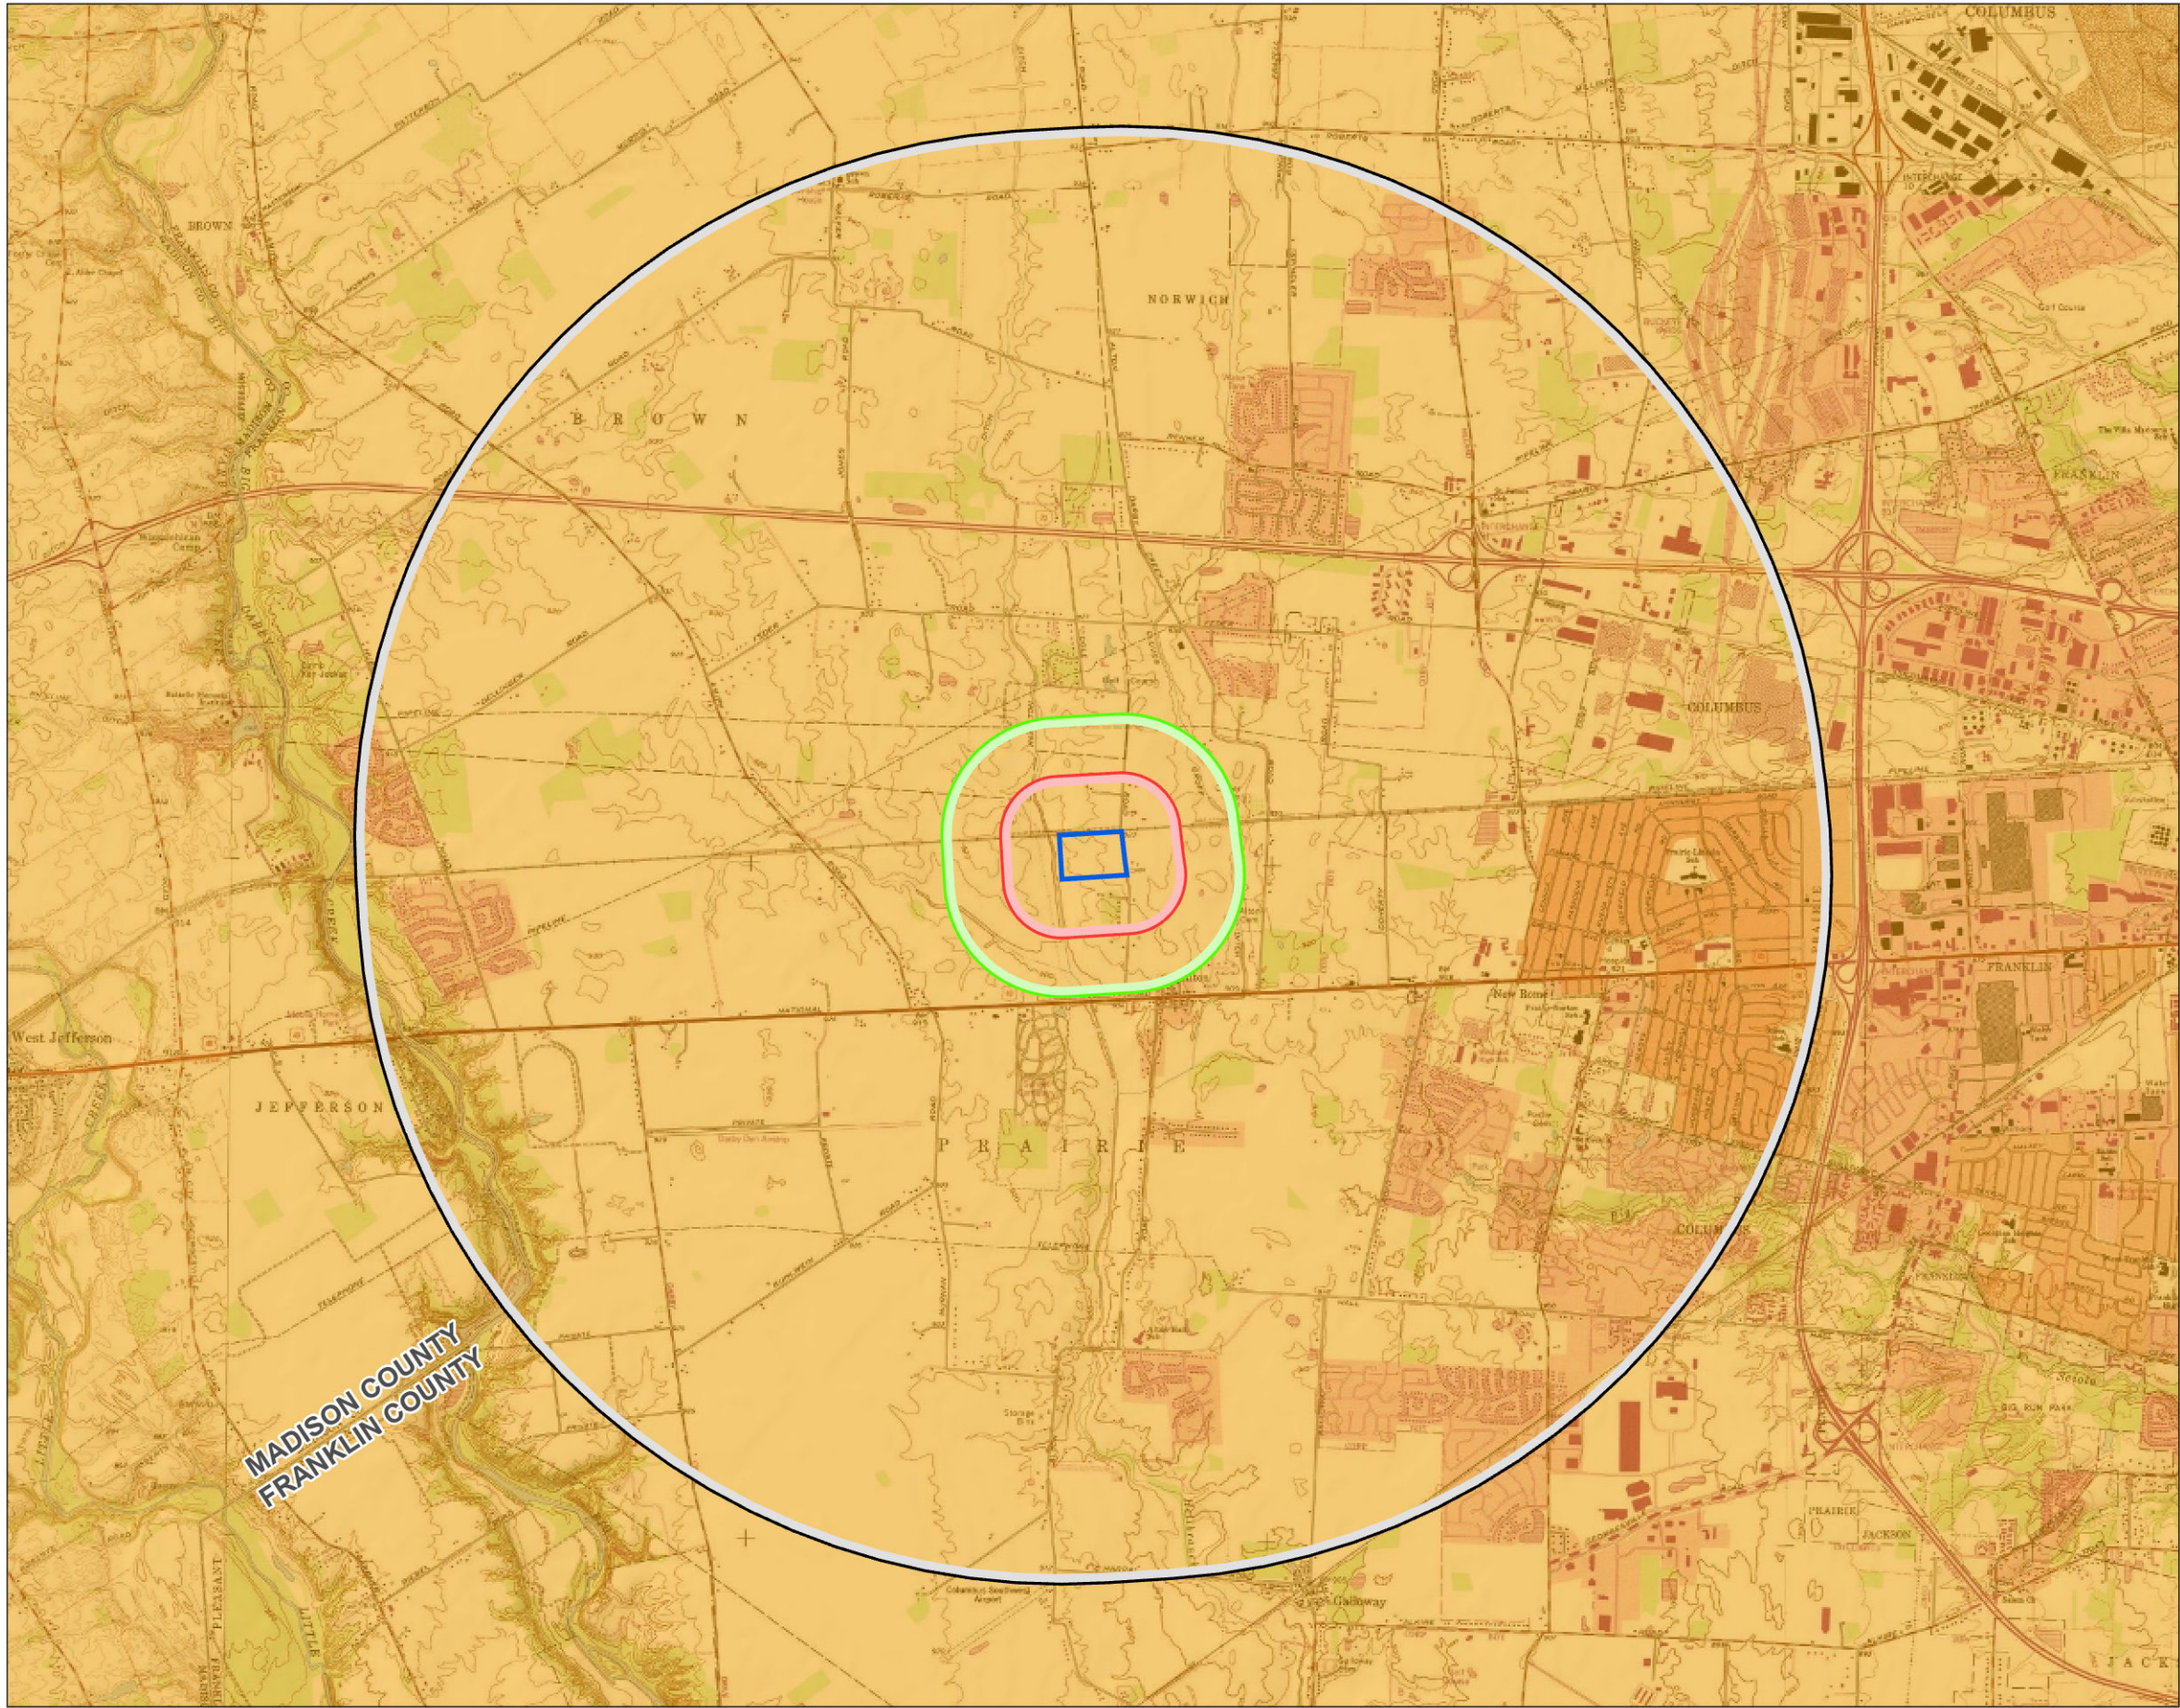
Figure No.
4

Title
Bat Hibernacula Desktop Study Map

The ODNR also recommended that a desktop habitat assessment be conducted, followed by a field assessment if needed, to determine if there are potential bat hibernacula present within 0.25 miles of the Project area. Stantec completed a desktop habitat assessment in accordance with the 2024 Range-wide Indiana Bat and Northern Long-eared Bat Survey Guidelines (USFWS 2024b) utilizing available ODNR websites, including data on known abandoned or active mines (ODNR 2024c) and locations of known or suspected karst geology (ODNR 2024b). As part of the desktop assessment, Stantec identified that the entirety of the Project area is located within a mapped area of karst geology (Figure 4, Appendix A). However, no abandoned or active underground mines, underground openings, caves, or any other potentially suitable bat hibernacula were observed within the Project area during the field surveys completed by Stantec. Therefore, no impacts to potential bat hibernacula are anticipated.

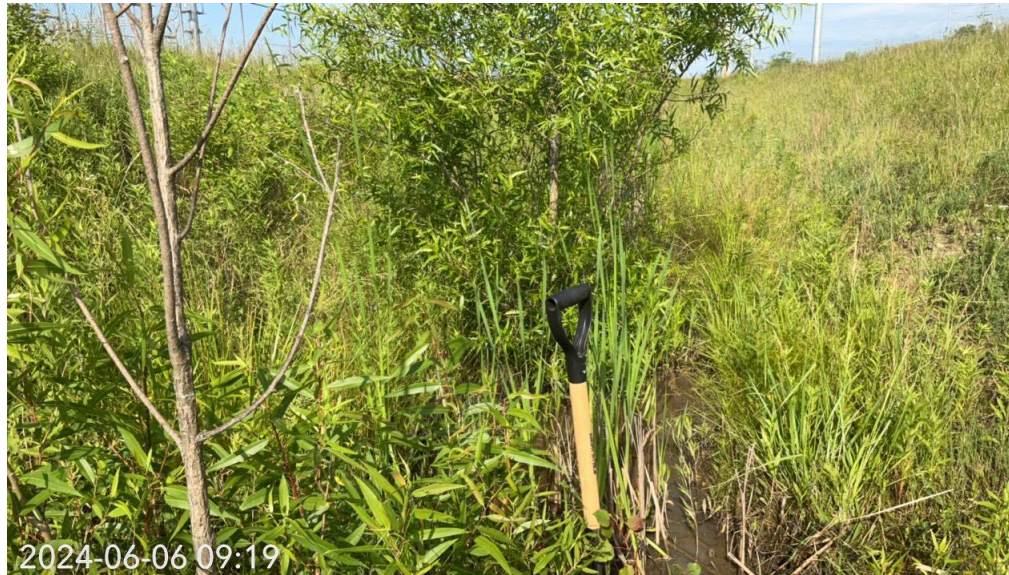
Photograph Location 1. View of upland (old field habitat) at wetland determination sample point location SP01 within an existing upland drainage feature. Photograph taken facing west.

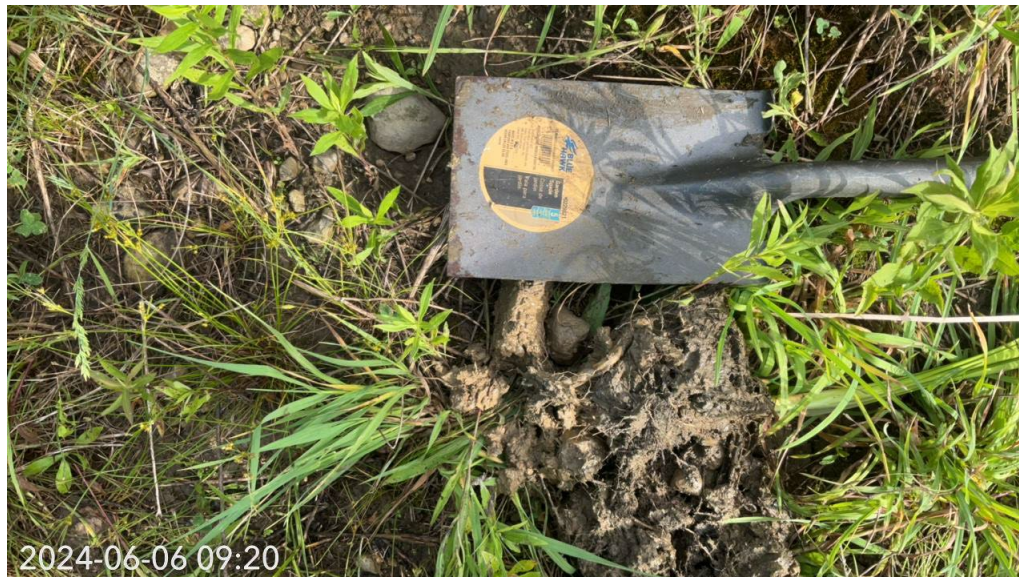
Photograph Location 1. View of soil profile at wetland determination sample point location SP01.

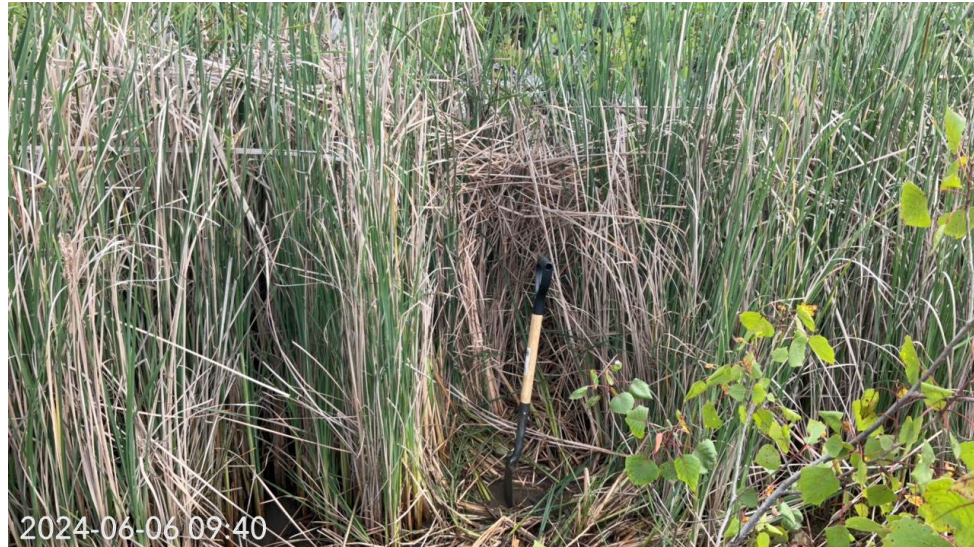
Photograph Location 2. View of upland (old field habitat) at wetland determination sample point location SP02 located within an existing upland drainage feature. Photograph taken facing north.

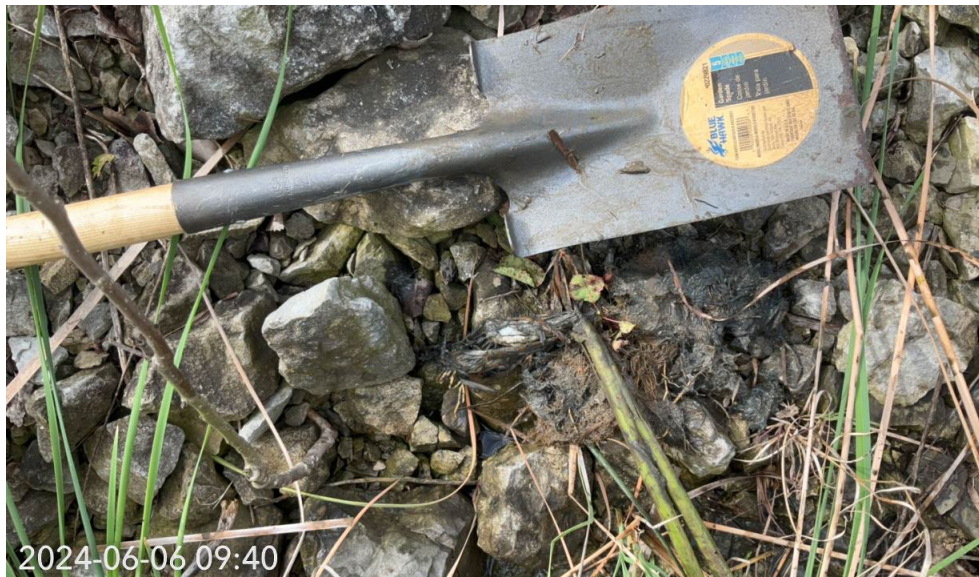
Photograph Location 2. View of soil profile at wetland determination sample point location SP02.

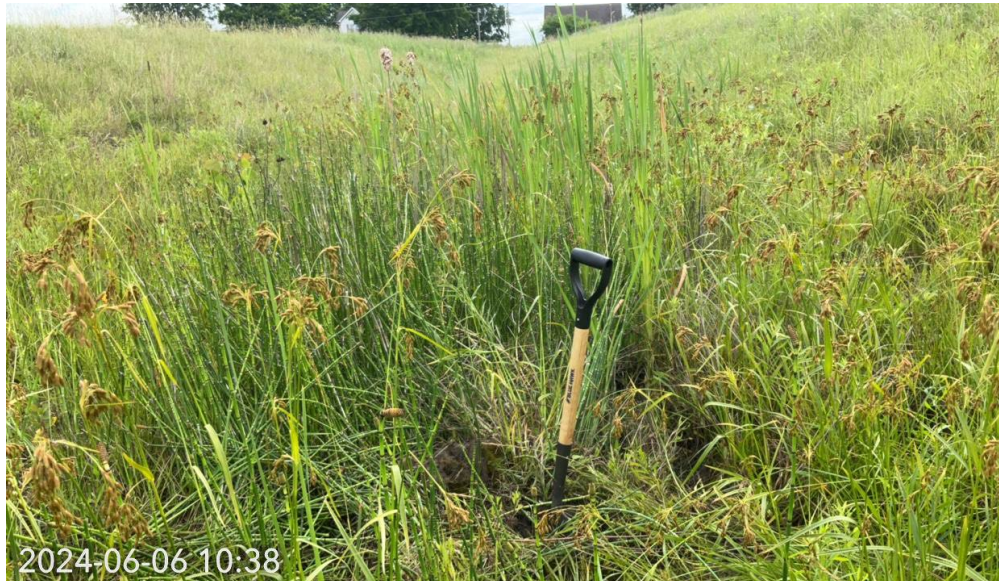
Photograph Location 3. View of upland (old field habitat) at wetland determination sample point location SP03 located within an existing upland drainage feature. Photograph taken facing east.

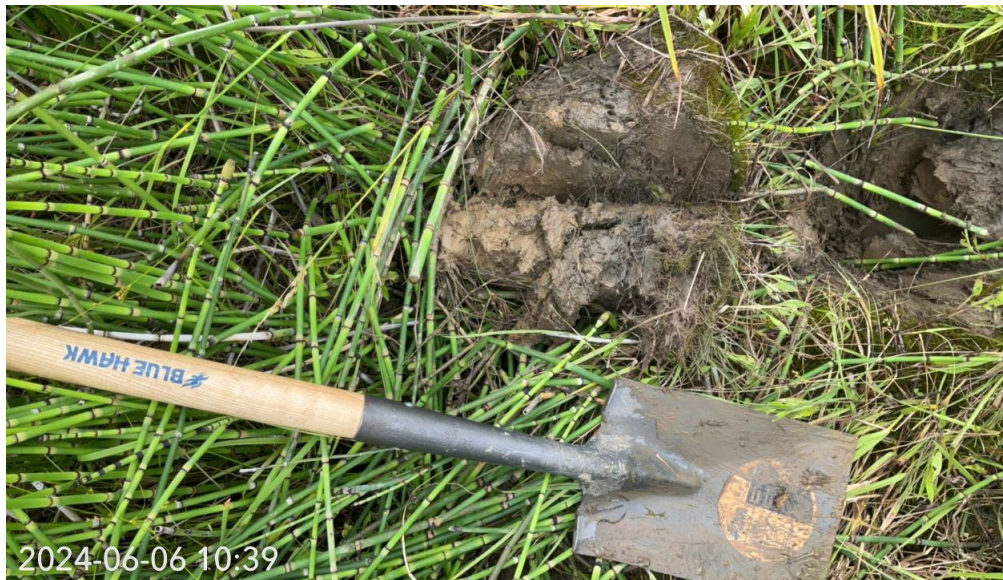
Photograph Location 3. View of soil profile at wetland determination sample point location SP03.

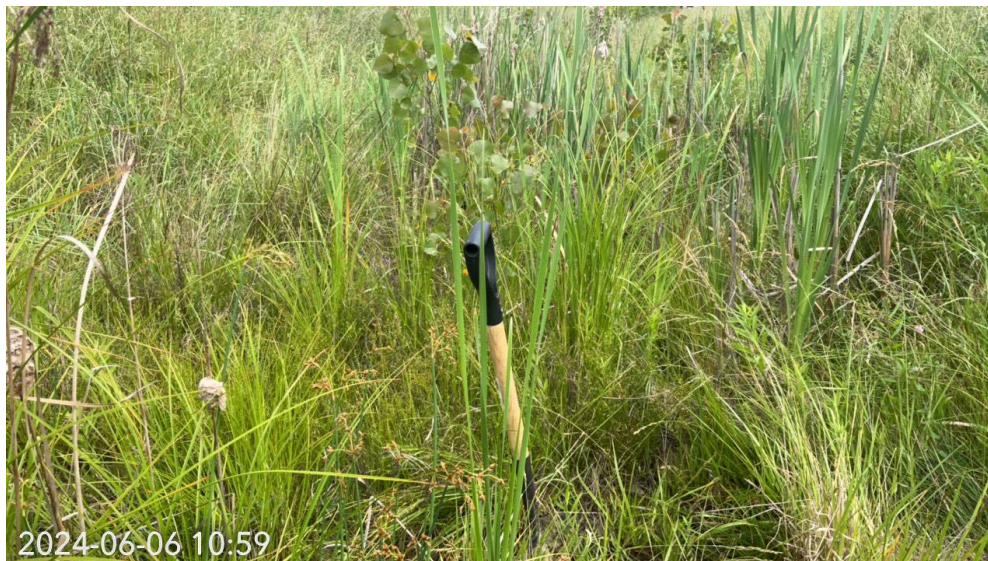
Photograph Location 4. View of upland (old field habitat) at wetland determination sample point location SP04 located within an existing upland drainage feature. Photograph taken facing north.

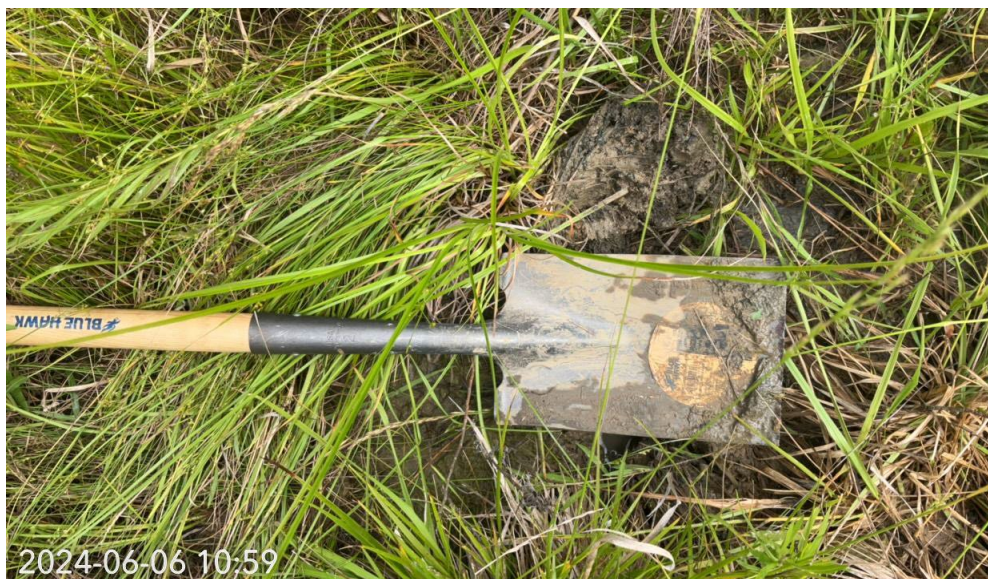
Photograph Location 4. View of soil profile at wetland determination sample point location SP04.

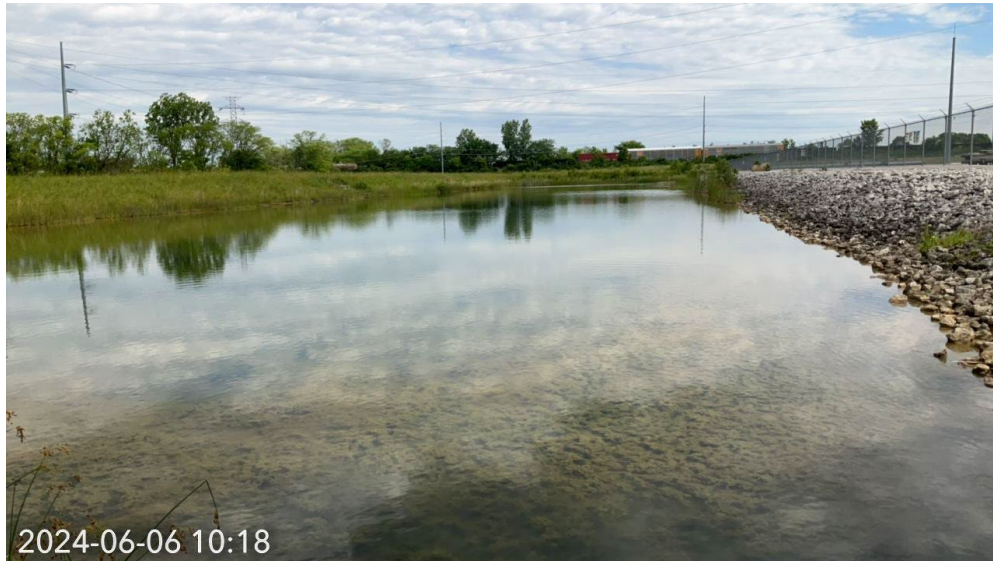
Photograph Location 5. View of Open Water 1. Photograph taken facing east

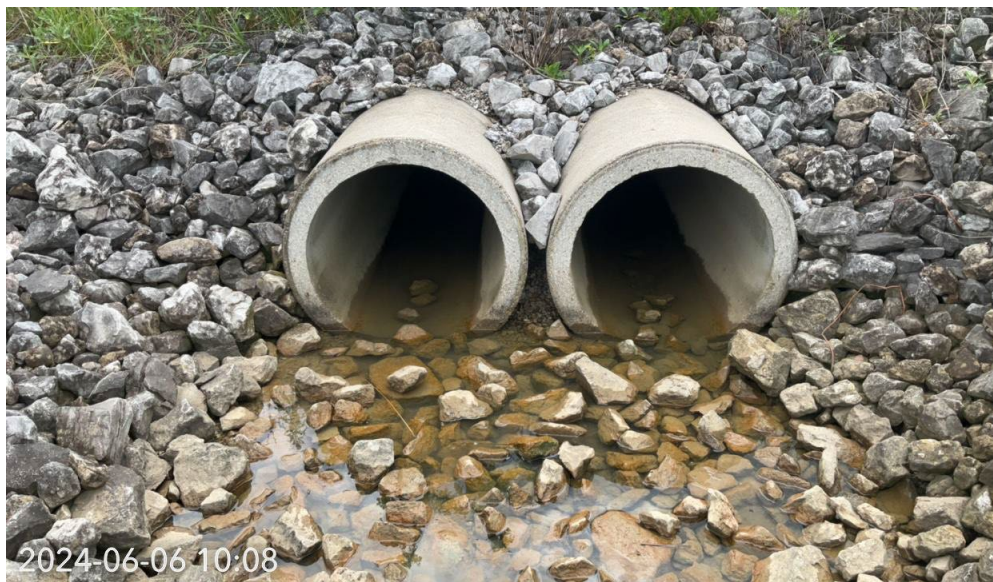
Photograph Location 6. Representative view of existing culverts within the Project area. Photograph taken facing south.

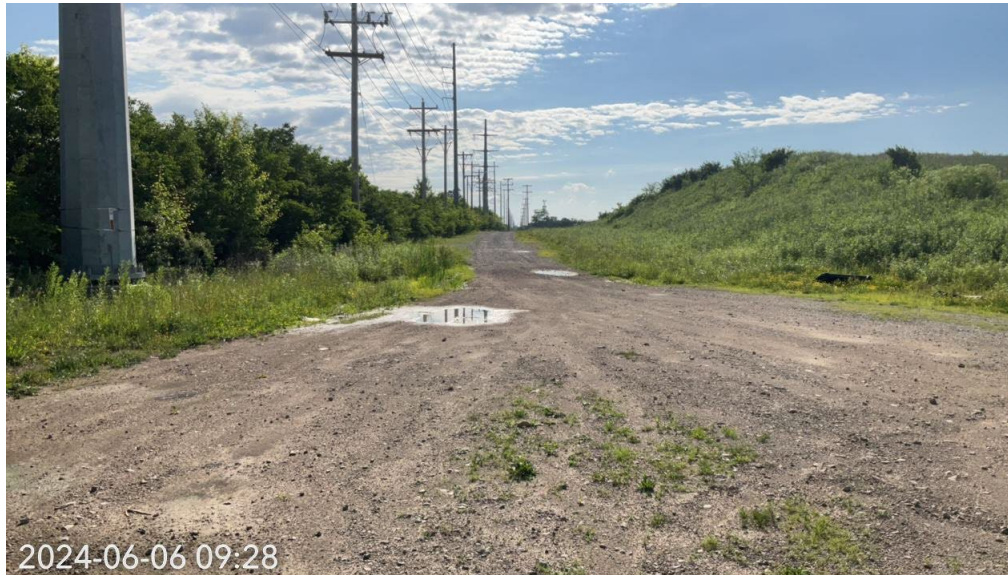
Photograph Location 1. View of old field habitat and existing gravel road within the Project area. Photograph taken facing east.

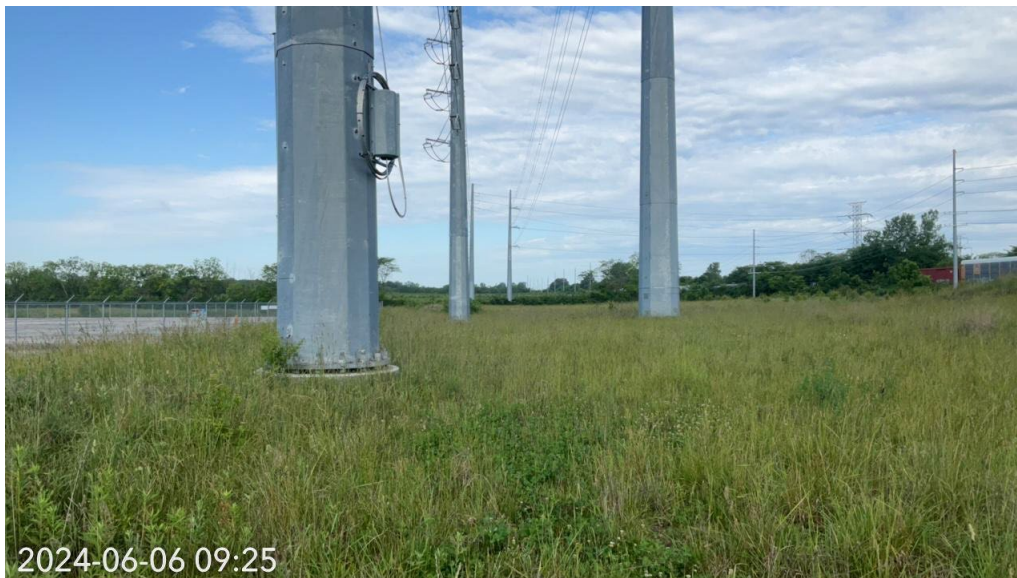
Photograph Location 2. View of old field habitat and industrial land (existing Cole Station) within the Project area. Photograph taken facing northwest.

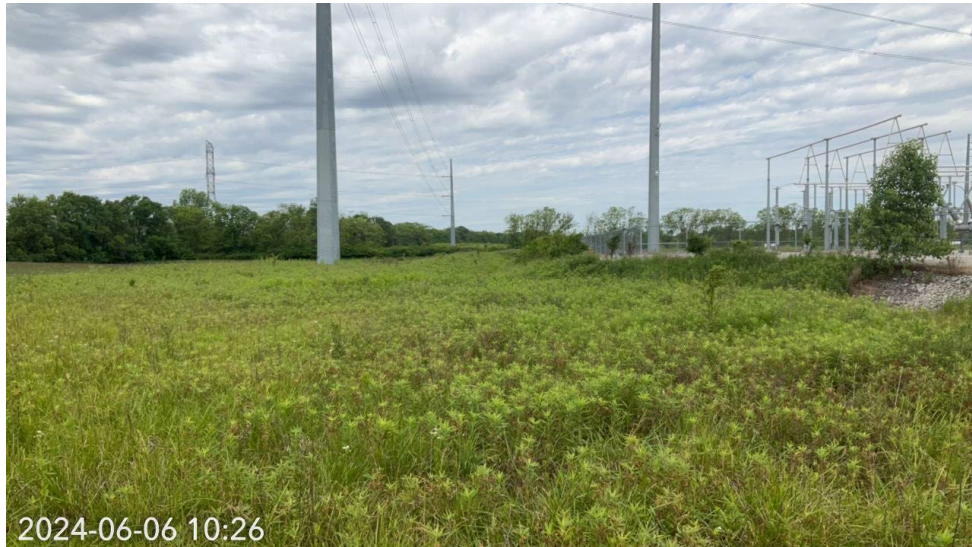
Photograph Location 3. View of old field habitat and industrial land (existing Cole Station) within the Project area. Photograph taken facing west.

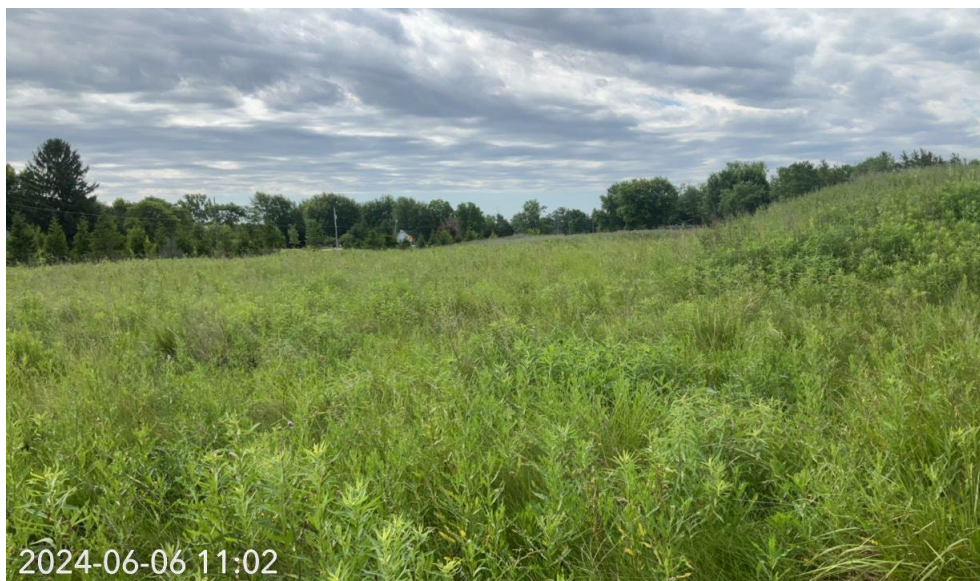
Photograph Location 4. View of old field habitat within the Project area. Photograph taken facing west.
