Construction Notice for the Gunn Road-Scioto Ridge Solar 345 kV Generation Tie Line Project

PUCO Case No. 25-0155-EL-BNR

Submitted by: AEP Ohio Transmission Company, Inc.

### Gunn Road-Scioto Ridge Solar 345 kV Generation Tie Line

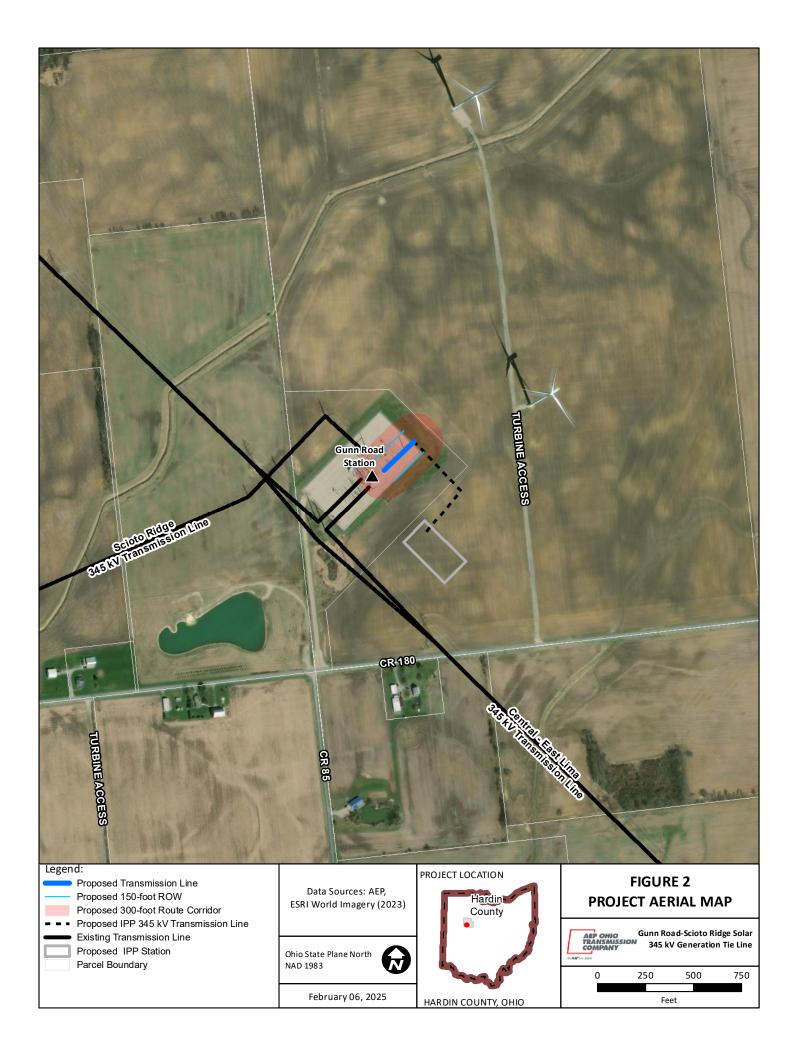
Appendix A Project Maps

The Company proposes to construct the Gunn Road-Scioto Ridge Solar 345 kV Generation Tie Line Project (the "Project") in Lynn Township, Hardin County Ohio. The purpose of the Project is to provide a 345 kV interconnection to the Scioto Ridge Solar facility (OPSB Case Number 23-0146-EL-BGN), proposed by Scioto Ridge Solar, L.L.C., an Independent Power Producer (IPP). The PJM Queue Position is AE2-306. One span of 345 kV transmission line will be constructed between the Company's existing Gunn Road Station to a point of interconnection with the IPP transmission line located just outside the station fence. The length of the Project transmission line is approximately 220 feet. The Project will be built entirely on land owned by the Company. The location of the Project is shown on **Figure 1** and **Figure 2** in **Appendix A**.

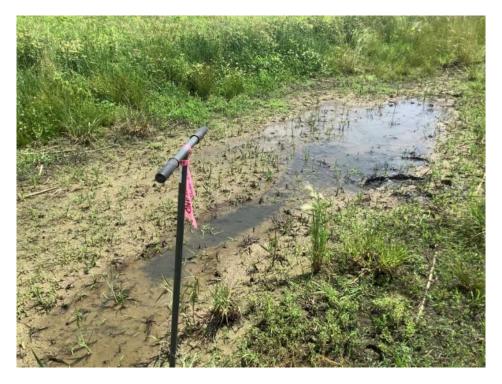
Photo Location 71. View of wetland determination sample point (SP30; PEM). Photograph taken facing south.

Project/Site: Scioto Solar Project	City/County: Hardin Sampling Date: 06/14/2022
Applicant/Owner: RWE Solar Development, LLC	State: <u>Ohio</u> Sampling Point: <u>SP30</u>
Investigator(s): M Kearns, S Heitzenrater	Section, Township, Range: N/A
Landform (hillside, terrace, etc.): Depression Local re	elief (concave, convex, none): Concave Slope %: 1
Subregion (LRR or MLRA): Lat: 40.58652	Long: <u>-83.732448</u> Datum: <u>WGS84</u>
Soil Map Unit Name: Blount silt loam, ground moraine, 2 to 4 percent s	lopes NWI classification: N/A
Are climatic / hydrologic conditions on the site typical for this time of year? Are Vegetation $\underline{N}$ , Soil $\underline{N}$ , or Hydrology $\underline{N}$ significantly distur- Are Vegetation $\underline{N}$ , Soil $\underline{N}$ , or Hydrology $\underline{N}$ naturally problem <b>SUMMARY OF FINDINGS – Attach site map showing sampling po</b>	atic? (If needed, explain any answers in Remarks.)

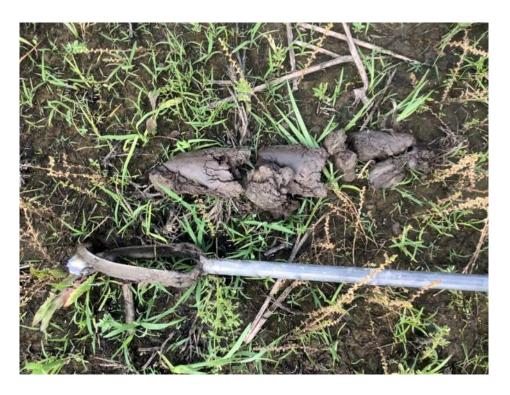
Photo Location 71. View of wetland determination sample point (SP30; PEM), soil profile.

Depth         Matrix         R           (inches)         Color (moist)         %         Color (moist)           0-21         2.5Y         3/2         93         10YR         6/6				nfirm the absence of indi	····· · ,
	edox Featur				
0-21 2.5Y 3/2 93 10YR 6/6	) %	Type <sup>1</sup>	Loc <sup>2</sup>	Texture	Remarks
	7	С	М	Clay Loam	
<sup>1</sup> Type: C=Concentration, D=Depletion, RM=Reduced Mat	rix, MS=Mas	ked San	d Grains		
Hydric Soil Indicators:				Indicators for P	roblematic Hydric Soils <sup>3</sup> :
Histosol (A1) Sandy Gleye	ed Matrix (S4)			Coast Prairie F	Redox (A16)
Histic Epipedon (A2) Sandy Redo	x (S5)			Iron-Mangane	se Masses (F12)
Black Histic (A3) Stripped Ma	trix (S6)			Red Parent Ma	aterial (F21)
Hydrogen Sulfide (A4) Dark Surface	e (S7)			Very Shallow [	Dark Surface (F22)
Stratified Layers (A5) Loamy Much	ky Mineral (F1	)		Other (Explain	in Remarks)
	ed Matrix (F2)				
Depleted Below Dark Surface (A11) Depleted Ma

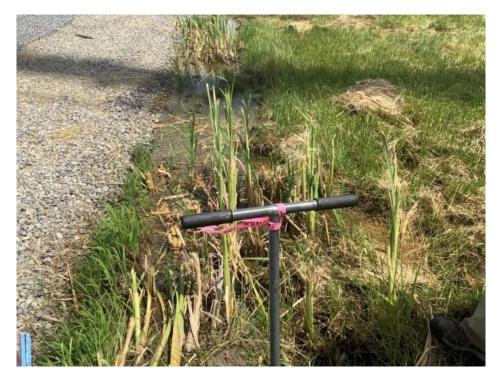
Photo Location 74. View of wetland determination sample point (SP31; PEM). Photograph taken facing southeast.

Project/Site: Scioto Solar Project	City/County: Hardin Sampling Date: 06/14/2022
Applicant/Owner: RWE Solar Development, LLC	State: <u>Ohio</u> Sampling Point: <u>SP31</u>
Investigator(s): M Kearns, S Heitzenrater	Section, Township, Range: N/A
Landform (hillside, terrace, etc.): Depression Local r	elief (concave, convex, none): Concave Slope %: 1
Subregion (LRR or MLRA): Lat: 40.585856	Long: -83.731999 Datum: WGS84
Soil Map Unit Name: Blount silt loam, ground moraine, 2 to 4 percent	slopes NWI classification: N/A
Are climatic / hydrologic conditions on the site typical for this time of year?	Yes X No (If no, explain in Remarks.)
Are Vegetation <u>N</u> , Soil <u>N</u> , or Hydrology <u>N</u> significantly distu	rbed? Are "Normal Circumstances" present? Yes X No
Are Vegetation <u>N</u> , Soil <u>N</u> , or Hydrology <u>N</u> naturally problen	natic? (If needed, explain any answers in Remarks.)
SUMMARY OF FINDINGS – Attach site map showing sampling po	int locations, transects, important features, etc.

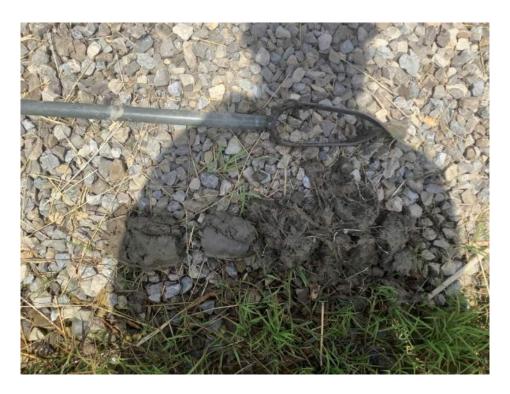
Photo Location 74. View of wetland determination sample point (SP31; PEM), soil profile.

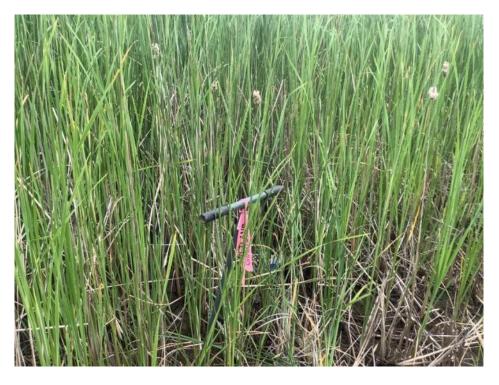
Photo Location 80. View of wetland determination sample point (SP34; PEM). Photograph taken facing northeast.

Project/Site: Scioto Solar Project	City/County: Hardin Sampling Date: 06/14/2022
Applicant/Owner: RWE Solar Development, LLC	State: Ohio Sampling Point: SP34
Investigator(s): M Kearns, S Heitzenrater	Section, Township, Range: N/A
Landform (hillside, terrace, etc.): Depression Local re	elief (concave, convex, none): Concave Slope %: 1
Subregion (LRR or MLRA): Lat: 40.585289	Long: -83.732149 Datum: WGS84
Soil Map Unit Name:Pewamo silty clay loam, 0 to 1 percent slopes	NWI classification: N/A
Are climatic / hydrologic conditions on the site typical for this time of year?	Yes X No (If no, explain in Remarks.)
Are Vegetation       N       , Soil       N       , or Hydrology       N       significantly distu         Are Vegetation       N       , Soil       N       , or Hydrology       N       naturally problem	
SUMMARY OF FINDINGS – Attach site map showing sampling po	int locations, transects, important features, etc.

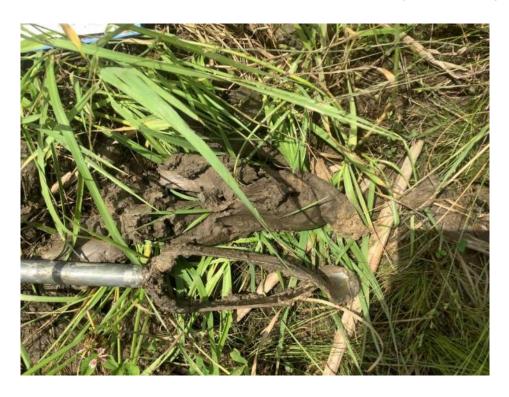
Photo Location 80. View of wetland determination sample point (SP34; PEM), soil profile.

Profile Description: (Describe to the Depth Matrix	Redo	ox Feature				-
(inches) Color (moist)	% Color (moist)	%	Type <sup>1</sup>	Loc <sup>2</sup>	Texture	Remarks
		7				
0-21 10YR 4/2 9	10YR 5/6	7	С	М	Clay Loam	
		·				
		·				
		·				
		·				
<sup>1</sup> Type: C=Concentration, D=Depletio	n, RM=Reduced Matrix,	MS=Mask	ked San	d Grains		re Lining, M=Matrix.
Hydric Soil Indicators:					Indicators for	Problematic Hydric Soils <sup>3</sup> :
Histosol (A1)	Sandy Gleyed M	/atrix (S4)			Coast Prair	ie Redox (A16)
Histic Epipedon (A2)	Sandy Redox (S	65)			Iron-Manga	anese Masses (F12)
Black Histic (A3)	Stripped Matrix	(S6)			Red Parent	t Material (F21)
Hydrogen Sulfide (A4)	Dark Surface (S	S7)			Very Shallo	ow Dark Surface (F22)
Stratified Layers (A5)	Loamy Mucky N	/lineral (F1)			Other (Expl	lain in Remarks)
2 cm Muck (A10)	Loamy Gleyed M	Matrix (F2)				
Depleted Below Dark Surface (A11)	X Depleted Matrix	(F3)

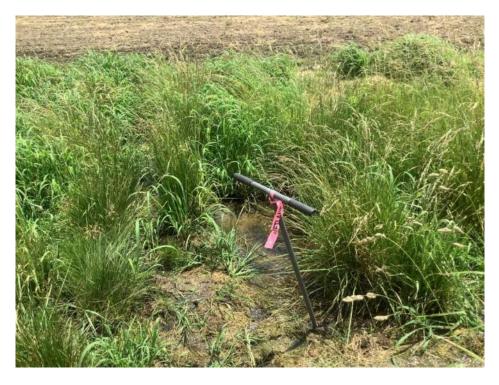
Photo Location 82. View of wetland determination sample point (SP35; PEM). Photograph taken facing south.

Project/Site: Scioto Solar Project	City/County: Hardin Sampling Date: 06/14/2022
Applicant/Owner: RWE Solar Development, LLC	State: <u>Ohio</u> Sampling Point: <u>SP35</u>
Investigator(s): M Kearns, S Heitzenrater	Section, Township, Range: N/A
Landform (hillside, terrace, etc.): Depression Local re	elief (concave, convex, none): Concave Slope %: 1
Subregion (LRR or MLRA): Lat: 40.586158	Long: <u>-83.730975</u> Datum: <u>WGS84</u>
Soil Map Unit Name: Pewamo silty clay loam, 0 to 1 percent slopes	NWI classification: N/A
Are climatic / hydrologic conditions on the site typical for this time of year?	Yes X No (If no, explain in Remarks.)
Are Vegetation <u>N</u> , Soil <u>N</u> , or Hydrology <u>N</u> significantly distu	rbed? Are "Normal Circumstances" present? Yes X No
Are Vegetation <u>N</u> , Soil <u>N</u> , or Hydrology <u>N</u> naturally problem	atic? (If needed, explain any answers in Remarks.)

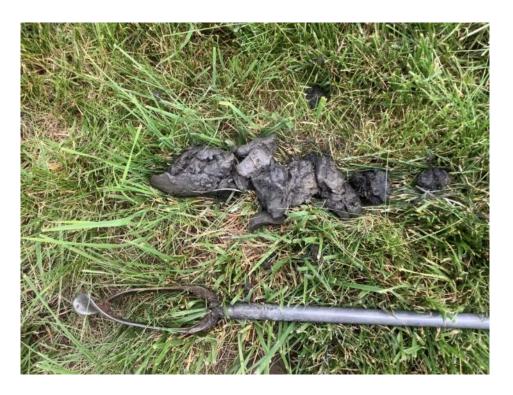
Photo Location 82. View of wetland determination sample point (SP35; PEM), soil profile.

Depth	Matrix		Redo	x Featur				
inches)	Color (moist)	%	Color (moist)	%	Type <sup>1</sup>	Loc <sup>2</sup>	Texture	Remarks
0-21	Gley3/N	100					Clay Loam	
							_	
Type: C=C	oncentration, D=D	epletion, RM	M=Reduced Matrix,	MS=Mas	ked San	d Grains	2Location: PL=Po	ore Lining, M=Matrix.
dric Soil I	ndicators:						Indicators for	r Problematic Hydric Soils <sup>3</sup> :
Histosol (A	A1)		Sandy Gleyed N	latrix (S4)			Coast Prai	rie Redox (A16)
Histic Epip			Sandy Redox (S					anese Masses (F12)
Black Histi			Stripped Matrix (	-				t Material (F21)
_	Sulfide (A4)		Dark Surface (S					ow Dark Surface (F22)
	_ayers (A5)		Loamy Mucky M		)			lain in Remarks)
2 cm Mucł			X Loamy Gleyed N					,
	Below Dark Surface (	A11)	Depleted Matrix					
_	x Surface (A12)	,	Redox Dark Sur					
	cky Mineral (S1)		Depleted Dark S		7)
