# Letter of Notification for the Monza 345 kV Station Project

PUCO Case No. 26-0866-EL-BLN

Submitted by:  
AEP Ohio Transmission Company, Inc.

September 3, 2026

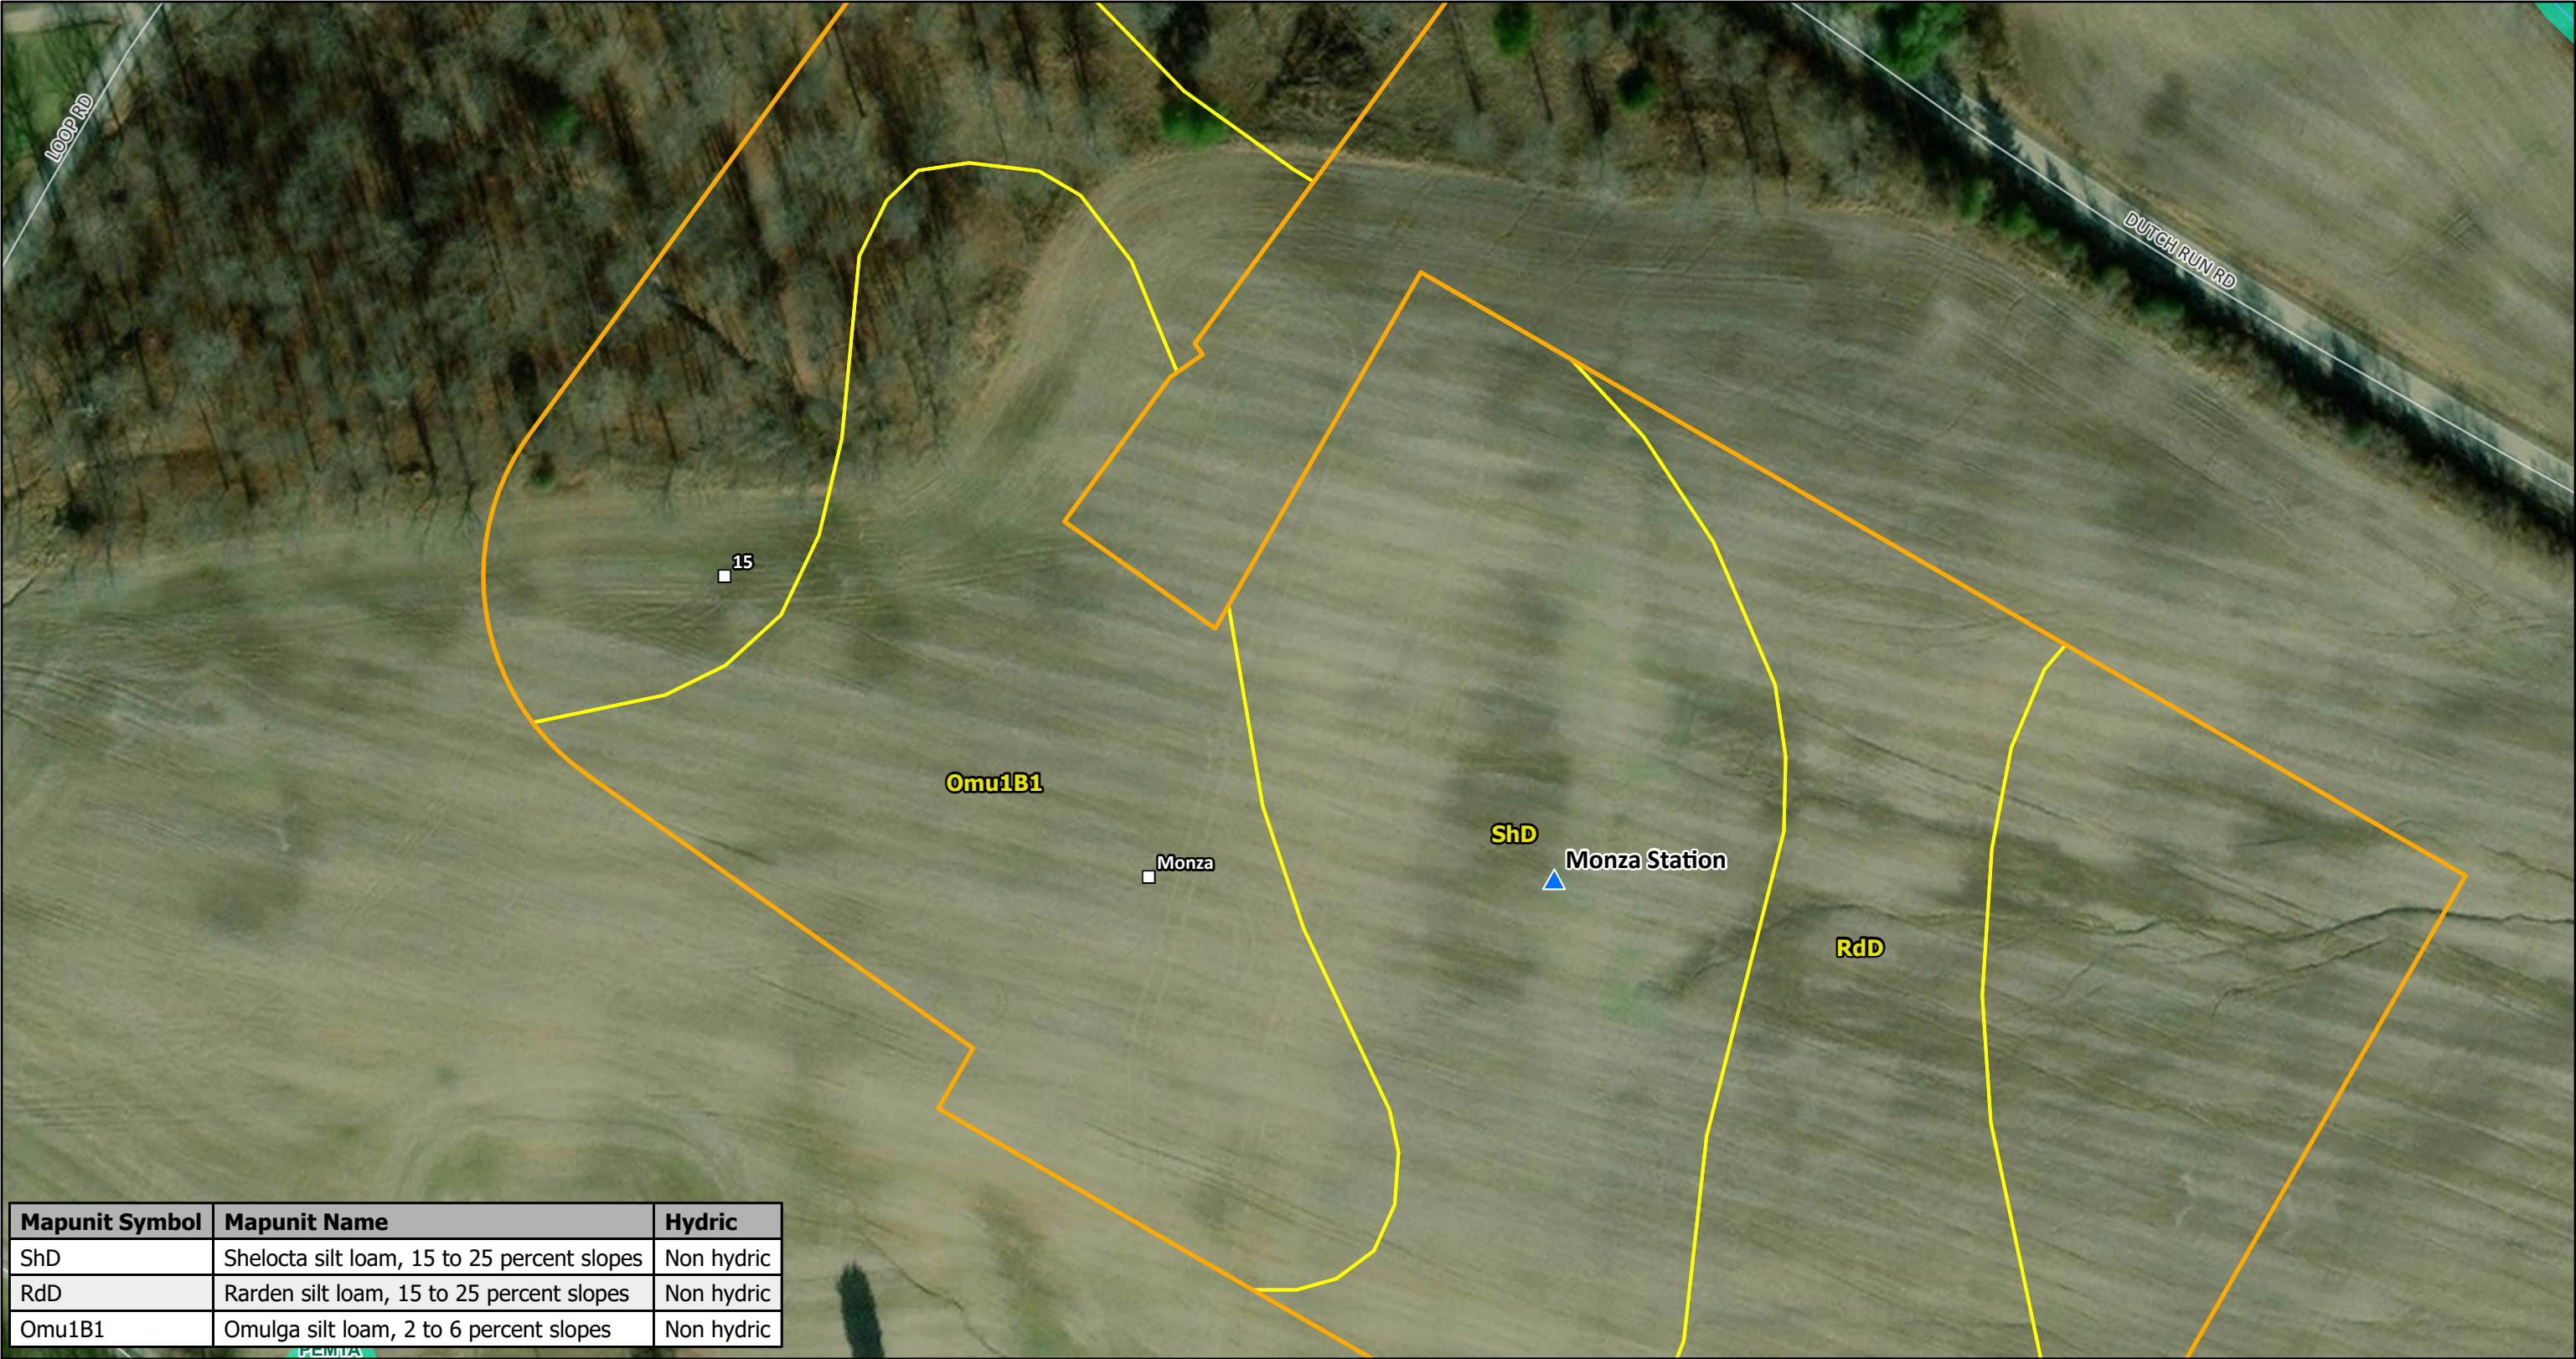
FIGURE 2  
SOILS, NHD FEATURES, NWI WETLANDS  
AND FEMA FLOODPLAIN MAP

Note: No FEMA floodplain features are present within the map area

| Mapunit Symbol | Mapunit Name | Hydric |
| ShD | Shelocta silt loam, 15 to 25 percent slopes | Non hydric |

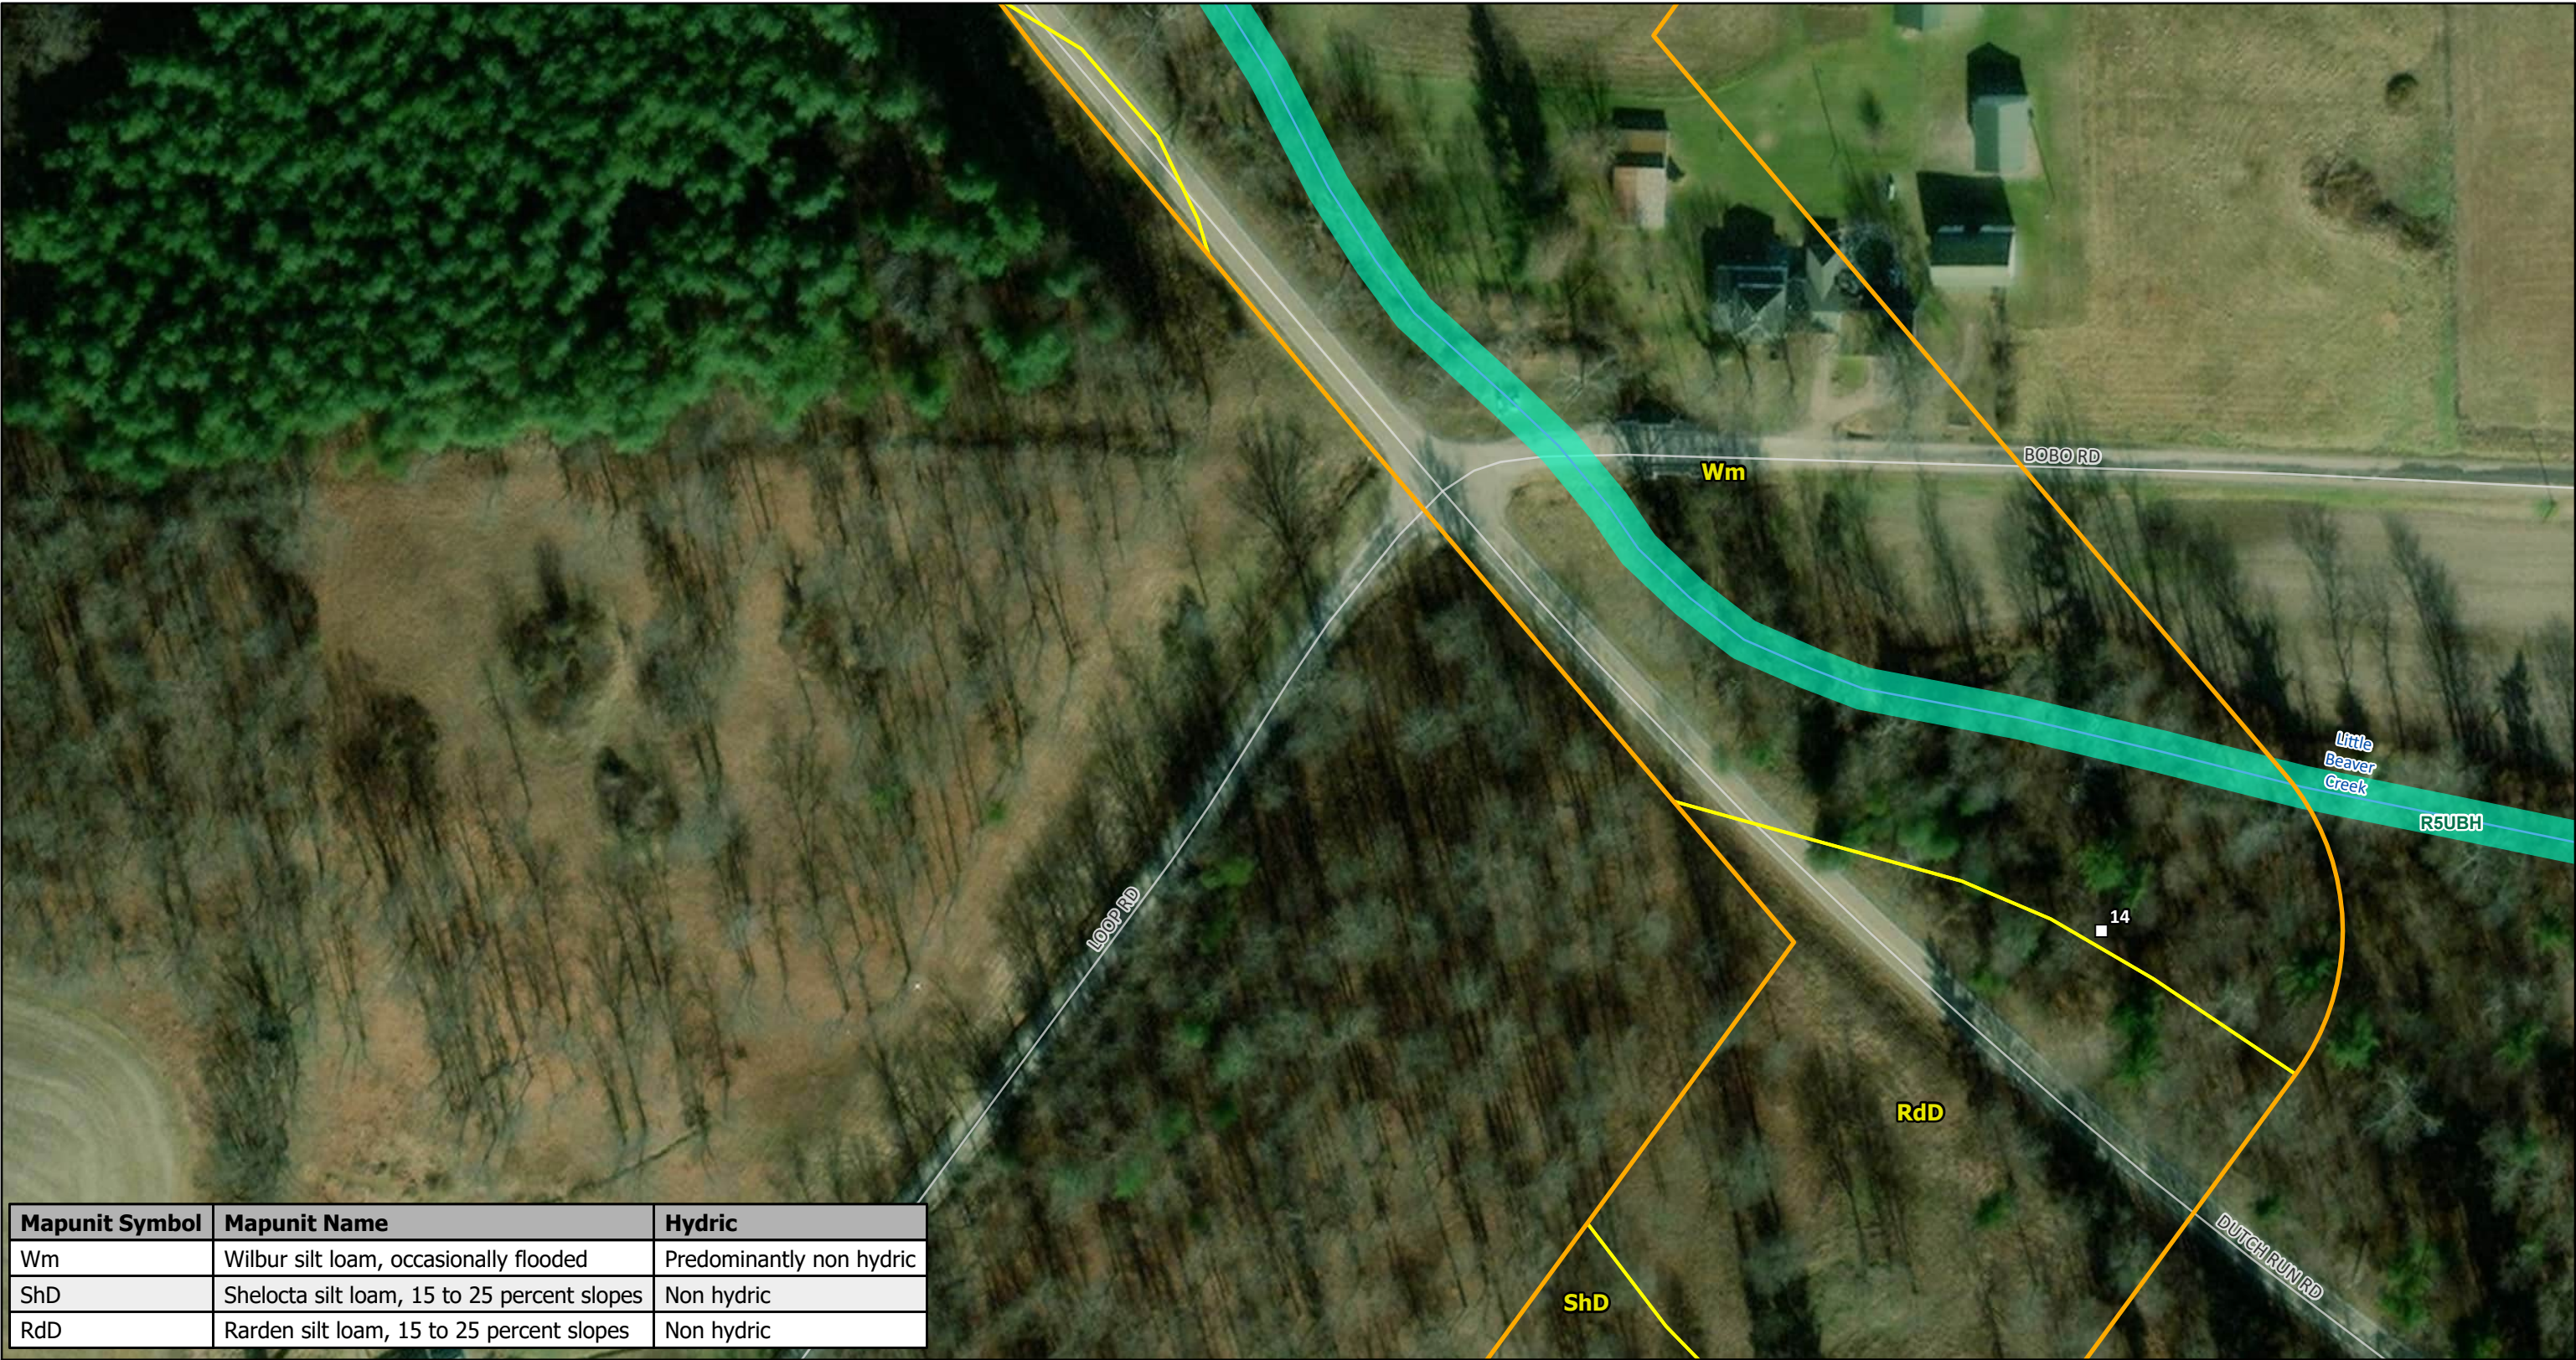
FIGURE 2  
SOILS, NHD FEATURES, NWI WETLANDS  
AND FEMA FLOODPLAIN MAP

Note: No FEMA floodplain features are present within the map area

| Mapunit Symbol | Mapunit Name | Hydric |
| Wm | Wilbur silt loam, occasionally flooded | Predominantly non hydric |

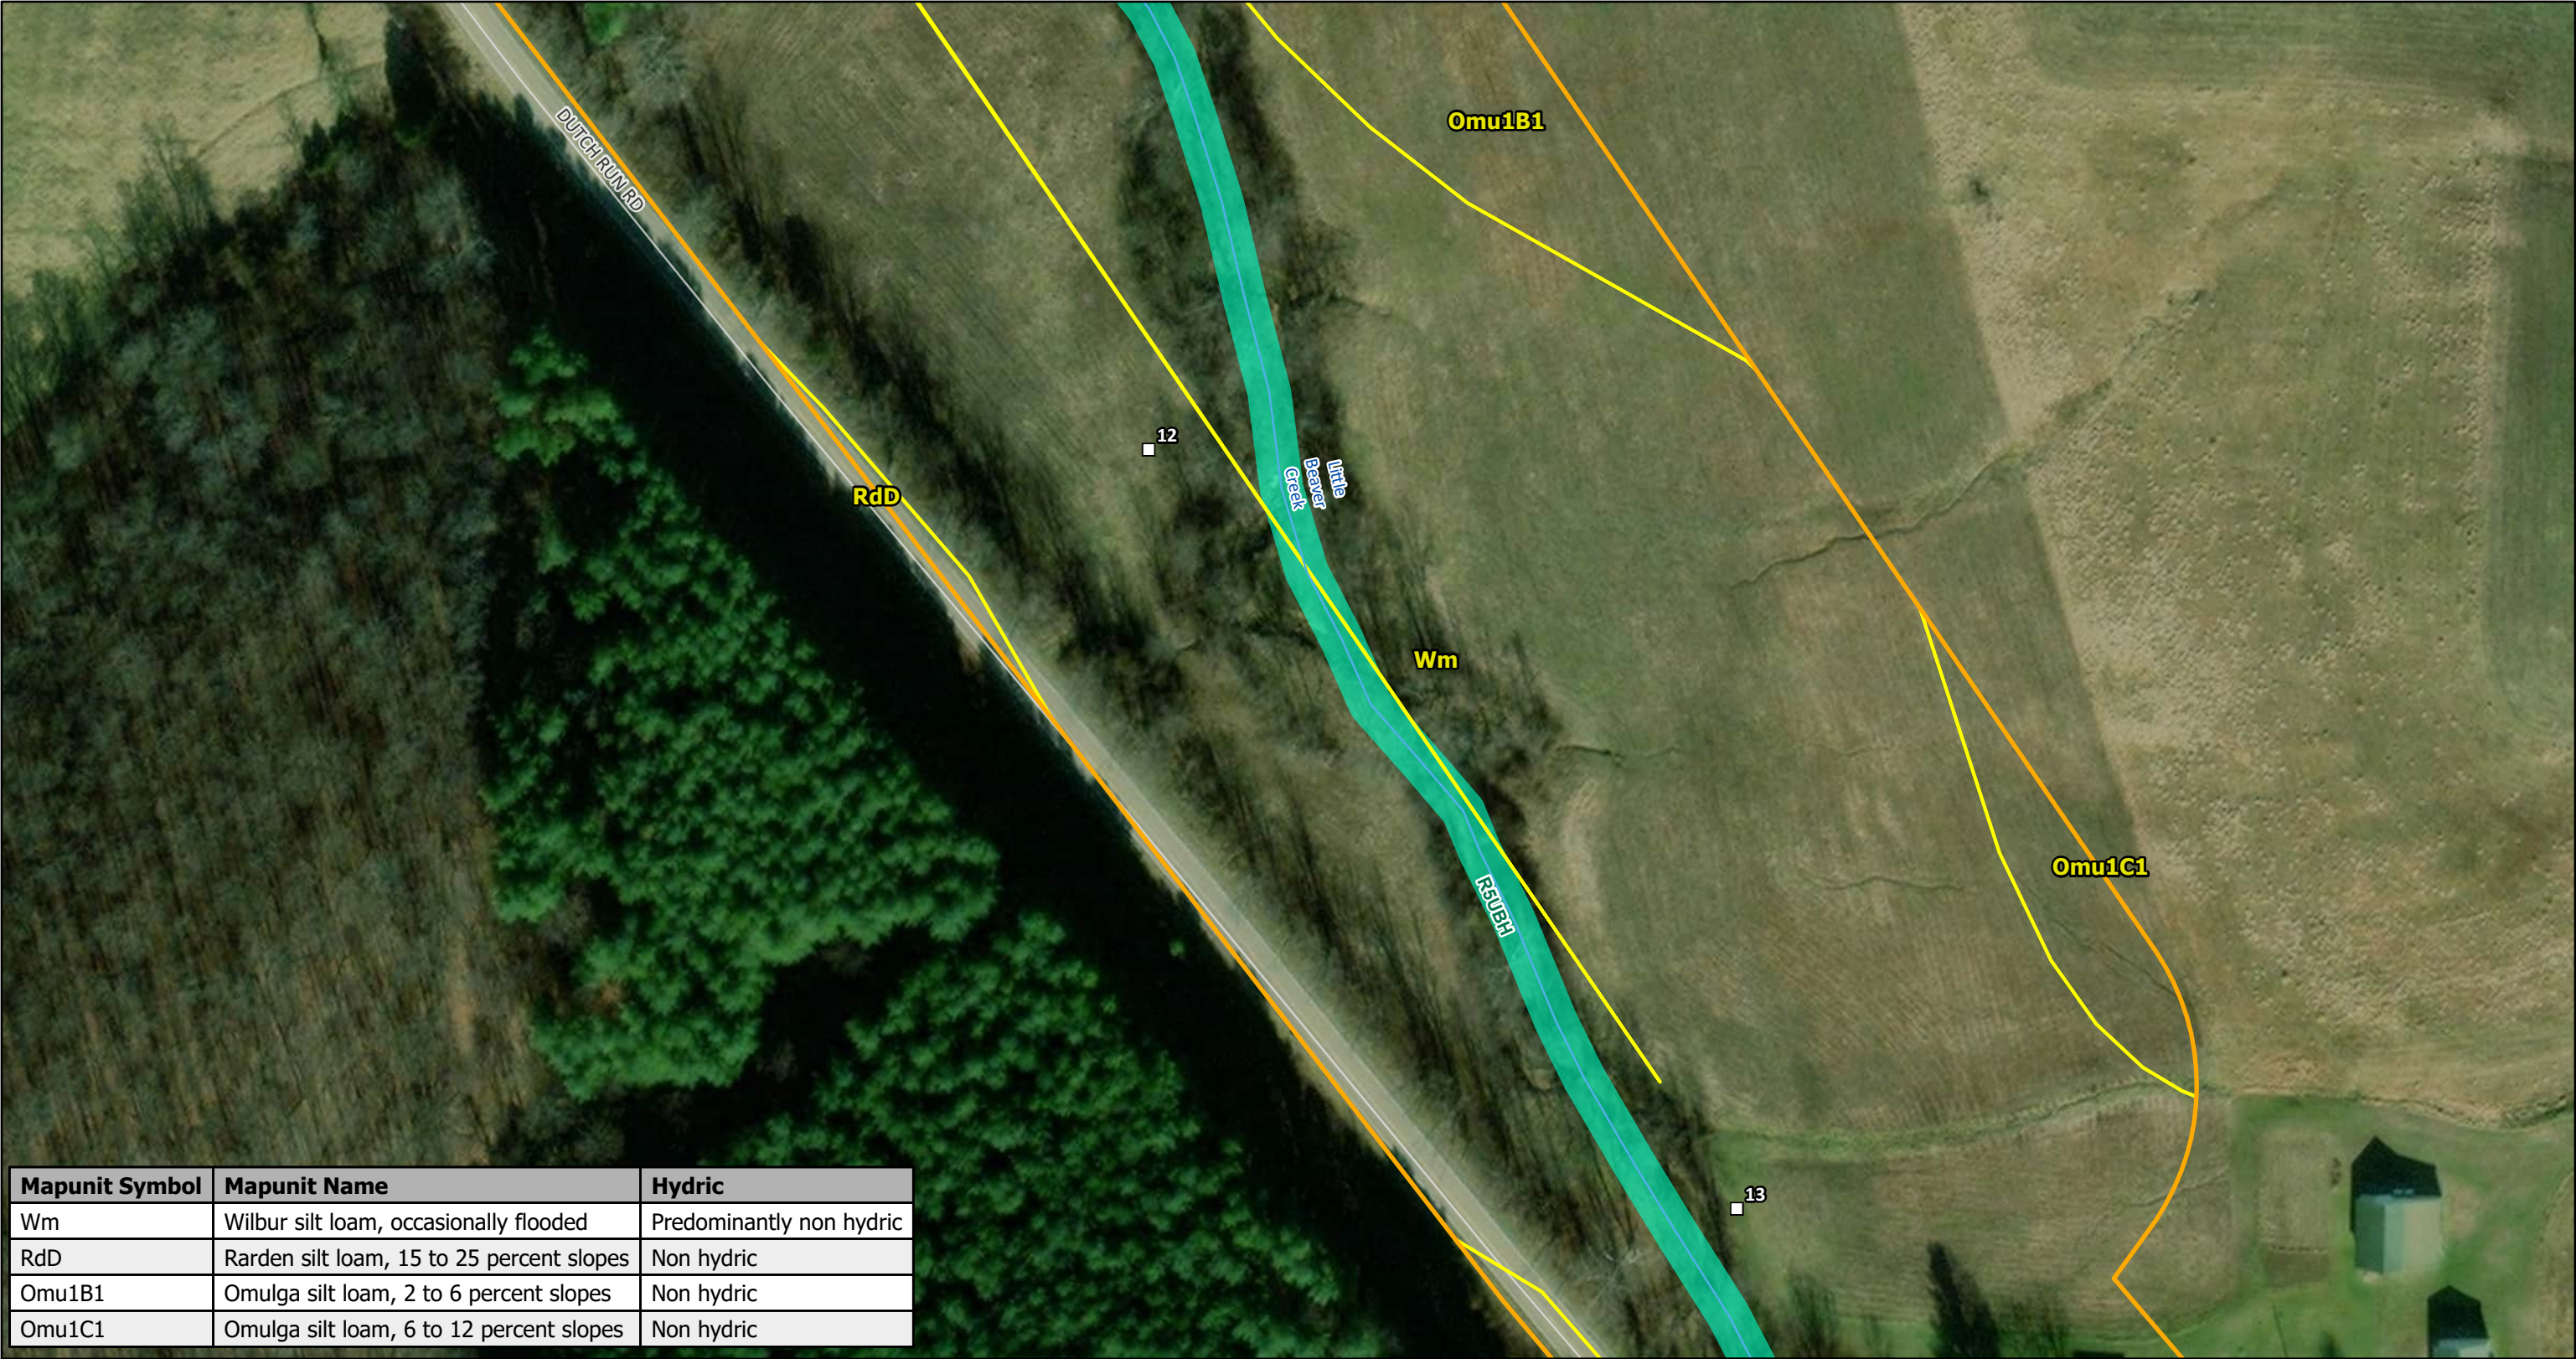
FIGURE 2  
SOILS, NHD FEATURES, NWI WETLANDS  
AND FEMA FLOODPLAIN MAP

| Mapunit Symbol | Mapunit Name | Hydric |
| Wm | Wilbur silt loam, occasionally flooded | Predominantly non hydric |

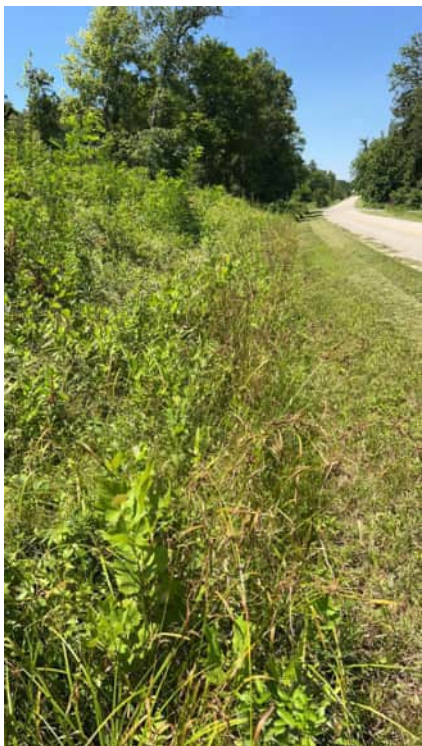
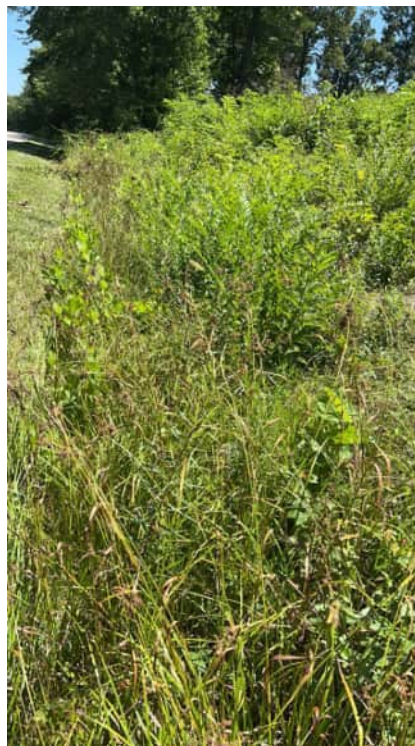
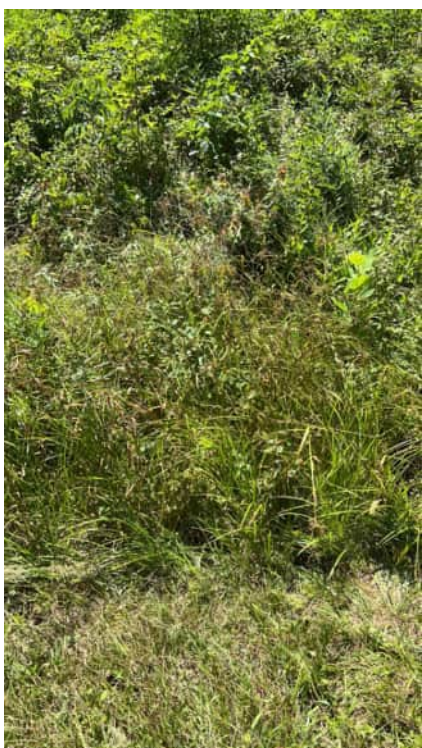
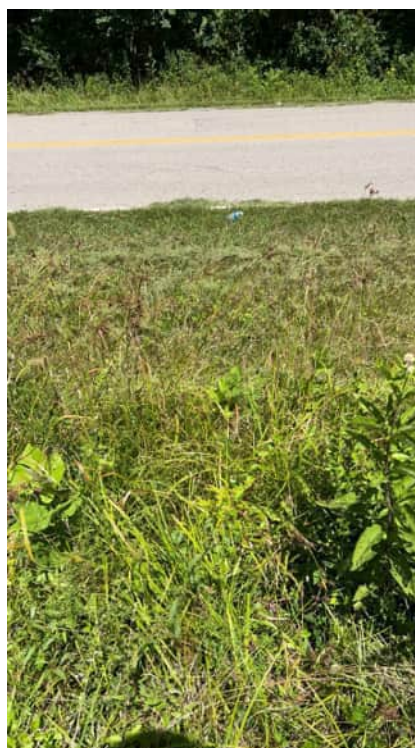
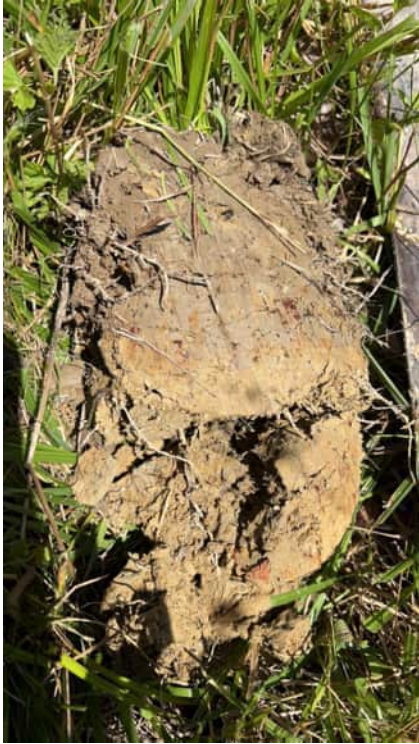
Sampling Point: Wetland MD-01

N

S

W

E

Soil

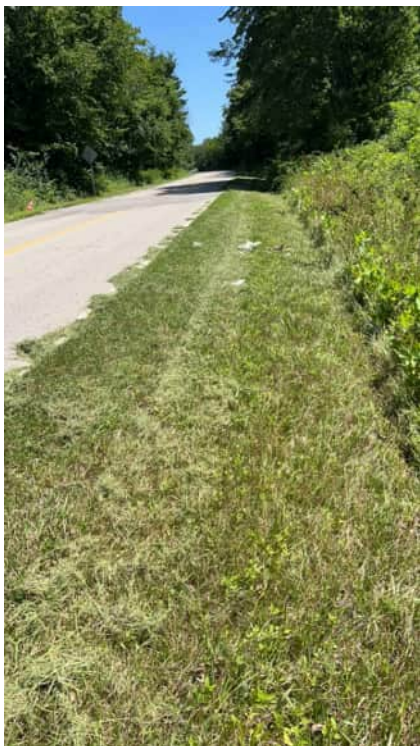
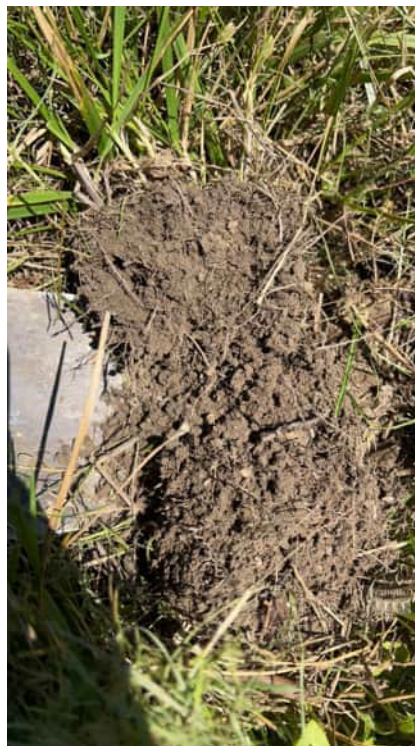
Sampling Point: Upland MD-01

S

Soil

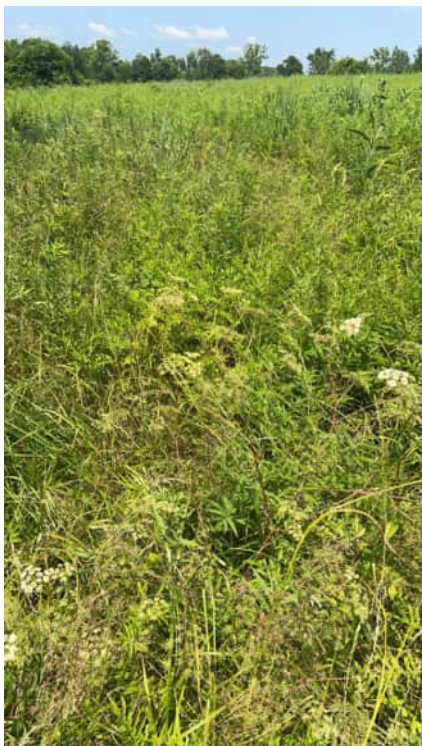
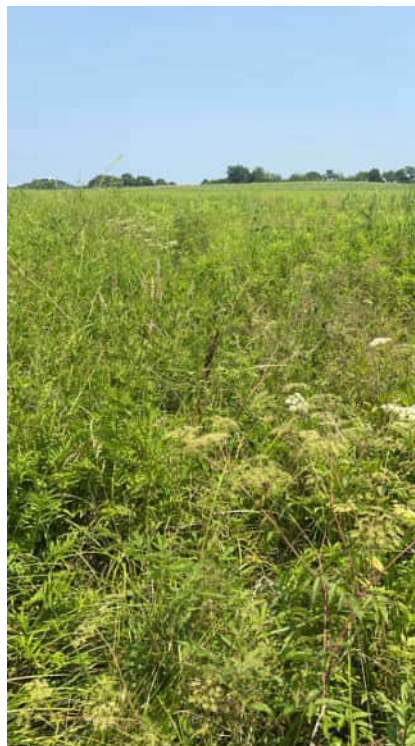
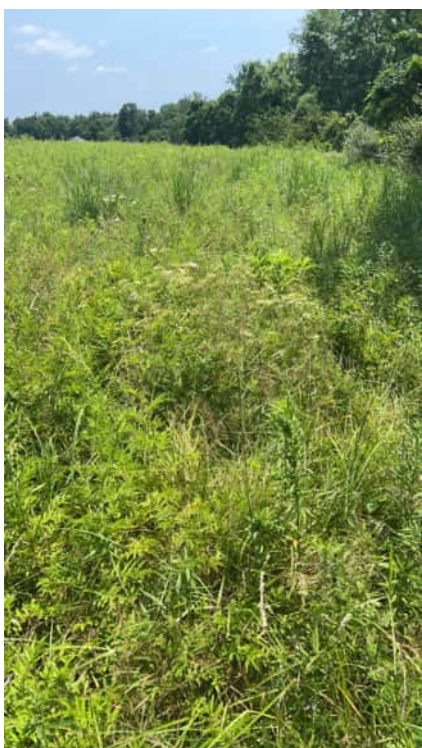
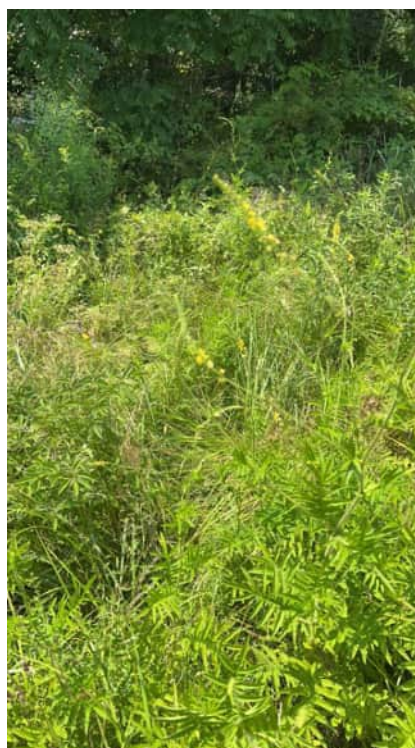
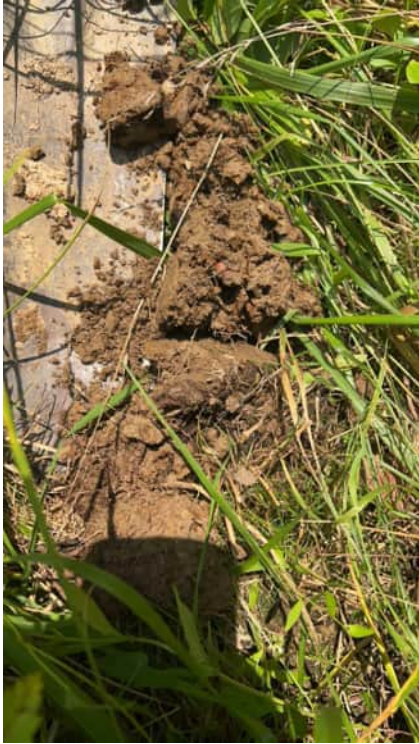
Sampling Point: Wetland MD-02

N

E

S

W

Soil

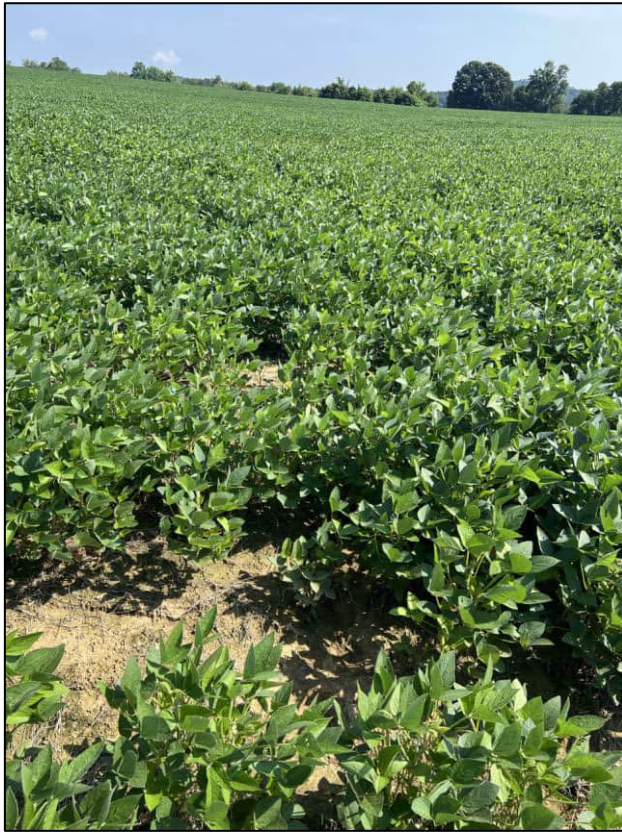
Representative photo of **agriculture**

In addition to the delineated wetland and waterbody features, Jacobs observed the following land use types and habitats within the ESB: forested, maintained lawn, impervious surface, old field, agriculture, scrub/shrub, and grassland (Figure 4). Based on Jacobs observations, the primary land use in the ESB is forested. Land use descriptions and percentages within the ESB are outlined in Table 4.4 and representative photographs of land use types are in Appendix G.

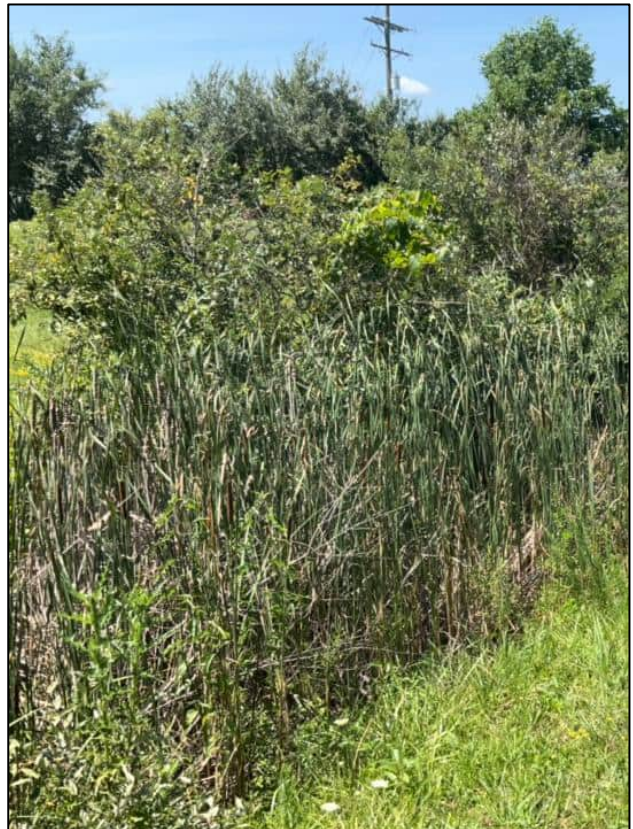
Representative photo of **delineated wetland**
