Re: Case No. 19-0266-EL-BLN
In the Matter of the Letter of Notification for the
Anguin-Babbitt 138 kV Transmission Line Project

Letter of Notification Anguin-Babbitt 138 kV Transmission Line Project

Letter of Notification for Anguin-Babbitt 138 kV Transmission Line

AEP Ohio Transmission Company, Inc. (AEP Ohio Transco) Anguin-Babbitt 138 kV Transmission Line

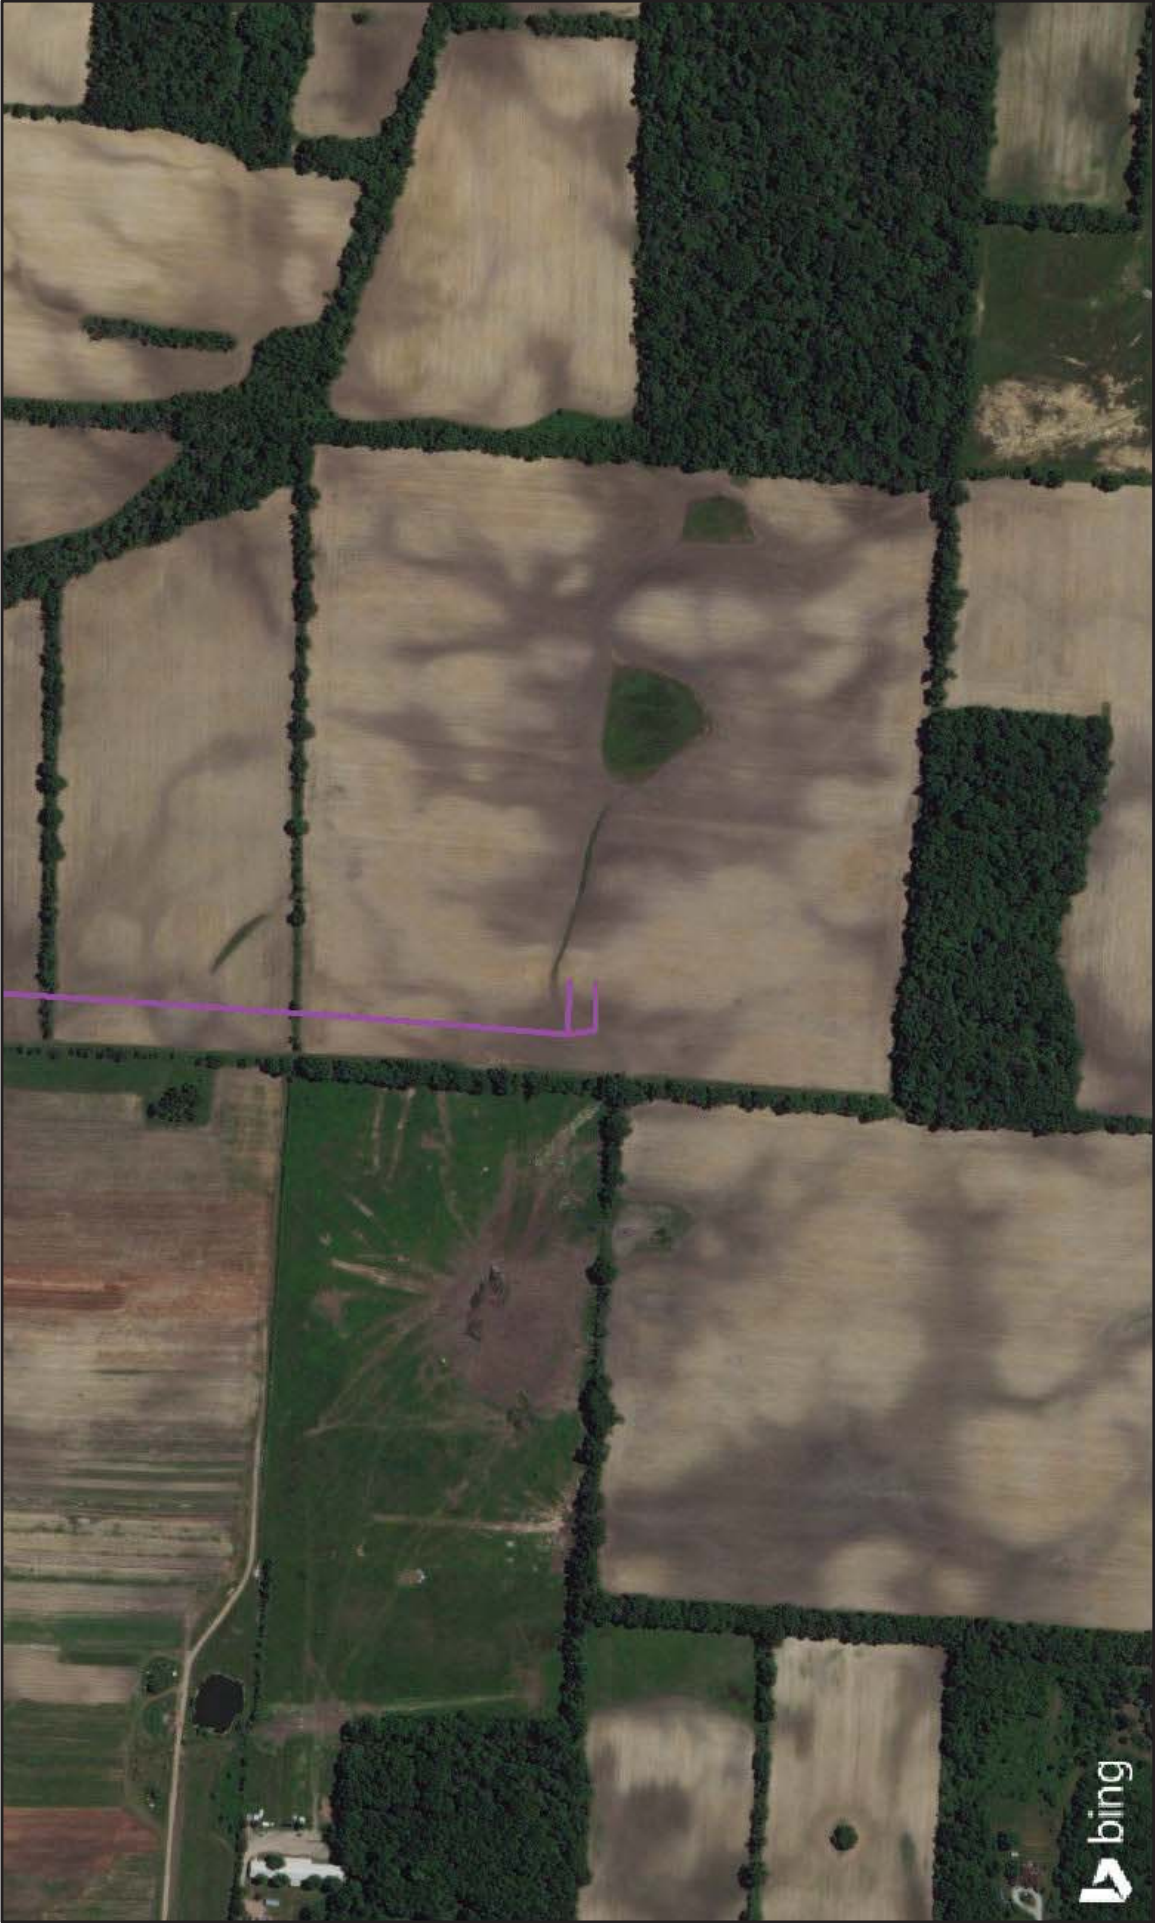
— Proposed Anguin 138 kV Extension

<p>Map 2C</p> <p>Aerial Imagery of Project Area</p>		<p>ANGUIN BABBITT 138 kV Transmission Line Project</p>	
<p>Data Sources: AEP (2019), Bing (2018)</p>		<p>AMERICAN ELECTRIC POWER</p>	
<p>Coordinate System: State Plane Ohio South NAD 83</p>		<p>Anguin-Babbitt</p>	
<p>February 28, 2019</p>		<p>0 250 500 750 1,000 Feet</p>

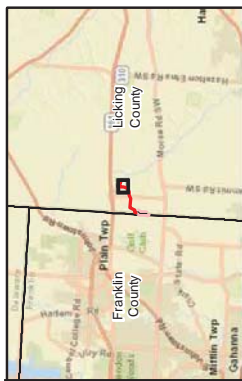
FIGURE 2A
SOIL MAP UNIT AND NATIONAL
WETLAND INVENTORY MAP

- Proposed Babbitt-Anguin 138 kV Transmission Line
 - Project Survey Corridor
 - Mapped NWI Wetlands
 - Soil Map Unit
- Soil Map Unit Symbol**
- BeB: Bennington silt loam, 2 to 6 percent slopes
 - Cen1B1: Centeburg silt loam, 2 to 6 percent slopes
 - Pe: Pewamo silty clay loam, low carbonate till, 0 to 2 percent slopes

series, two soil map units are listed as hydric, while the other three map units have hydric components that comprise 3-6% of the area mapped within the unit (NRCS 2015). Table 1 provides a detailed overview of the soil series and soil map units within the Project survey corridor. Soil map units located within the Project survey corridor are shown on Figure 2.

According to the NWI maps of the New Albany and Jersey, Ohio quadrangles, the Project survey corridor contains four mapped NWI wetlands. The four mapped wetlands include: two palustrine, emergent, persistent, seasonally flooded (PEM1C), one palustrine, unconsolidated bottom, excavated (PUBGx), and one intermittent streambed, seasonally flooded (R4SBC). The locations of the NWI mapped wetlands are shown on Figure 2.

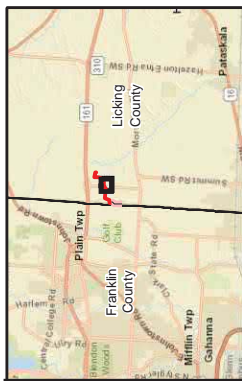
- Proposed Babbitt-Anguin 138 kV Transmission Line
- Project Survey Corridor
- Delineated Stream
- Delineated Wetland
- Agricultural Land
- Landscaped Area
- Old Field
- Stream/Wetland
- Successional Woodland
- Urban

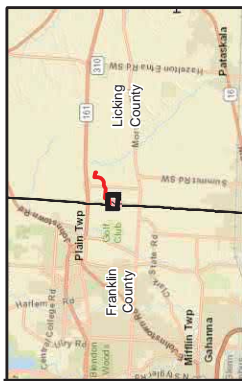
- Proposed Babbitt-Anguin 138 kV Transmission Line
- Proposed Anguin 138 kV Extension
- Station
- Project Survey Corridor
- Delineated Stream
- Delineated Wetland
- Delineated Pond
- Agricultural Land
- Old Field
- Stream/Wetland
- Successional Woodland

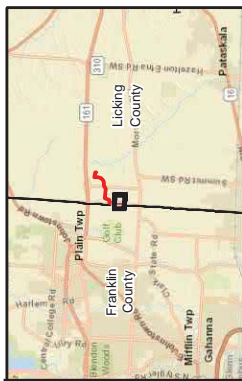
- Proposed Anguin 138 kV Extension
- Project Survey Corridor
- Delineated Stream
- Delineated Wetland
- Agricultural Land
- Stream/Wetland

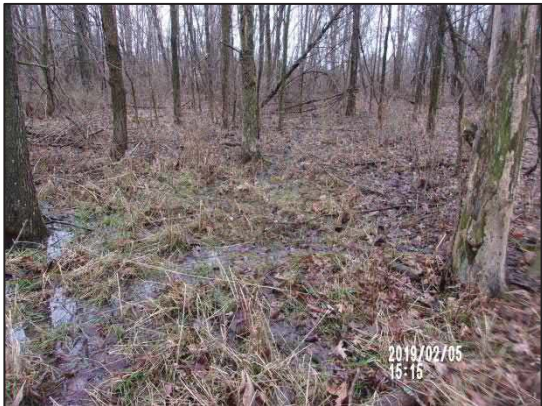
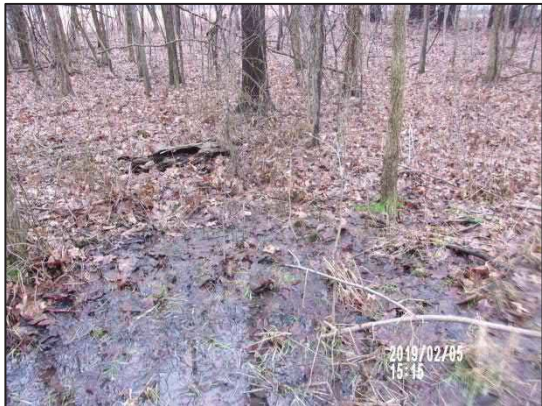
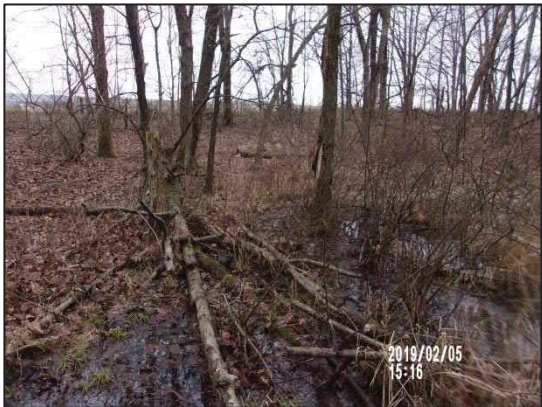
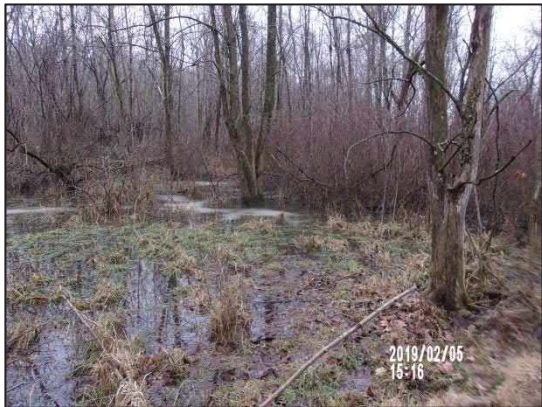
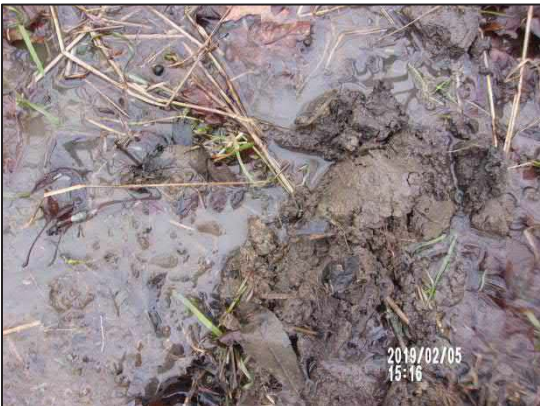
Date: February 5, 2019 Description: AECOM Wetland 01 PFO wetland Category 2

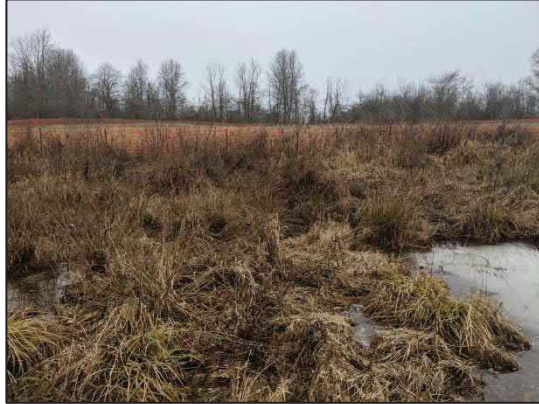
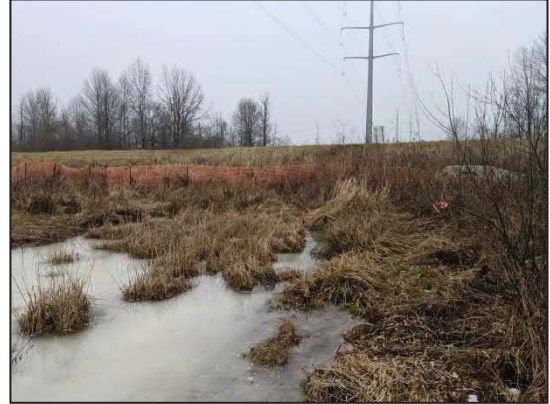
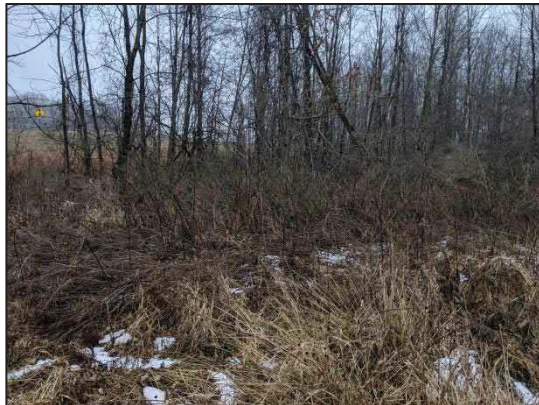
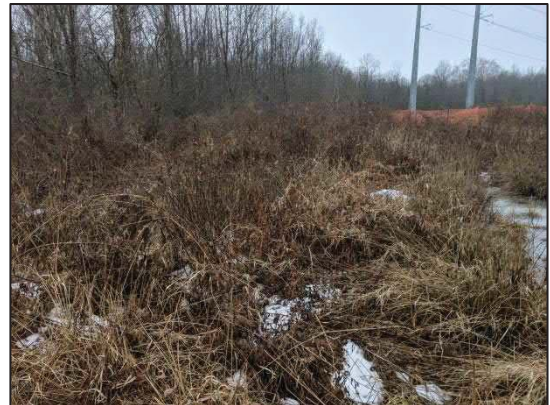
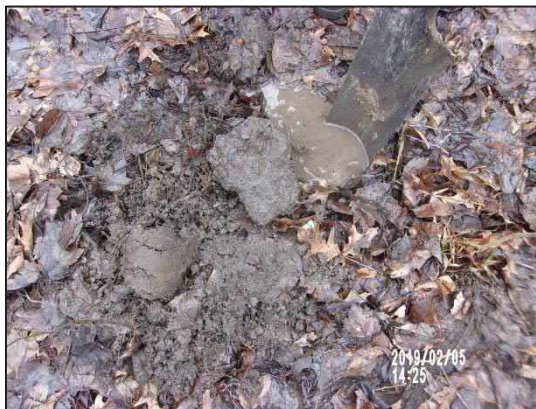
PEM wetland

Category 2

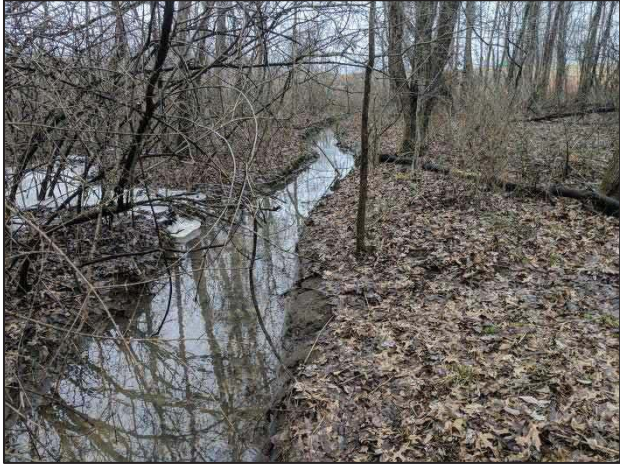
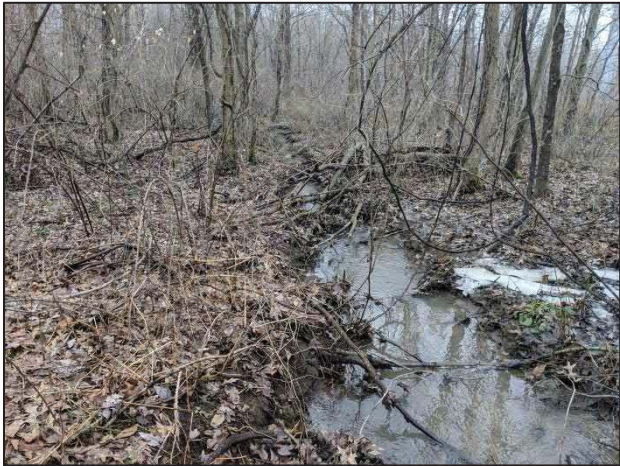
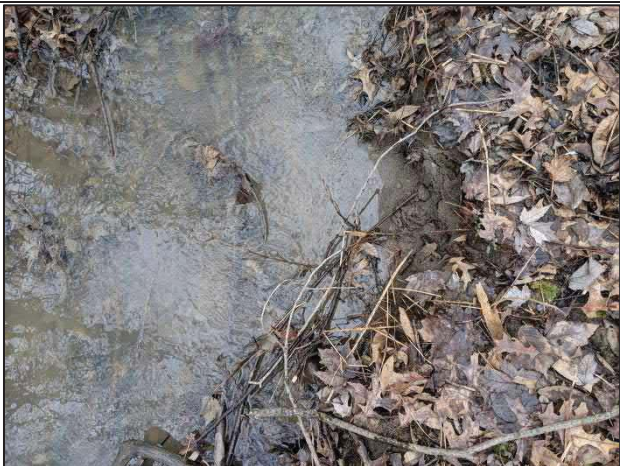
<p>Substrate</p>
Description: AECOM Stream 01 Intermittent Modified Class 2

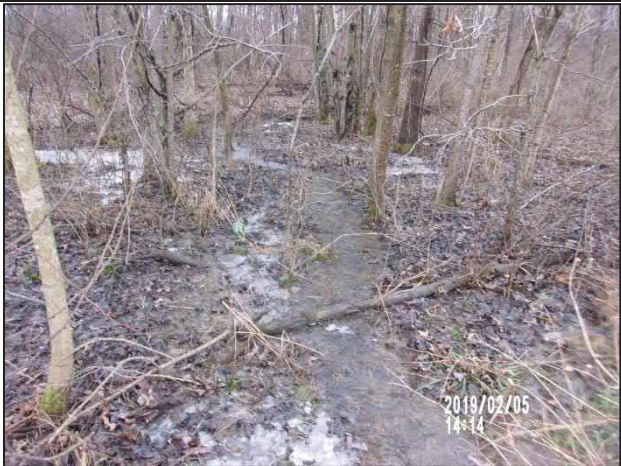
Date: February 5, 2019 Description: AECOM Stream 02 Intermittent Modified Class 1	
	  <p>Facing Upstream</p>
